DENGERINK TILE COLUMN REPAIR

WASHINGTON STATE UNIVERSITY - VANCOUVER
C/O FACILITIES SERVICES, CAPITAL
P.O. BOX 641150
PULLMAN, WA 99164-1150

CONDITION ASSESSMENT
APRIL 2025

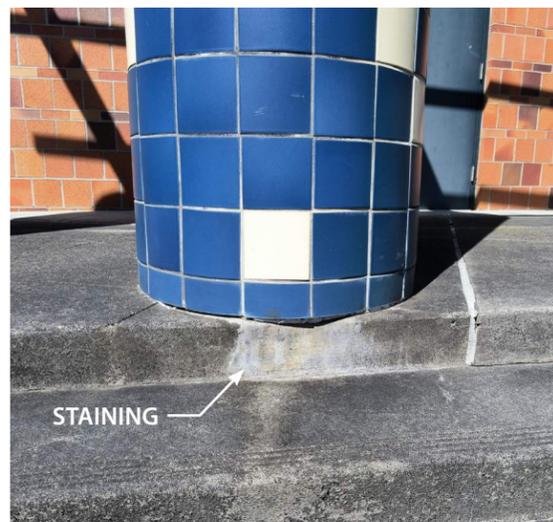
◀ Figure 5: (L) Concrete staining directly below overhanging purlin above.

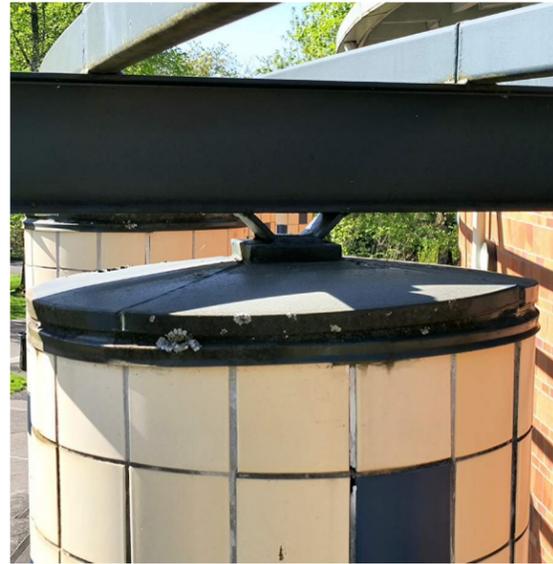
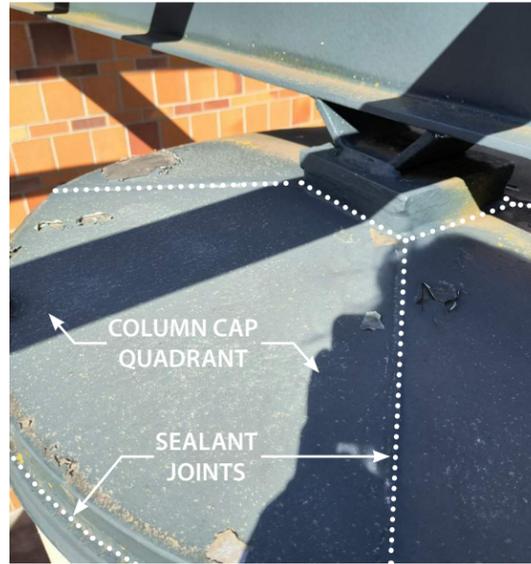
◀ Figure 13: (L) Overall column cap and trellis connection.
◀ Figure 14: (R) Quadrants of column cap.

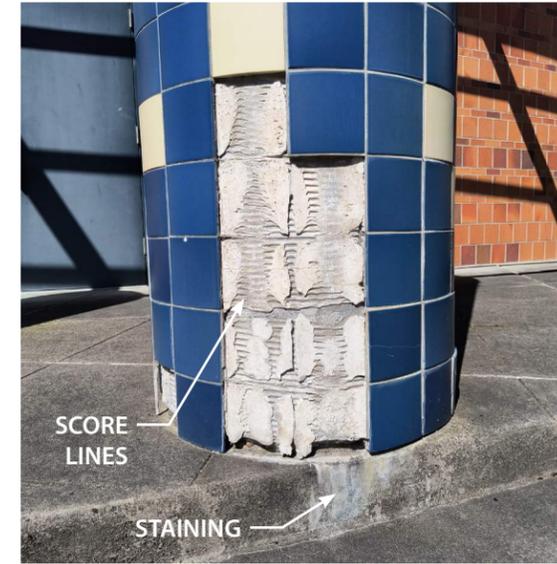
▶ Figure 19: (L) Scoring lines in exposed grout where tiles have fallen off.
▶ Figure 20: (R) Backer rod at vertical control joint between tiles; tile spacer at ground.

Installation means & methods may contribute when the improper installation of one or more components leads to failure. In multiple locations where tiles are missing, visible scoring can be observed in the grout which suggests that the tiles were not fully adhered to the substrate when applied (see Figure 19). Water intrusion behind tiles that were not fully adhered may have contributed to them falling off.

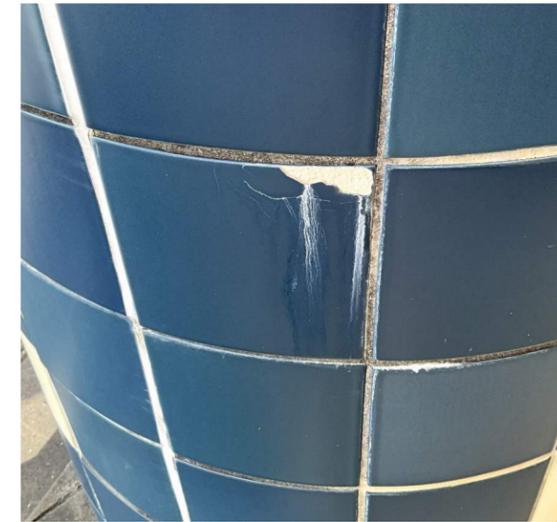
▶ Figure 21: (L) Spalled tile glaze.

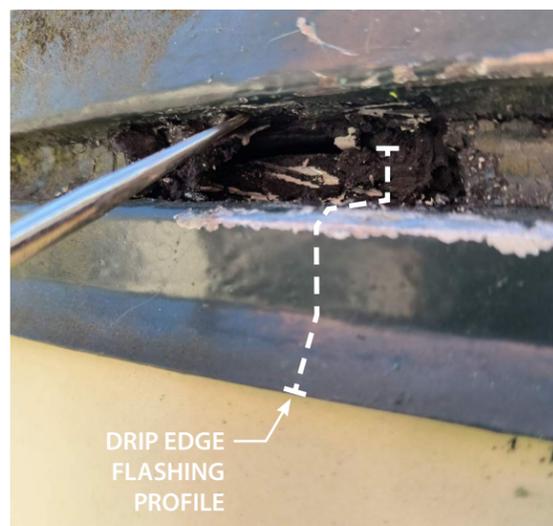
◀ Figure 17: (L) Sealant joint between cap and drip edge flashing; flashing leg turned up at back of joint.
◀ Figure 18: (R) Efflorescence staining at repointed tile joints.

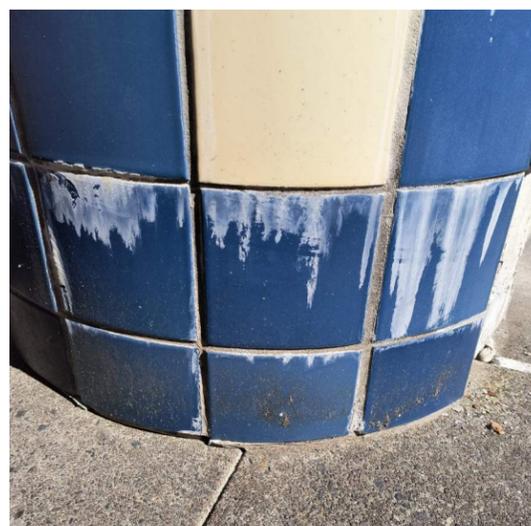
- Open joints at sky-facing sheet metal caps (see Figure 24)
- Wind-driven rain at open joints between tiles (see Figure 25)
- Capillary action at ground level drawing water up into the tile substrate (see Figures 19 & 27)
- Additional water dripping from the steel trellis structure, as evidenced by staining (see Figures 5, 16 & 19)
- Water trapped within column due to a lack of weeps and/or the use of excessive sealant as evidenced by efflorescence (see Figure 18)

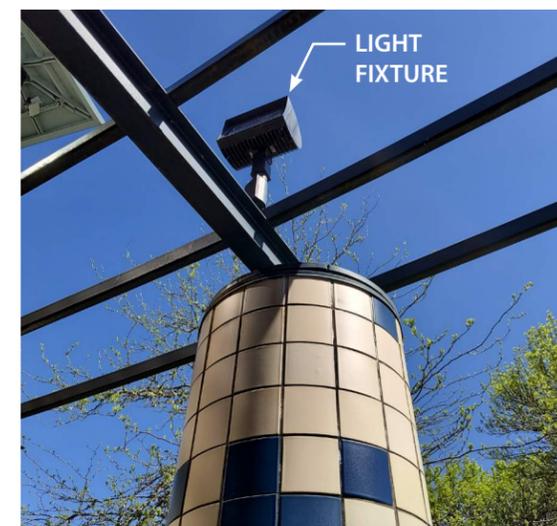
▶ Figure 22: (L) Light fixture mounted atop steel trellis.
▶ Figure 23: (R) Drip line on concrete below gutter.

Unrelated to the "Dengerink" columns, PMA noticed the adjacent gutter system of the auditorium roof appears to be leaking as evidenced by a semi-continuous drip-line on the concrete directly below the gutter (see Figure 23). PMA visually assessed the gutter and confirmed it is not filled with debris (see Figures 30-32), but was unable to confirm where the gutter is leaking from given the dry conditions during both site visits.

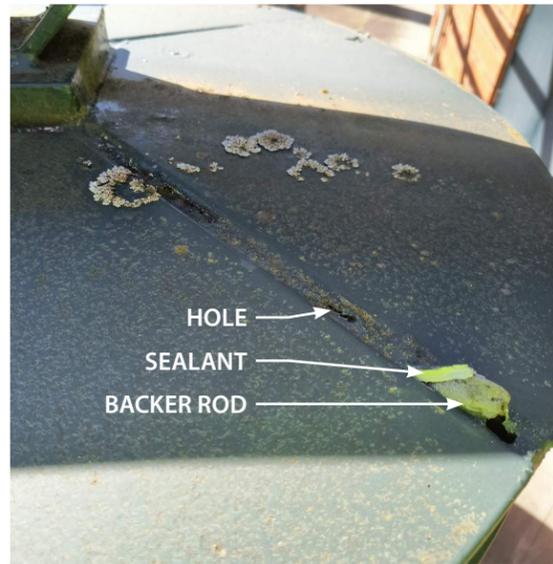
◀ Figure 24: (L) Open sealant joint at column cap with backer rod exposed.

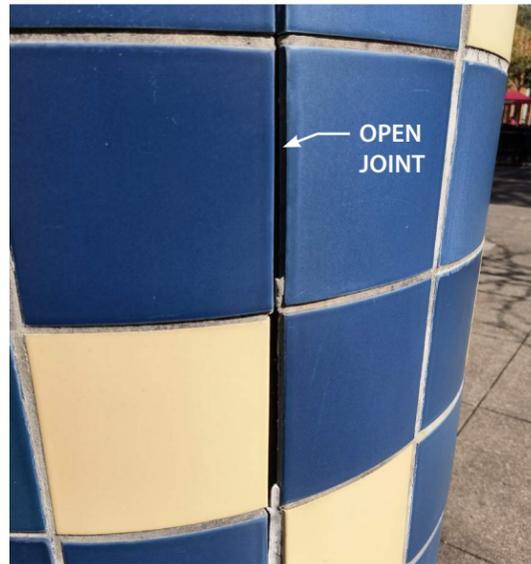
◀ Figure 25: (R) Open vertical joint at column face between tiles.

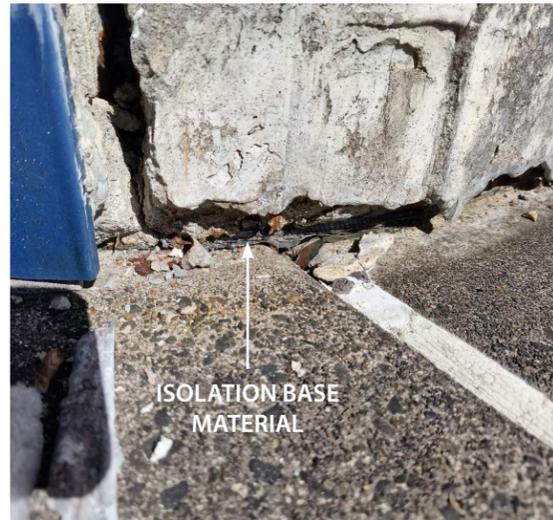
◀ Figure 26: (L) Isolation base material laid below steel framing tracks at ground level.

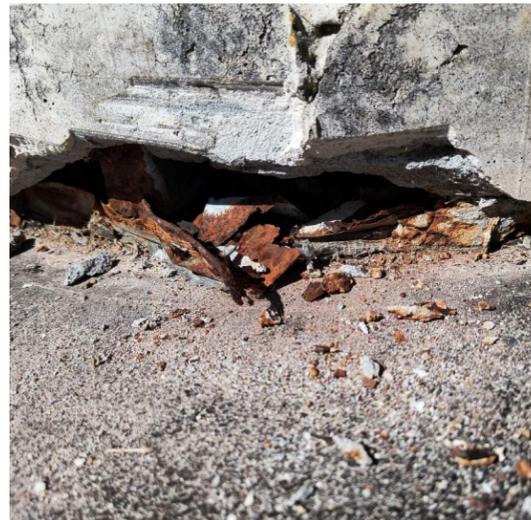
◀ Figure 27: (R) Corrosion of framing tracks and base of steel studs. Corrosion was not observed on visible areas of studs above ground level.

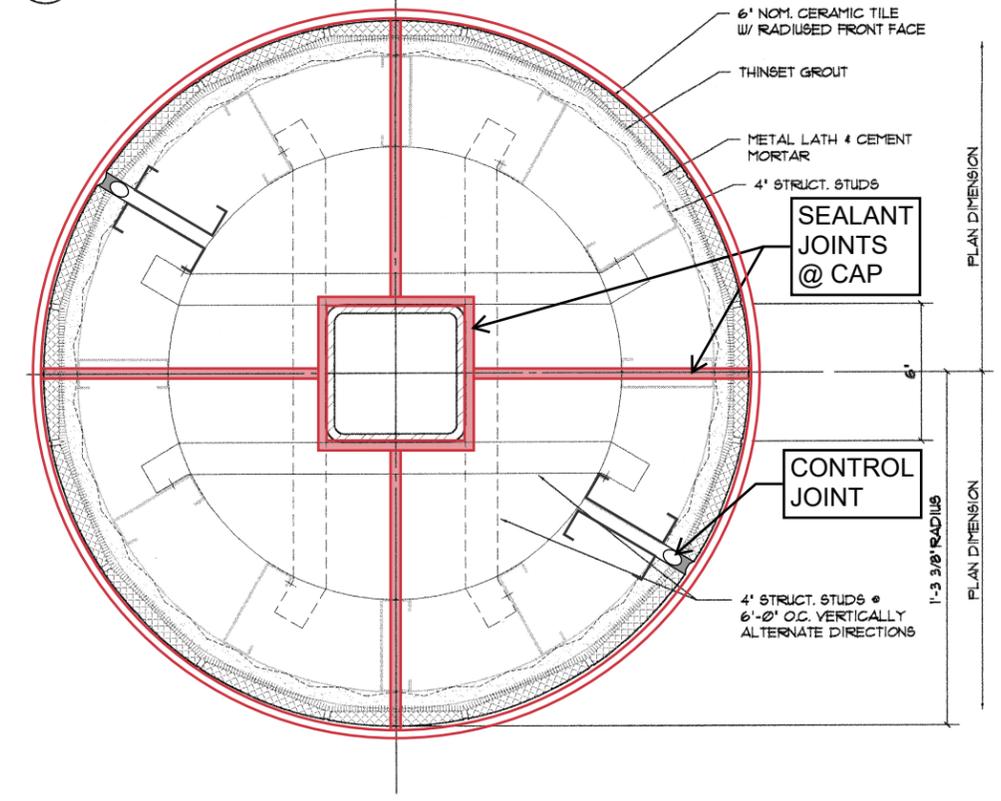
5 TILE COLUMN (EXISTING) * 15/A4.6 IN 1994 DRAWING SET
 G-01 SCALE: 1/2"=1'-0"

5/G-01 DRAWING NOTE:
 SEALANT JOINTS AND CONTROL JOINTS AS SHOWN ARE NOT PART OF ORIGINAL DESIGN; JOINTS ARE SHOWN TO REFLECT EXISTING CONDITIONS.
