Pacific madrone provenance trial – fall 2013 assessment

Starker Forests site

Pacific madrone trial: Starker Forest site -
fall 2013 assessment

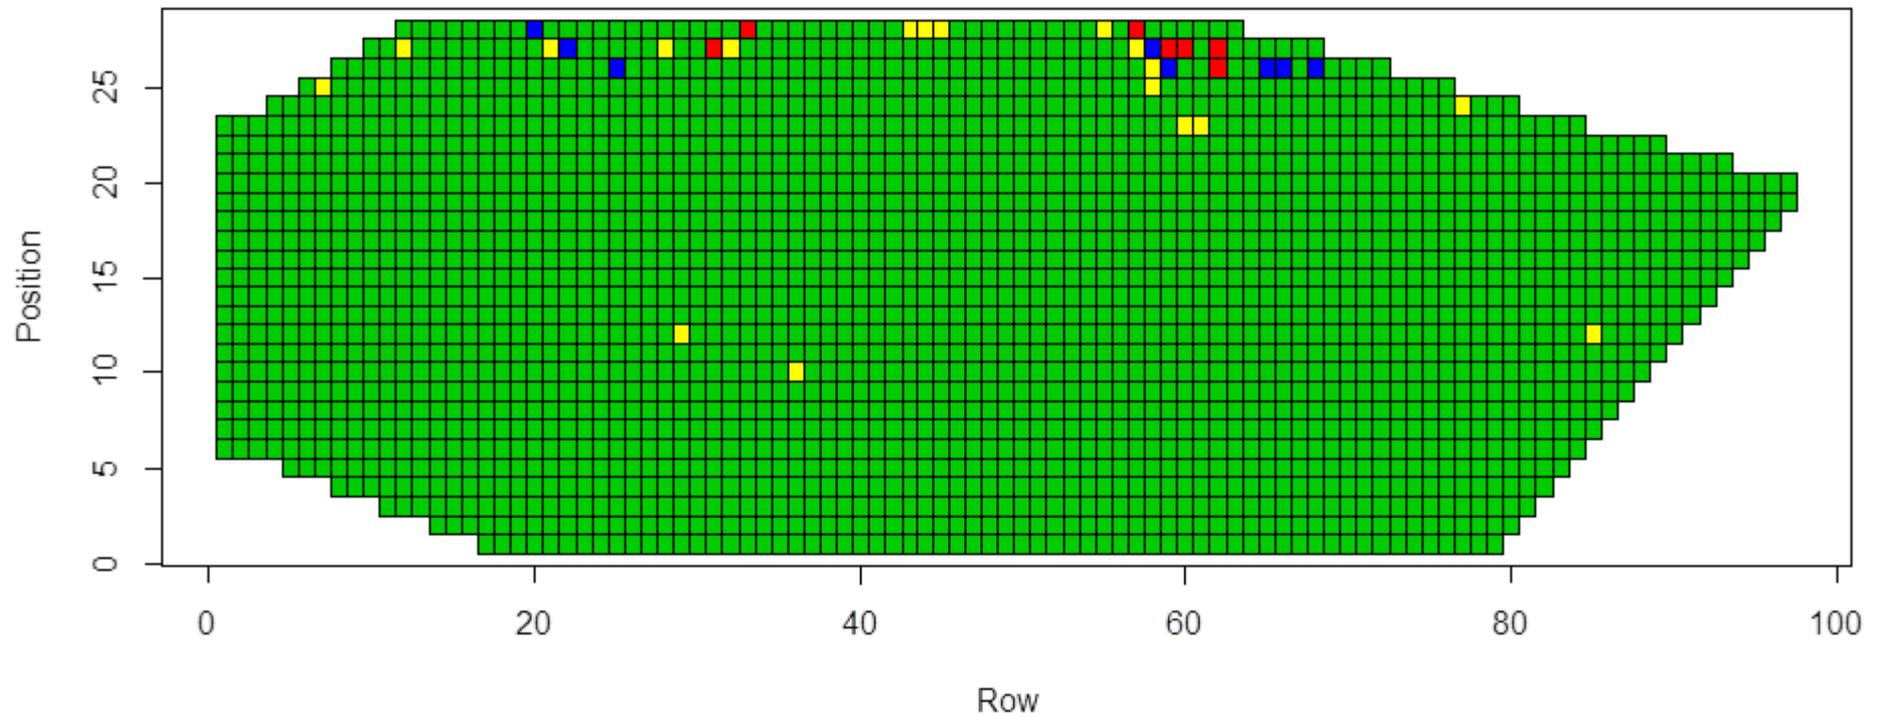
Pacific Madrone, Starker Forest Variegation Incidence for Alive Trees, 102913, DRAFT (Red = 2012, Yellow = 2013, Blue = Both)

Location of trees with variegated leaves. Note: most such trees are along the road, close to the forest area

Variegated Trees

- It will be interesting to see how many years these persist and whether they are generally the same trees over years.
- M.E. (in 2012) suggested possibly due to [1] virus, or [2] herbicide
- We haven't looked at family trend, but believe it is fairly independent of that

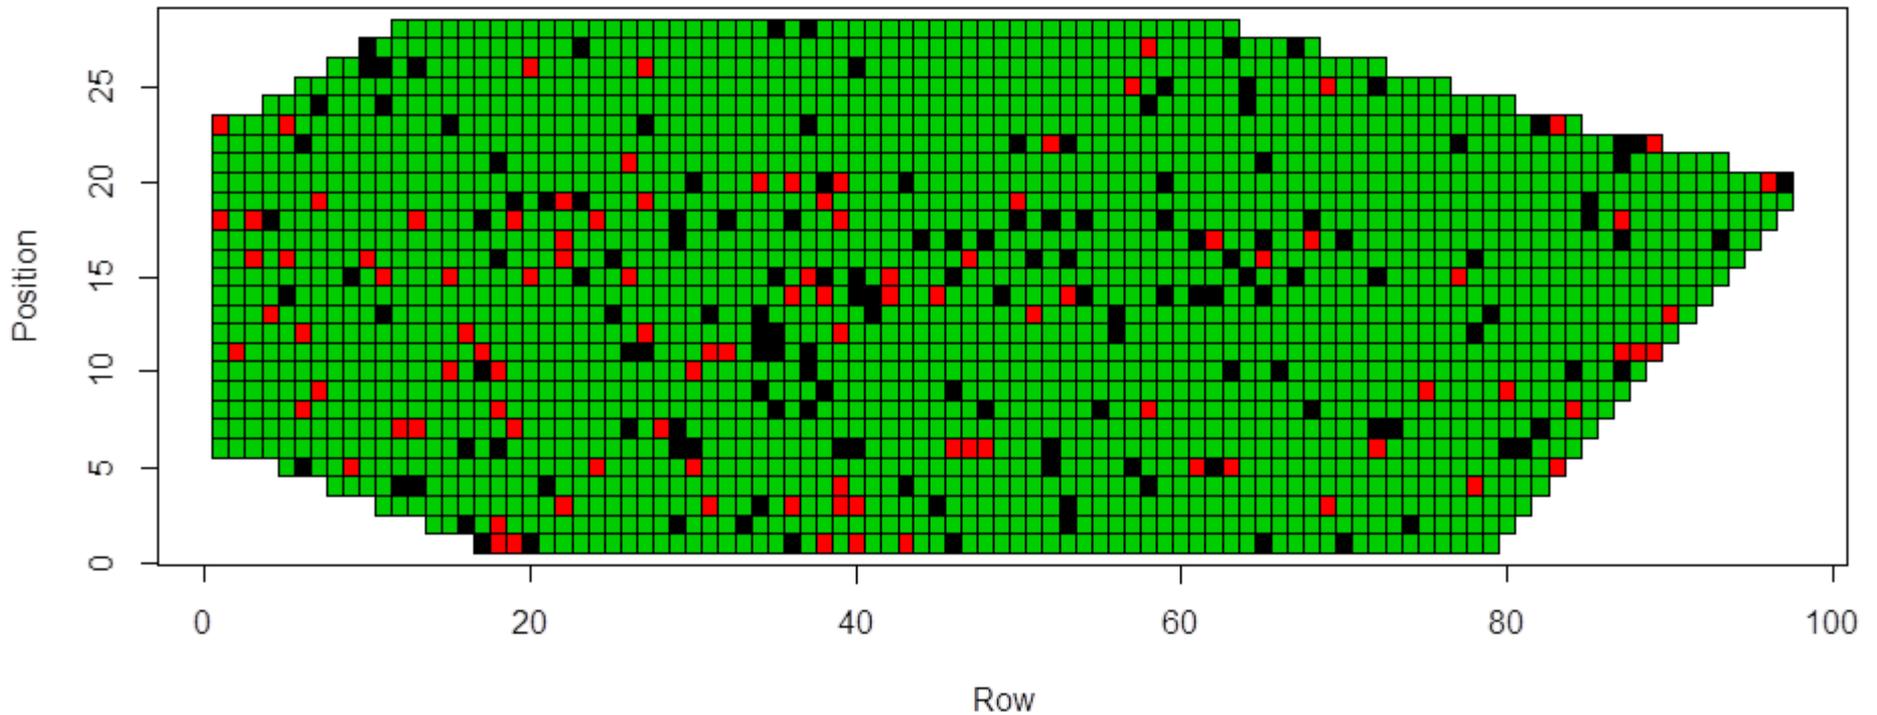
Pacific Madrone, Starker Forest 2013 Height Increments for Alive Trees, 102913, DRAFT (less than 5 cm growth is red, otherwise green)

Growth increment from Fall 2012 to Fall 2013 reading.

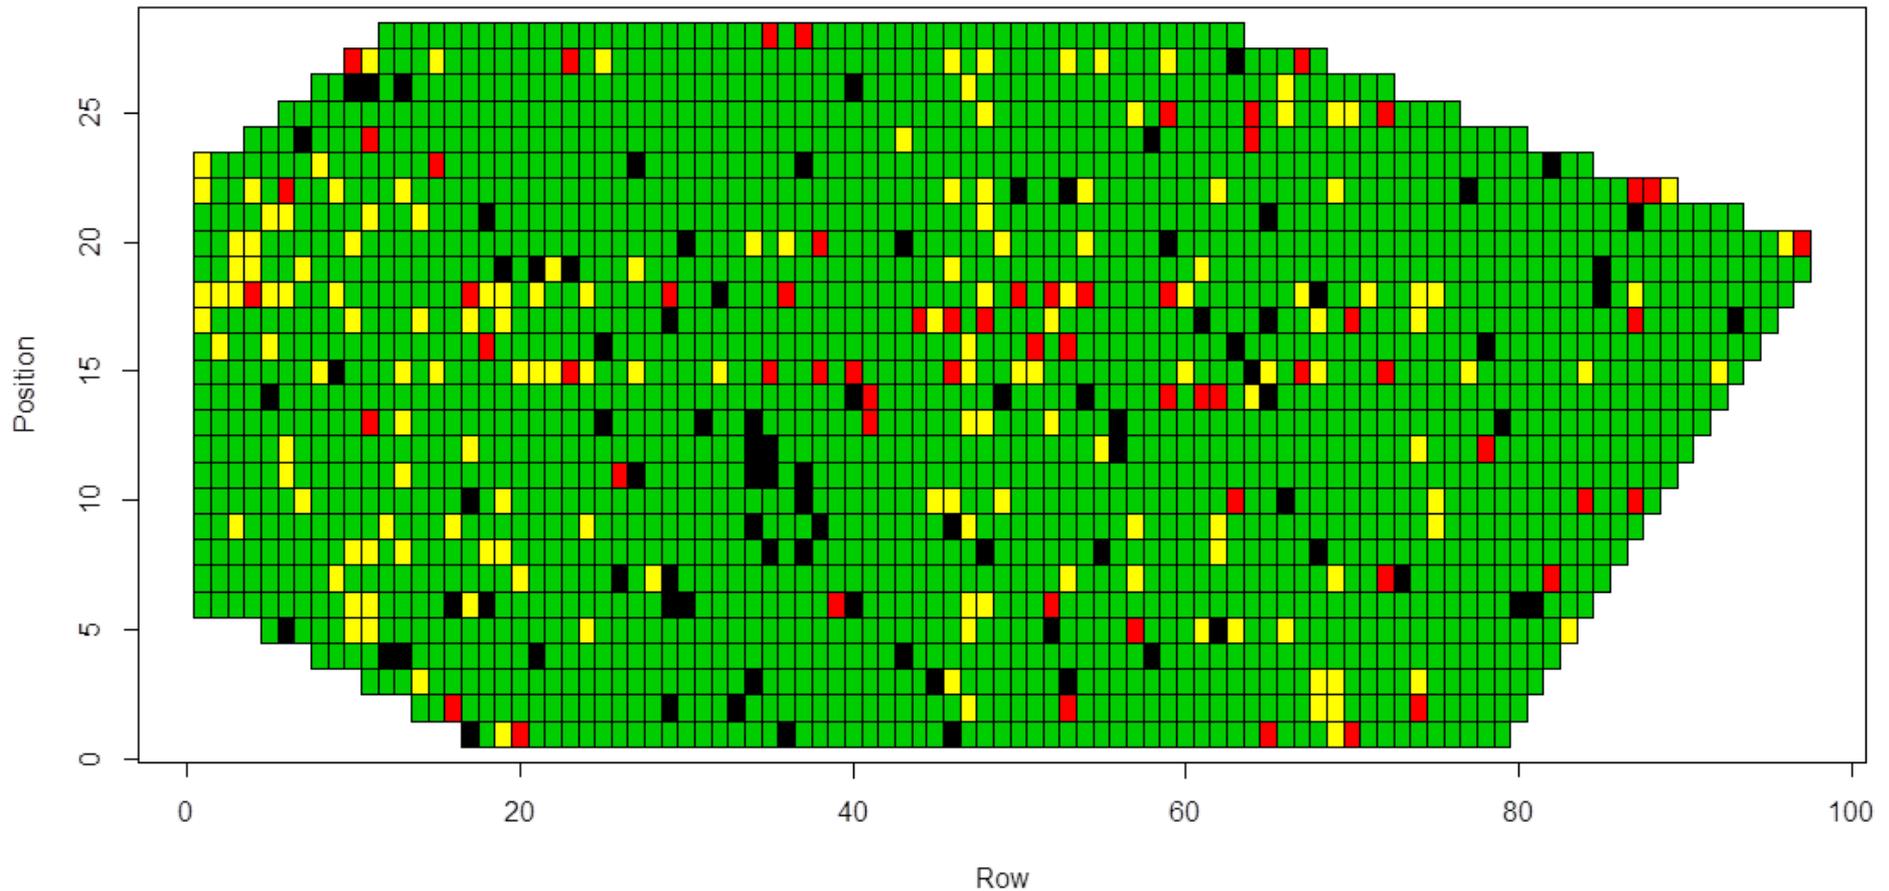
Pacific Madrone, Starker Forest 2013 Mortality (Red)
and 2013 Dieback (Yellow) with 2012 Dead/Missing in Black, 102813, DRAFT

Mortality in 2012 or 2013, or dieback in 2013

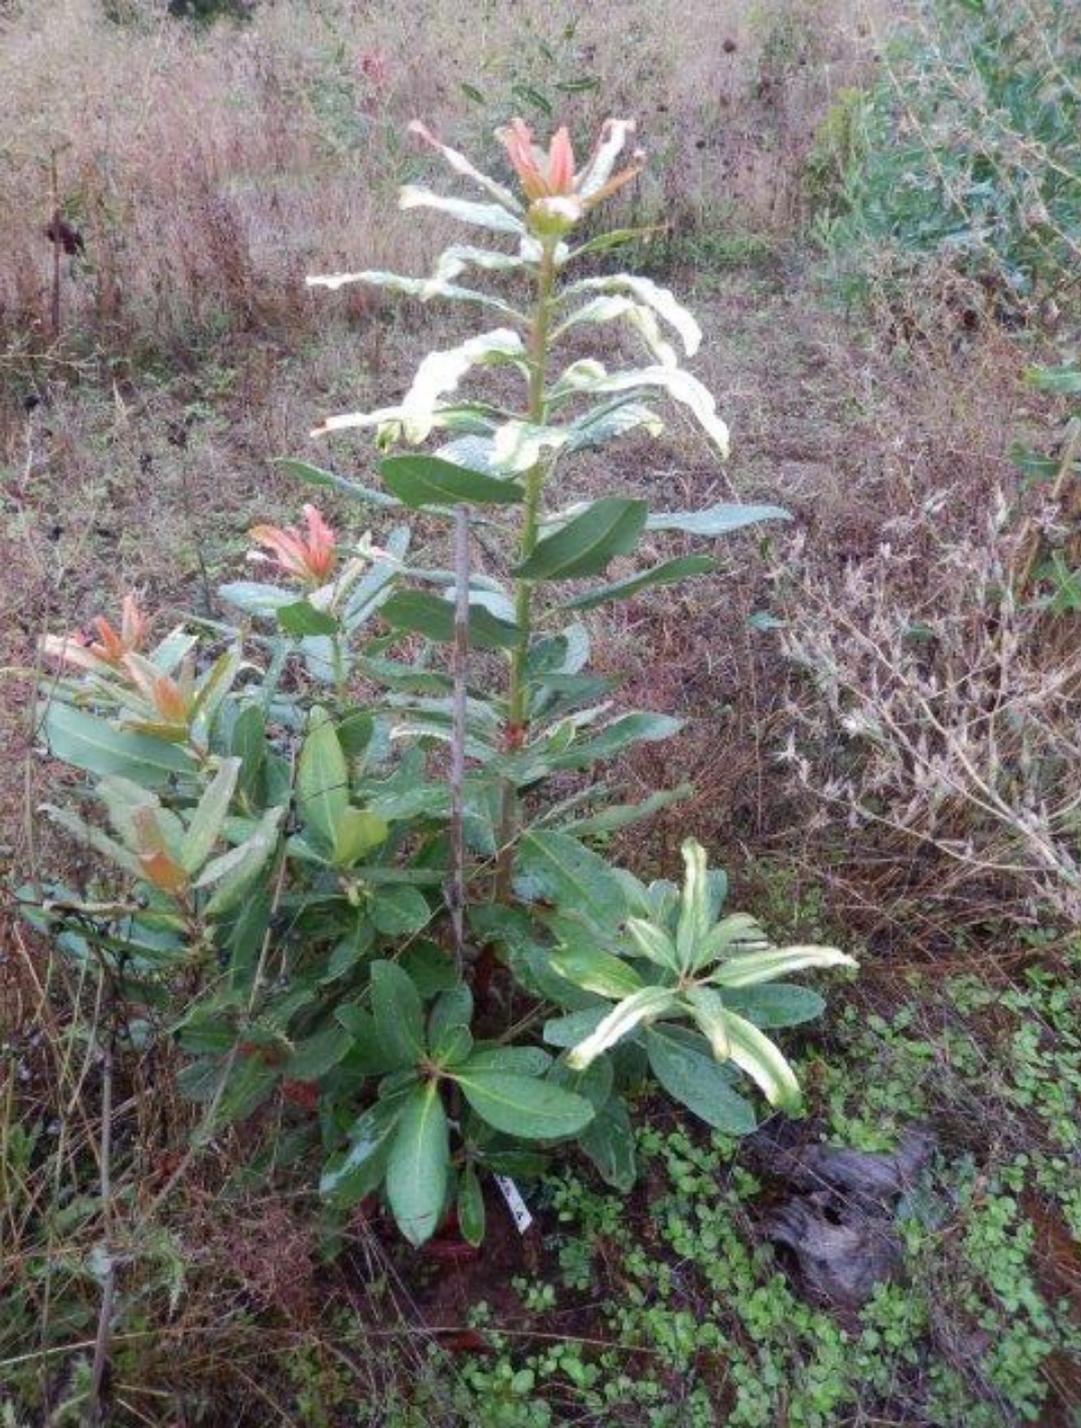
One of the variegation Pacific madrone at Starker Forests site – they occurred within ~3 rows of the road (DSCN606-607.jpg)

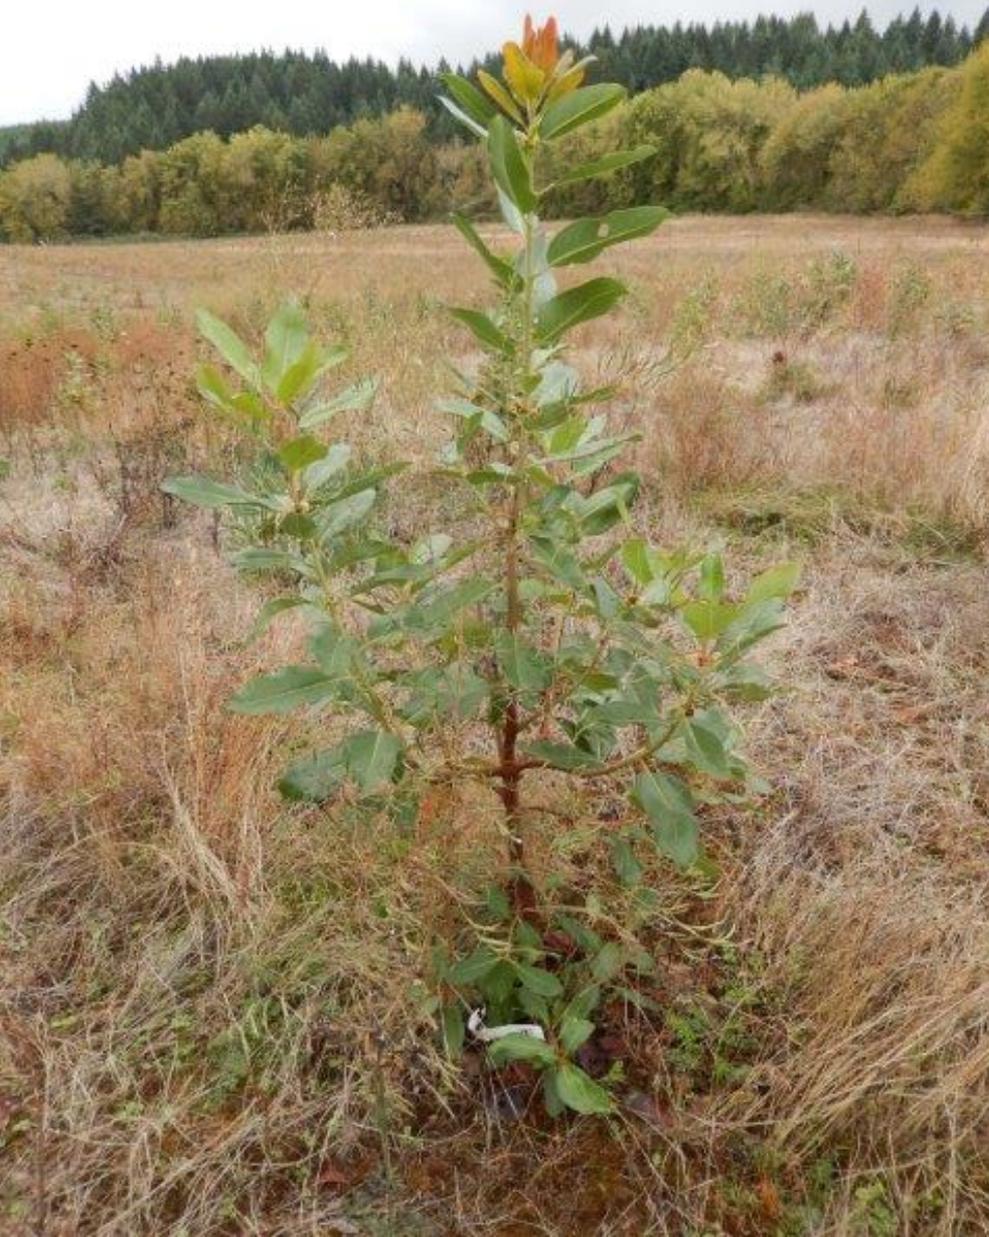
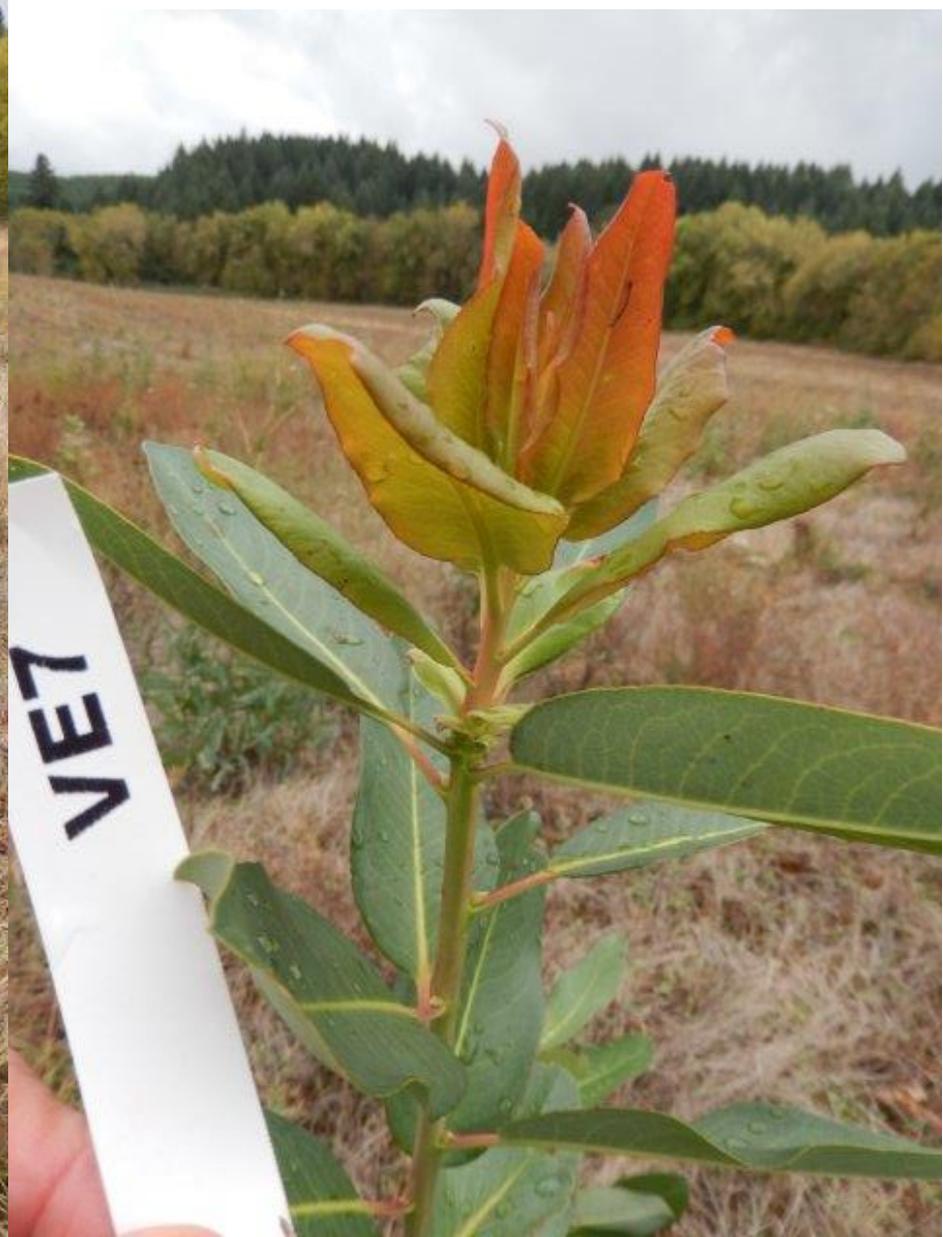
New growth occurring in late Sept 2013 (DSCN0622-0623.jpg)

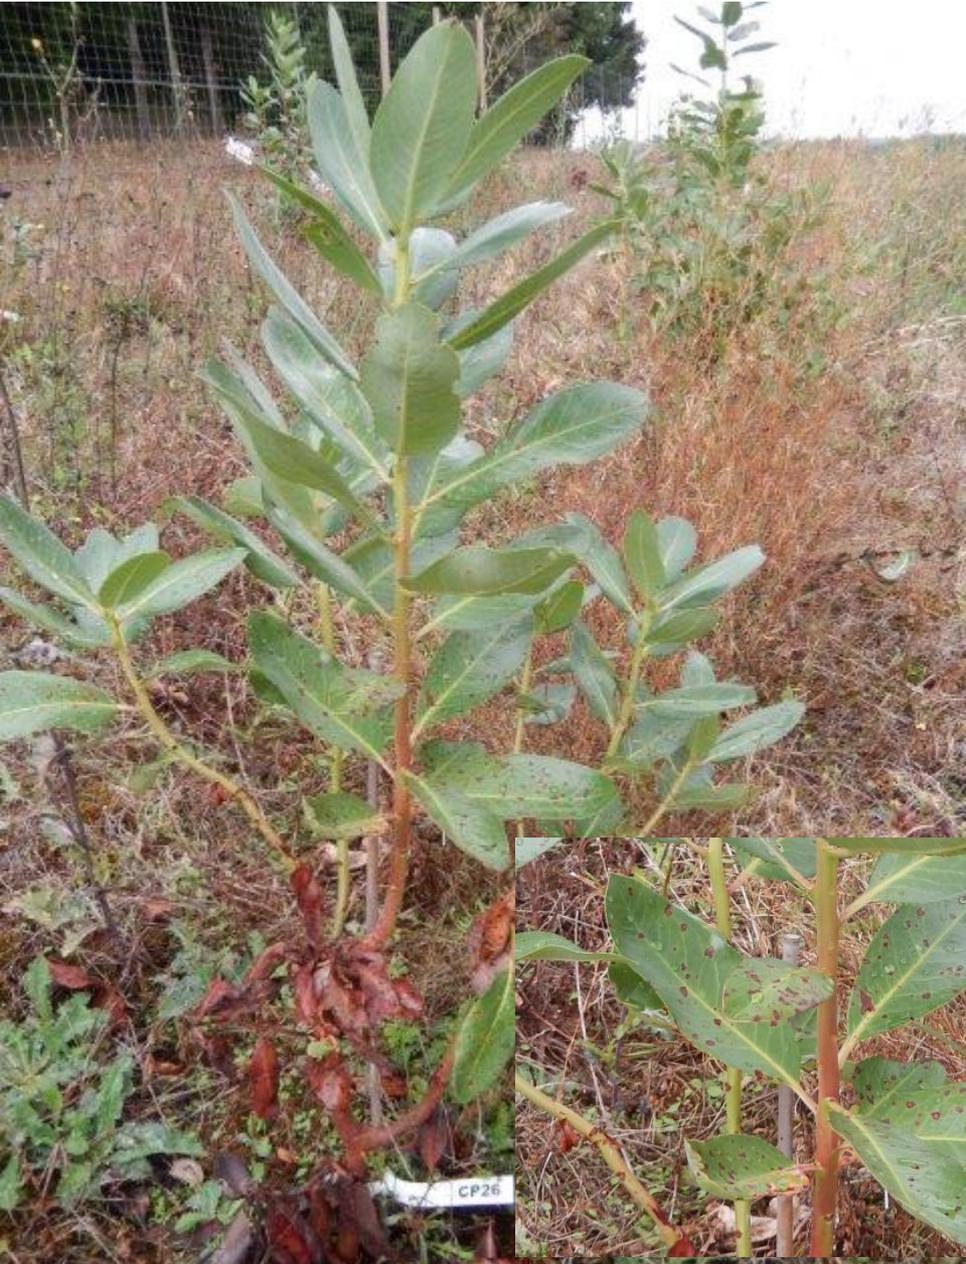
CP26 with leaf spots (DSCN0634.jpg)

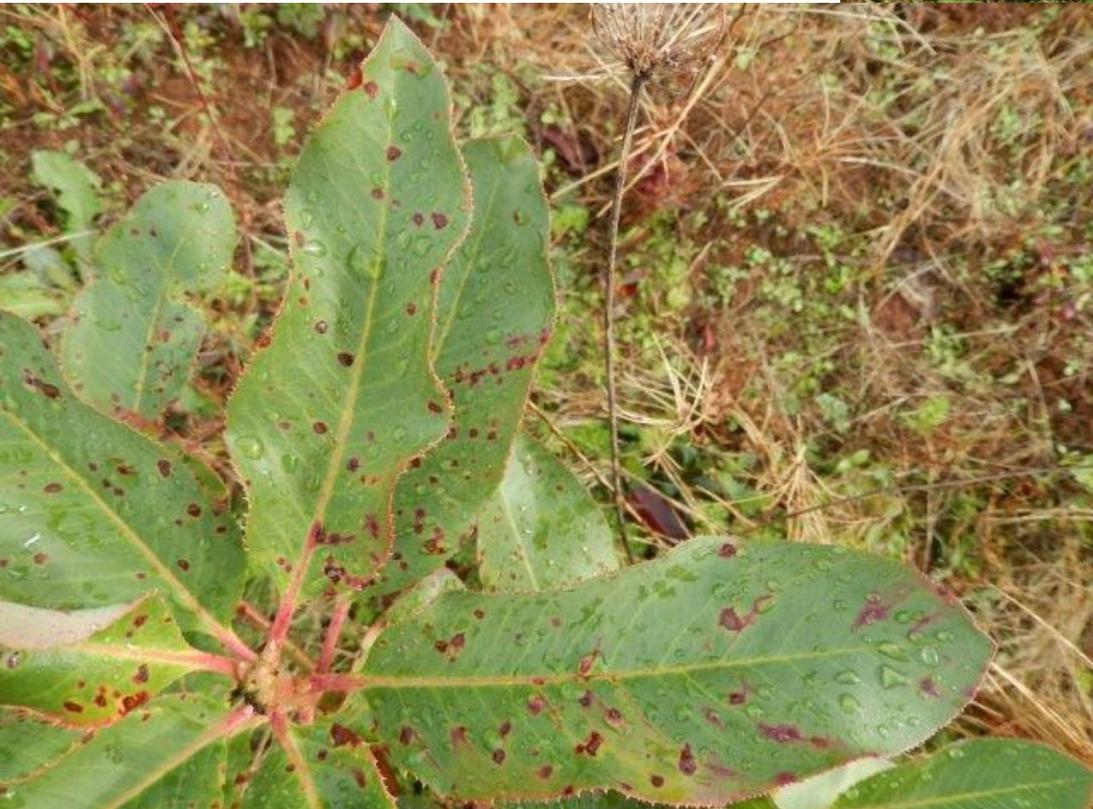
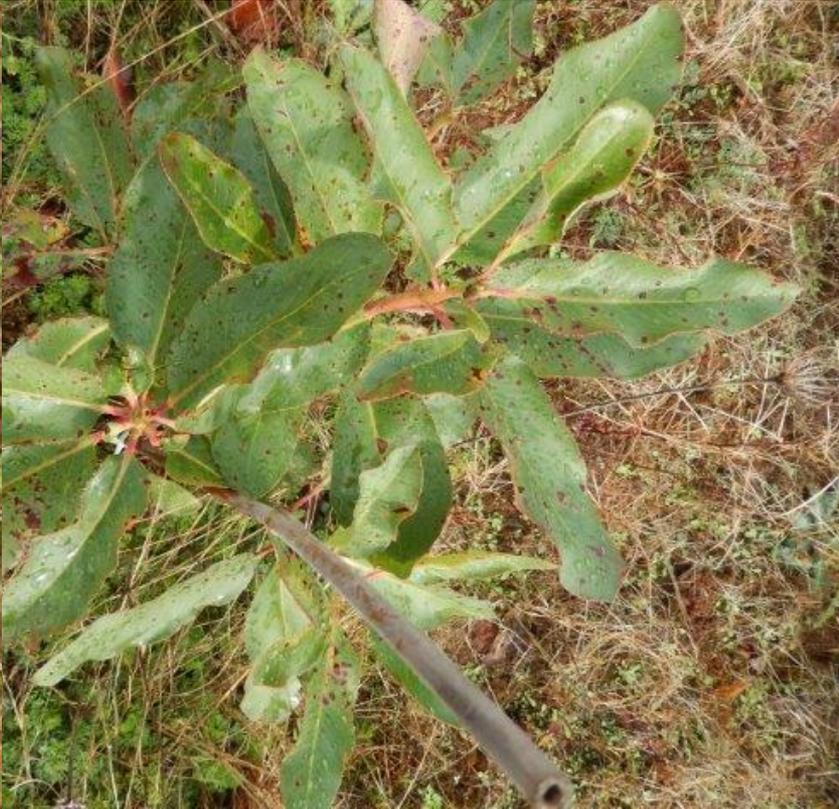
Leaf spotting on a KL10 tree (DSCN0643-0645.jpg)

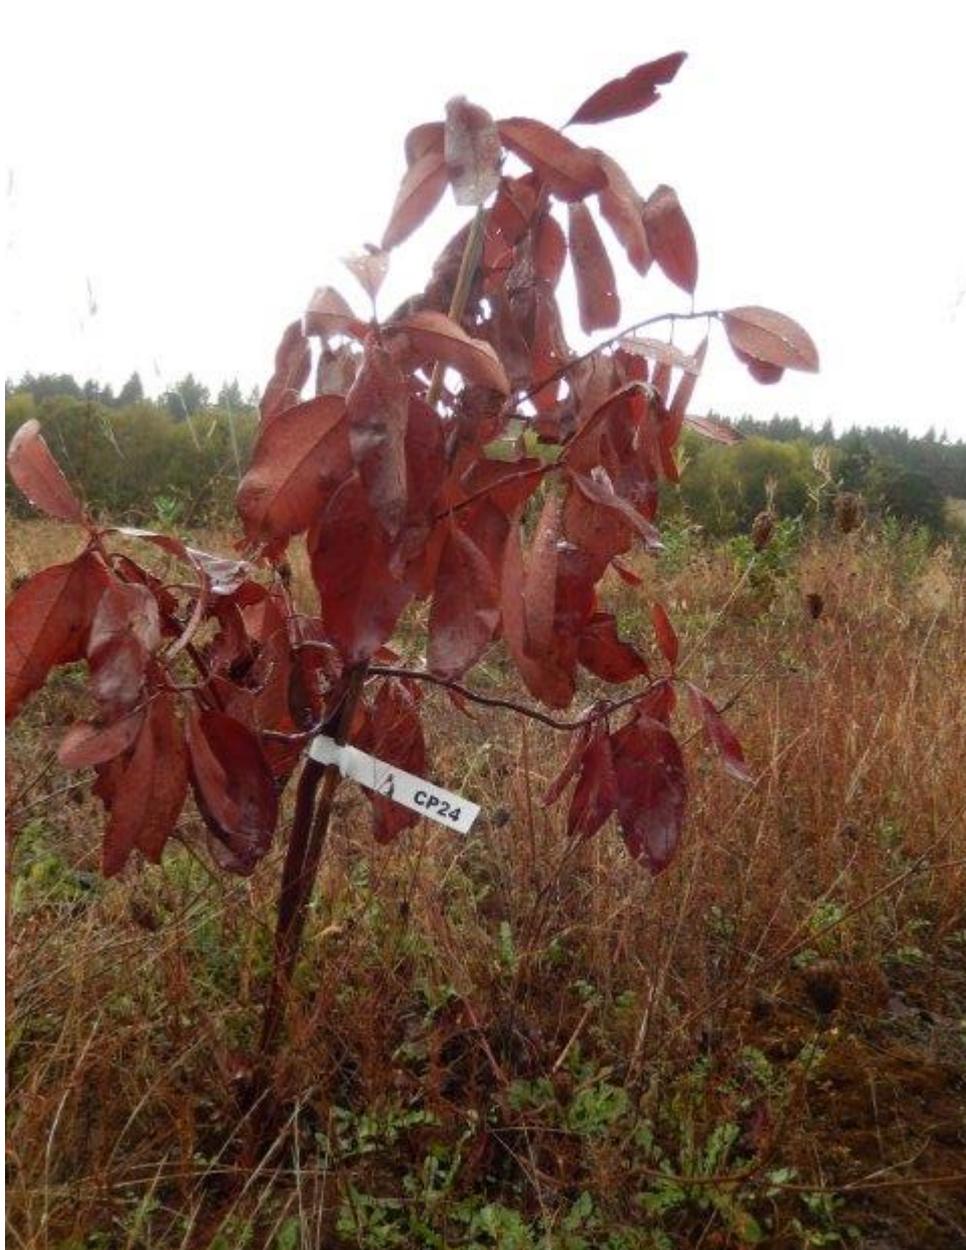
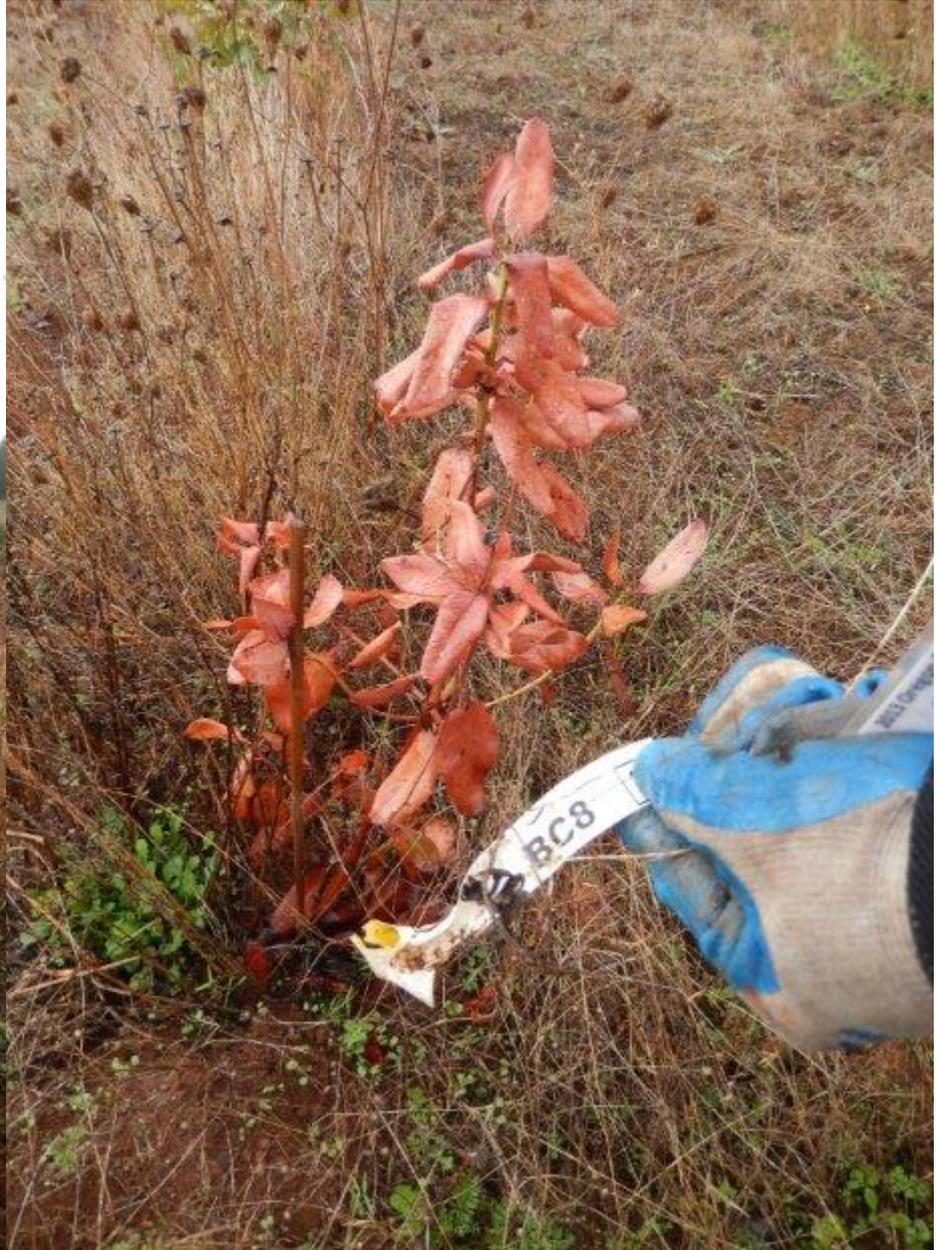
Two recent dead trees (DSCN0650-0651.jpg)

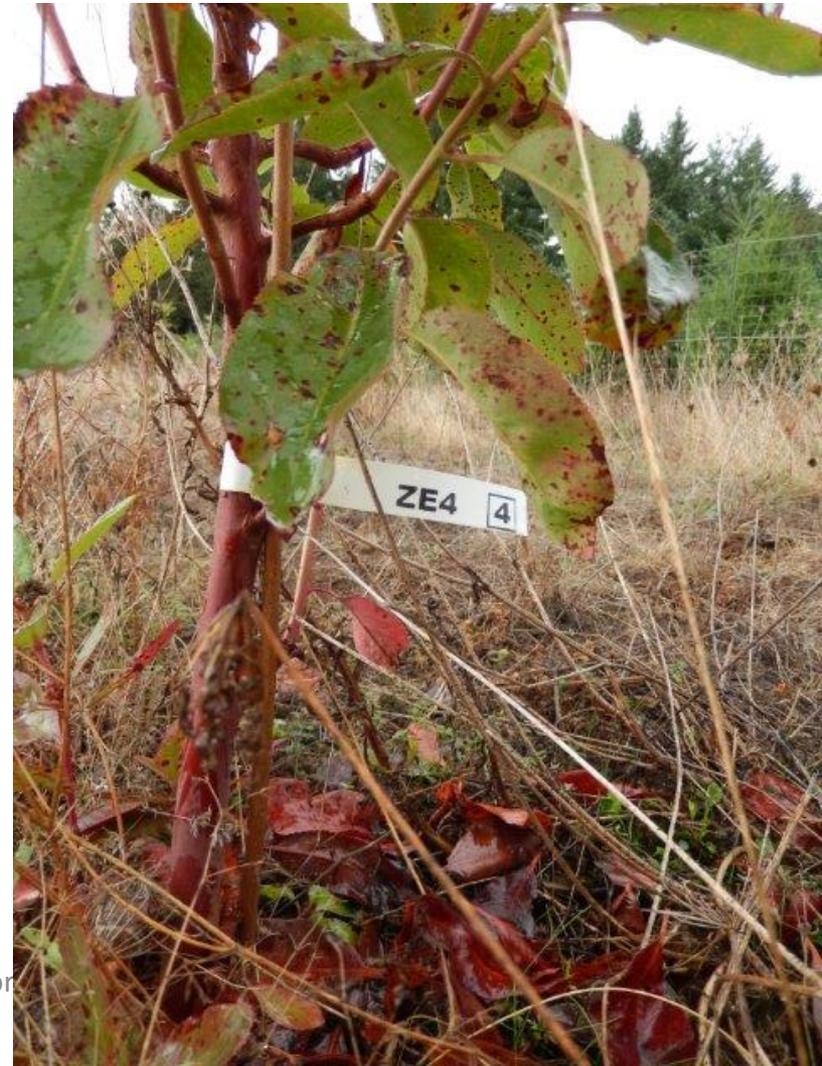
Leaf spot on old leaves
(DSCN0658-0659.jpg)

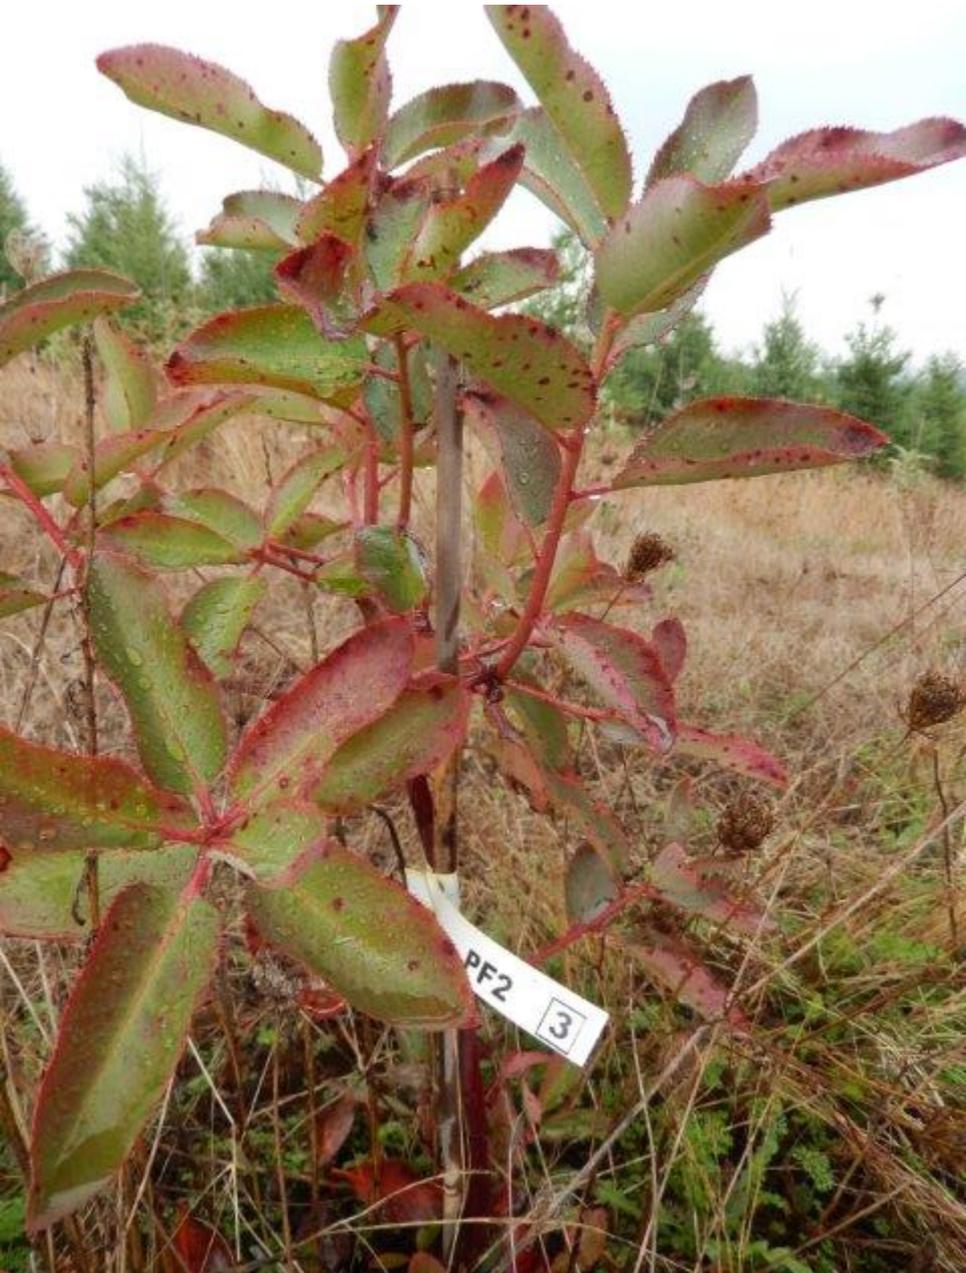
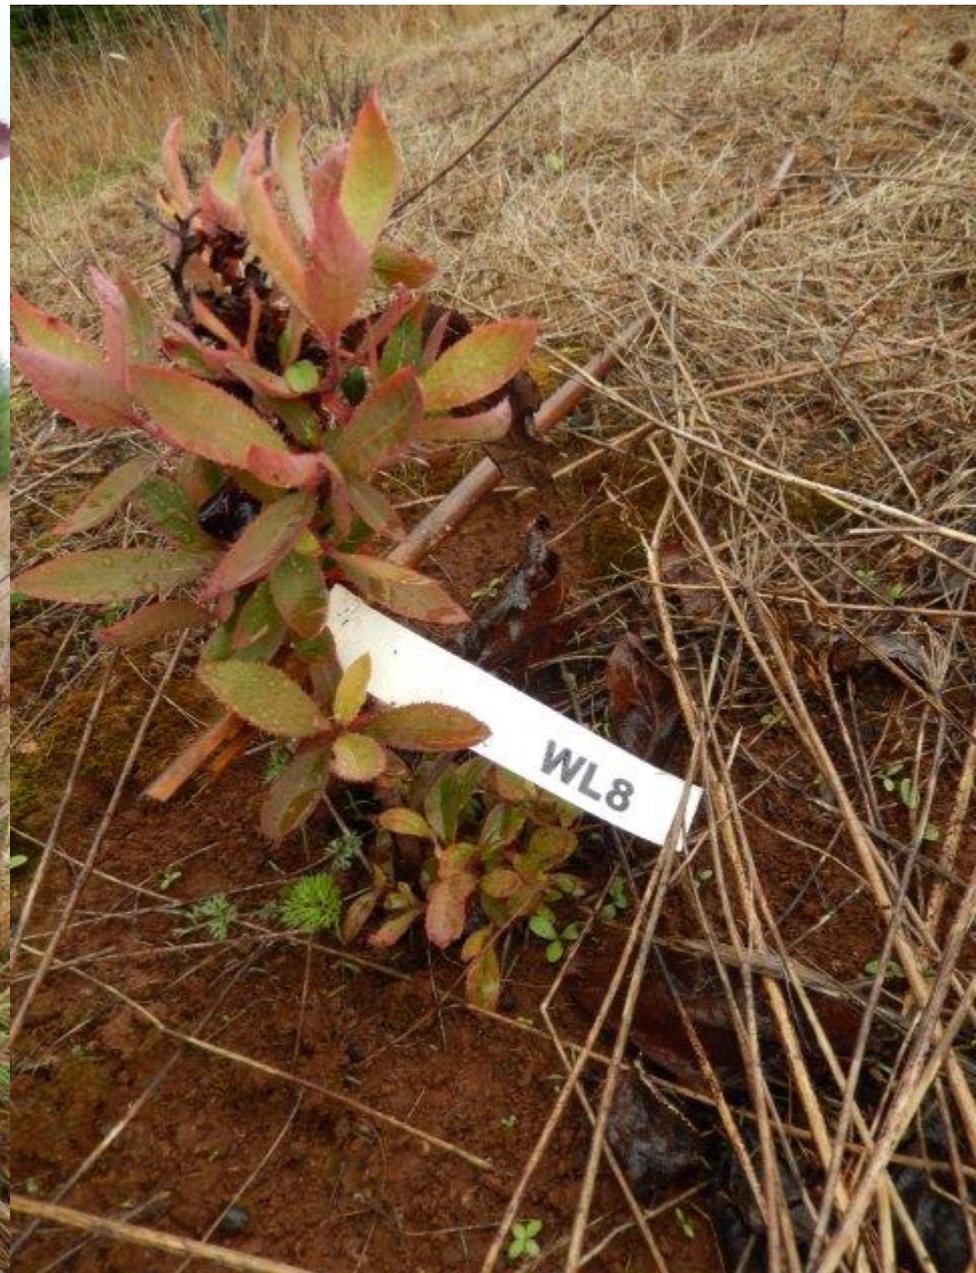
Reddish-green foliage on trees of 2 families (DSCN0660, 0662.jpg)

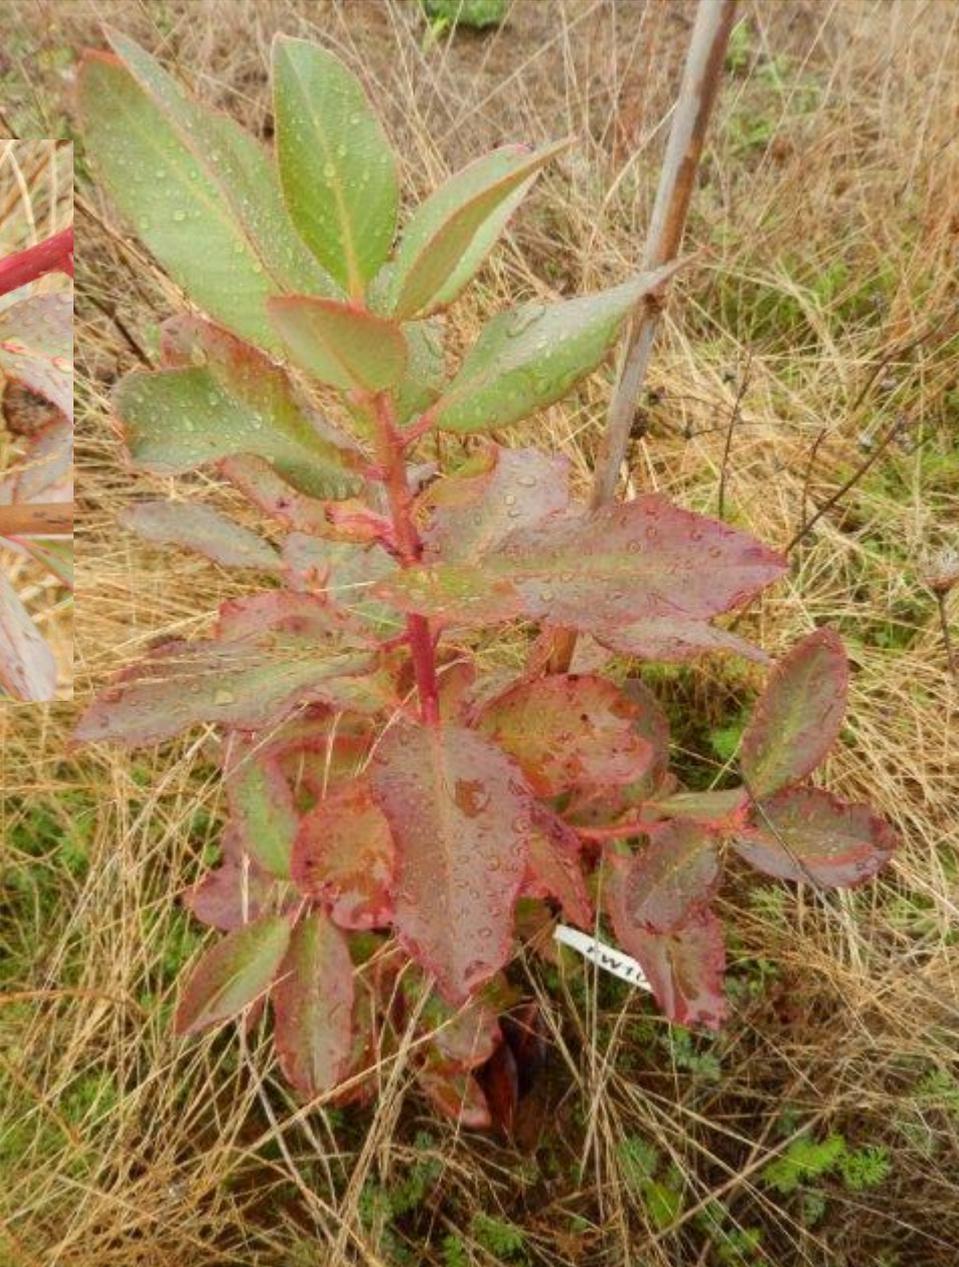
(DSCN0672-0674.jpg)

Red-green foliage on FW10 tree

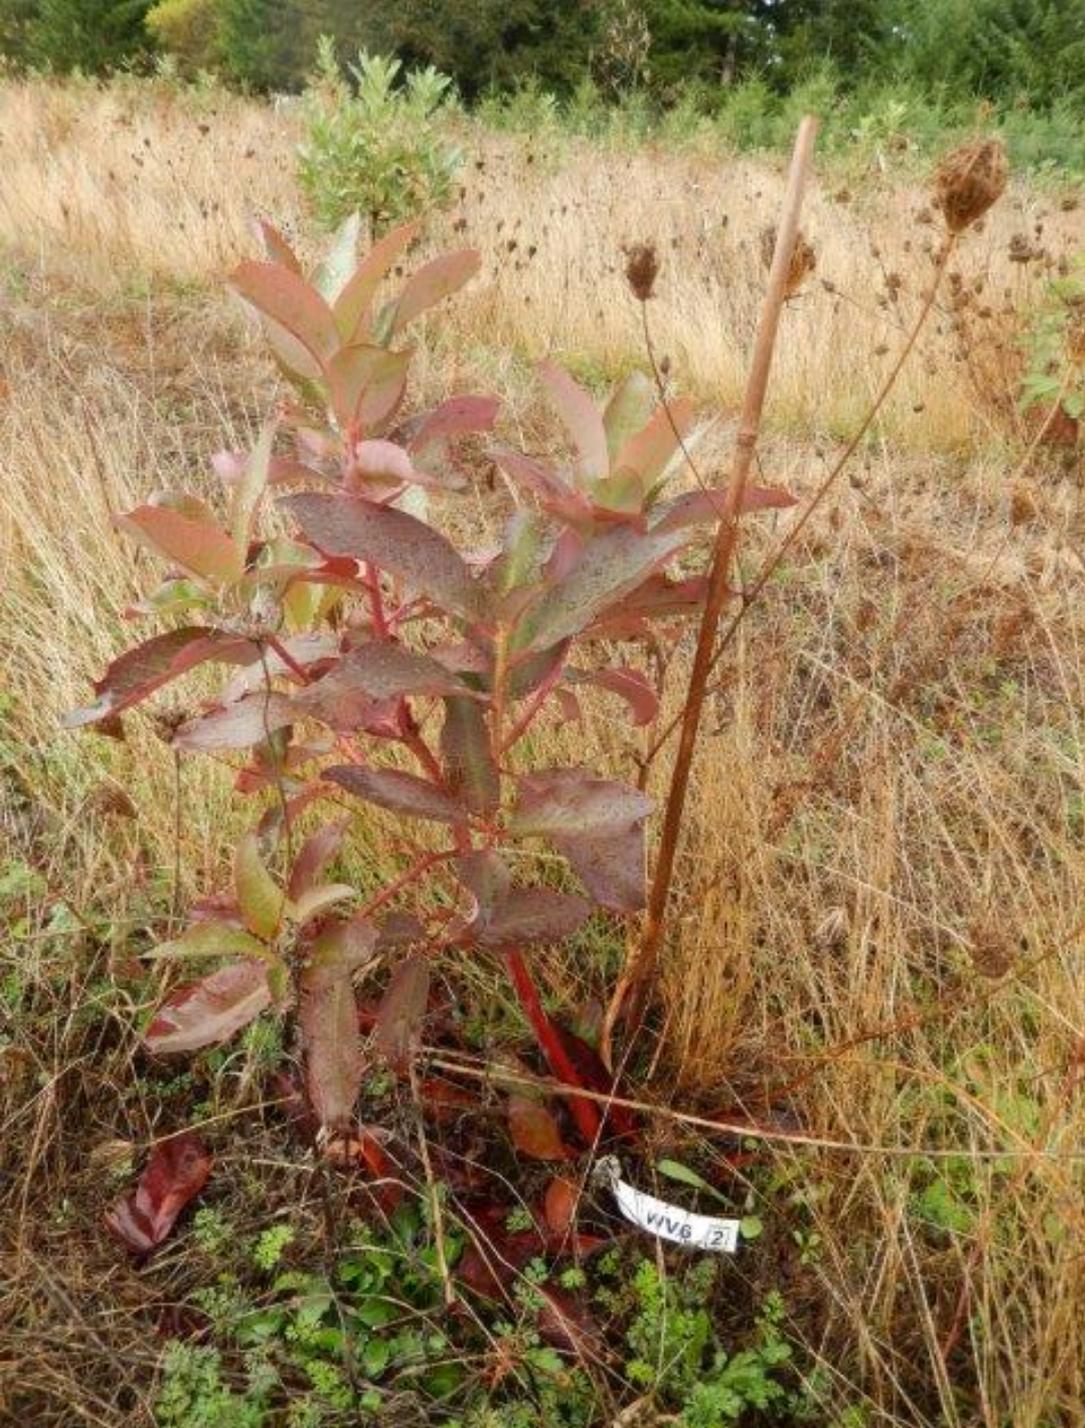
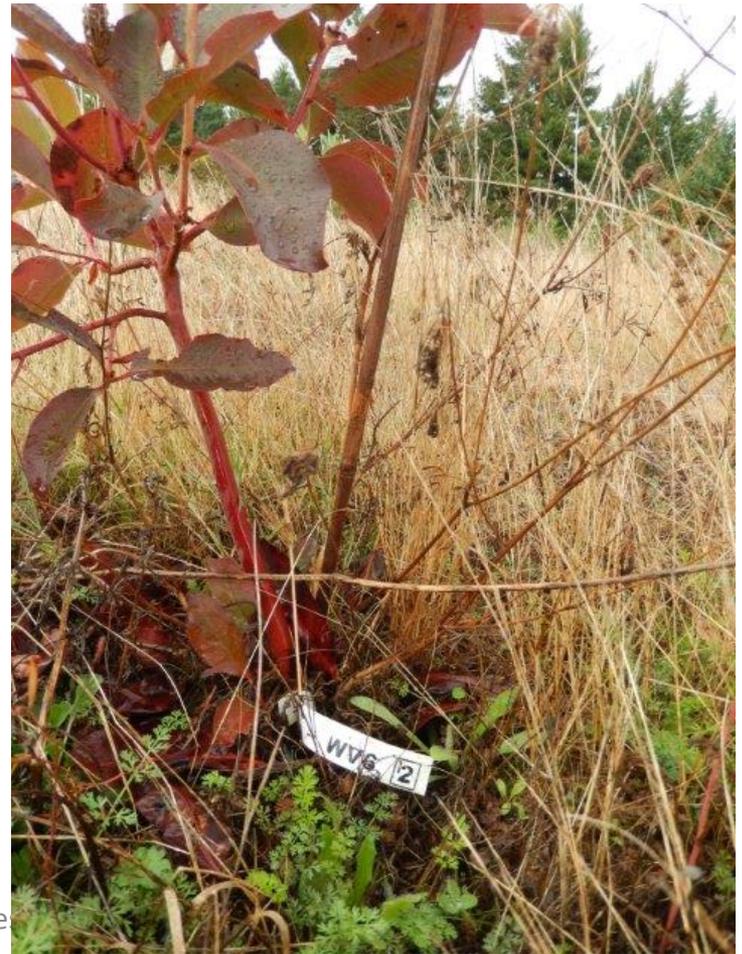
Red-green foliage on WV6(2) tree
(DSCN0677-0678.jpg)

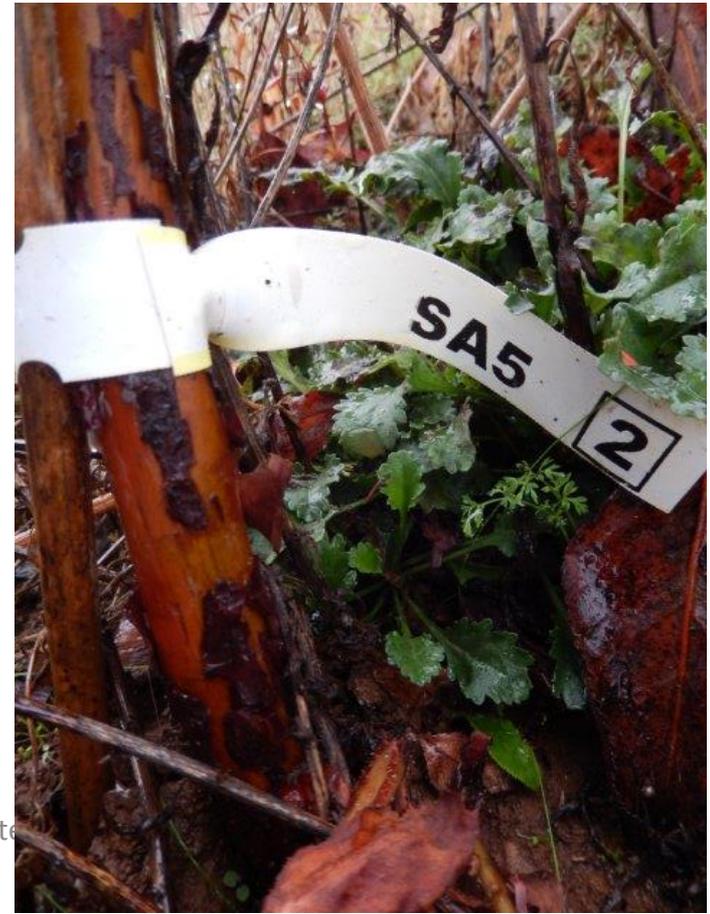
DSCN0681-0682.jpg

New growth at top of SA5(2)
