# SAFETY, HEALTH, AND SECURITY COMMITTEE MEETING AGENDA AND MINUTES

| 1. MEETING DATE<br>February 26, 2026 | 2. CAMPUS, COLLEGE, AREA, DEPARTMENT, PROGRAM, BUILDING, OR WORK UNIT COMMITTEE OR MEETING NAME<br>Nuclear Science Center | | |

## SAFETY CONCERN & RESOLUTION LOG

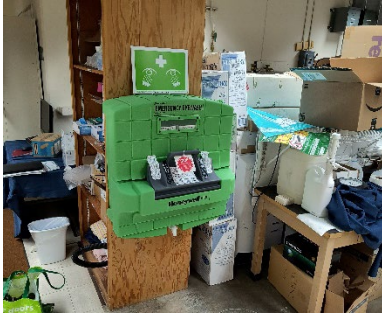
| ID INFO | SAFETY CONCERN | STATUS / RESOLUTION |
|---|---|---|
| 3/15/2023<br>2098<br>FULM-B3 | No eyewash or safety shower is available in Fulmer B3. Work request for quote has been submitted. | <p>Work request 2023-020047 under "estimating". Estimated at \$16,000.</p> <p>A portable eyewash has been ordered and has arrived.</p> <p>Portable eyewash was installed on February 13<sup>th</sup>, 2024</p> |

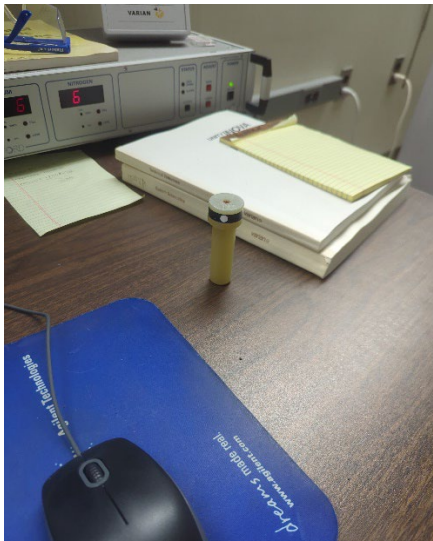
| ID INFO | SAFETY CONCERN | STATUS / RESOLUTION |
|---|---|---|
| 9/18/2023<br>NUCS-<br>Fulmer<br>Varian 500 | <p>Spinner has broken glass inside. I have left the spinner to the right of the computer monitor.</p> | <p>User went to use the machine and found it left in that state. Further investigation needed to determine more information on the broken sample, what potentially caused it, and why it was left as it was.</p> <p>Spinner determined to be non-rad. Broken tube and glass removed. Machine is fully functional. A message about broken NMR tubes in the NUCS Core Facility was sent out to users.</p> |

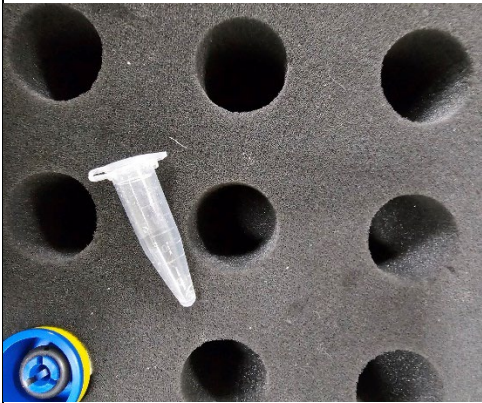
| ID INFO | SAFETY CONCERN | STATUS / RESOLUTION |
|---|---|---|
| 9/29/2023<br>NUCS-<br>Fulmer<br>Bruker 500 | <p>An unlabeled Eppendorf tube containing an unknown material was found at the Bruker 500.</p> | <p>Eppendorf tube determined to be non-rad. Eppendorf tube removed. Machine is fully functional. A message about bringing samples and completing experiments in the NUCS Core Facility was sent out to NMR users.</p> |

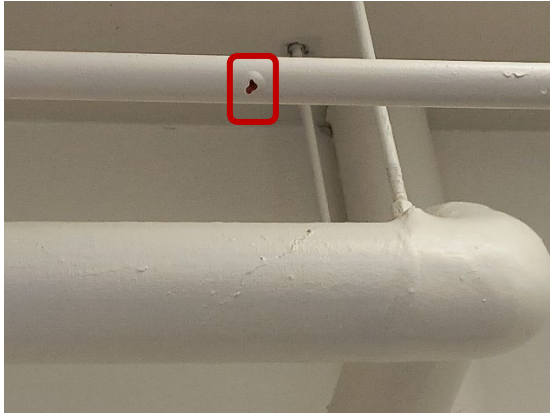
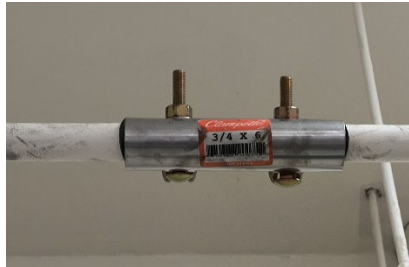
| ID INFO | SAFETY CONCERN | STATUS / RESOLUTION |
|---|---|---|
| 10/30/23<br>DODG-150 | Water dripping from pipe onto floor near TV and large table.<br> | Work Request submitted (#2024-009395). Was repaired 11/1/23 with a sleeve over the leak area. Work request (2024-009395) was closed by FacOps on 7/26/24. Sleeve still remains<br><br><br>New pipe was put in. Work Request closed 12/4/24 |

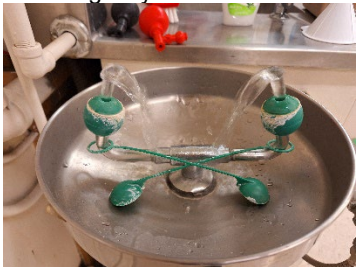
| ID INFO | SAFETY CONCERN | STATUS / RESOLUTION |
|---|---|---|
| 1/29/2024<br>DODG-101 | <p>Water pressure to 101 eyewash station is inadequate to flush eyes in an emergency.</p> | 1/29/2024 - Work request 2024-016117 submitted and completed |

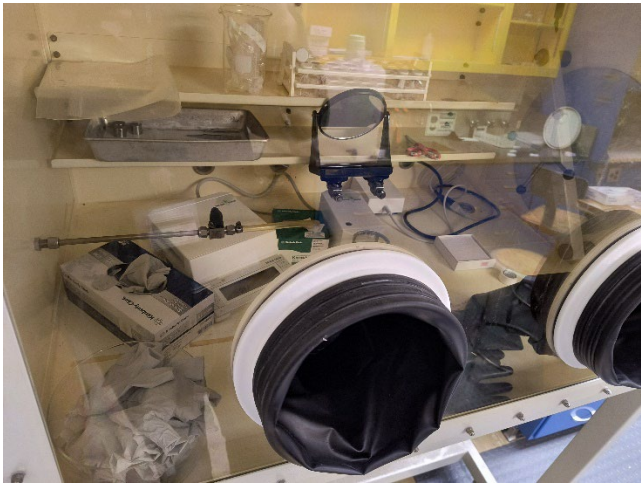
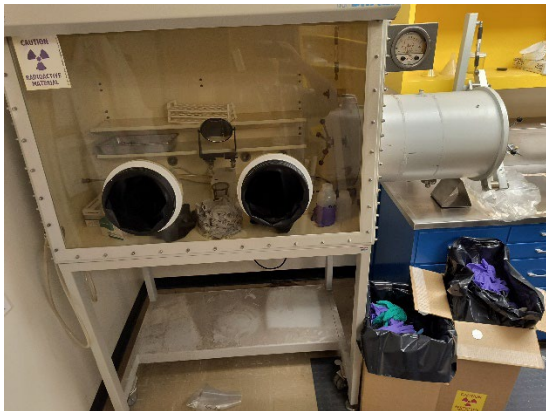
| ID INFO | SAFETY CONCERN | STATUS / RESOLUTION |
|---|---|---|
| 2/12/24<br>DODG-121<br>#5266 | <p>Suspected contamination of the glovebox in Dodgen 121 with plutonium. Also, a suspected hole in one of the gloves on the glovebox.</p> | <p>Draft memo sent to EH&amp;S and RSO. EH&amp;S and RSO worked with Dr. Guo and his students to clean it out. Are about 25% of the way completed as of July 23<sup>rd</sup>, 2024.</p> <p>Met with Guo on February 26<sup>th</sup>, 2025, about current and future gloveboxes. Have not heard anything after meeting.</p> <p>Current picture as of 8/26/25:</p> <p>No change as of 10/3/25.</p> <p>Sent an email requesting in update from Dr. Guo, received a response on 11/12/25, saying that RSO needs to supply an update.</p> <p>Requested an update from RSO on 12/16/25 via email. RSO responded on 12/18/25, deeming the glovebox safe.</p> |

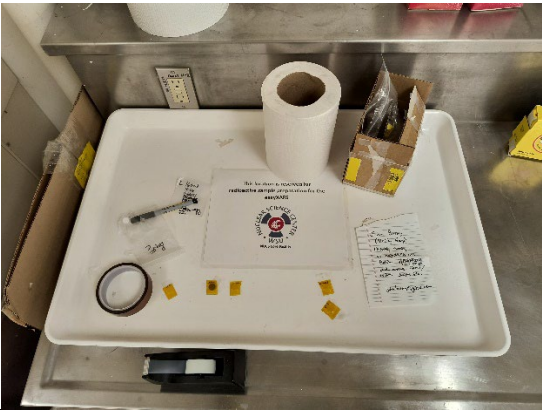
| ID INFO | SAFETY CONCERN | STATUS / RESOLUTION |
|---|---|---|
| 1/16/25<br>Dodgen 114<br>#7525 | A user was measuring radioactive samples at the easyXAFS and not following the radioactive sample analysis procedure (no lab paper or radioactive sticker labels).<br> | The user was called and returned to Dodgen about an hour after the phone call to remedy the situation. |

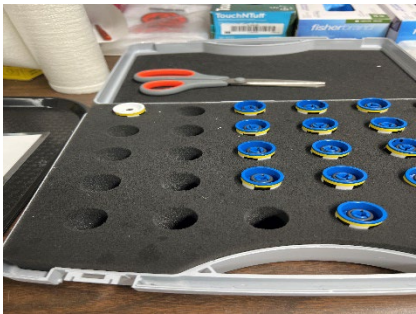
| ID INFO | SAFETY CONCERN | STATUS / RESOLUTION |
|---|---|---|
| 3/6/25<br>Fulmer B3<br>#7958 | <p>The Rad NMR tube sample holder was placed in the case with the non-rad NMR tube holders.</p> | A pencil case is now used to store the Rad NMR tube sample holder and depth gauge. |

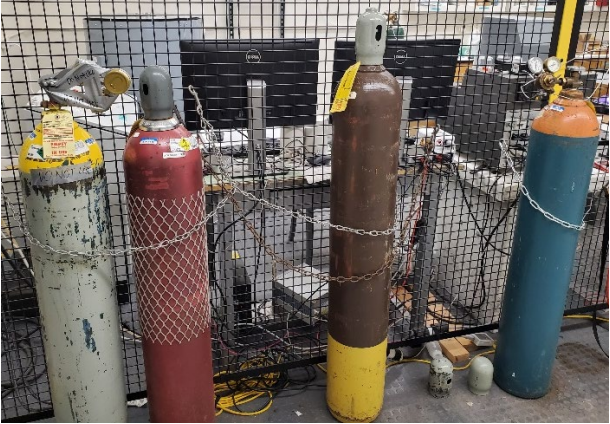
| ID INFO | SAFETY CONCERN | STATUS / RESOLUTION |
|---|---|---|
| 7/21/2025<br>Dodgen 21<br>#8964 | <p>There are two concerns related to gas bottle use and storage:</p> <p>1: An attached regulator and cylinder appears to be tagged out with duct tape. Every possible scenario for this type of tag out is concerning: is the regulator damaged - if so, why is it still on the cylinder? Is the regulator stuck - if so, why hasn't help been sought?, Is the cylinder not in use (which is obviously the case) then why is a regulator on it at all? Is there cylinder damage? If so, then why is it in the building at all?</p> <p>2: Very few, if any, of the cylinders are chained with sufficient tension to be certain that they cannot fall over. There may be sufficient slack for a cylinder to fall/slide. A quick test was made and the cylinder leaned to a sharp angle before being slowed to a full stop. I do not believe they are an immediate threat as the chains will reduce falling energy to a minimal level, but they do not meet the</p> | The Guo Group has been notified. Graduate students have taken steps to properly secure the gas bottles individually and communication with Central Stores to fix the damaged regulator. The damaged regulator was removed and the cylinders have been chained up appropriately. |

| ID INFO | SAFETY CONCERN | STATUS / RESOLUTION |
|---|---|---|
| | <p>definition of secure in the WSU SPPMs or WACs.</p> <p>Only one picture was allowed to be attached, but there is also a loosely chained flammable cylinder on the east side of the room. This is urgent but appears to be in a metastable state. Correction may be performed through regular channels rather than on an emergency basis by non-lab personnel.</p> | |

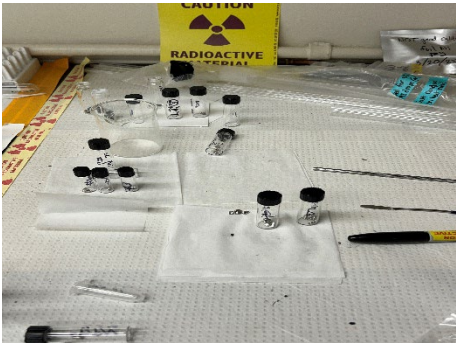
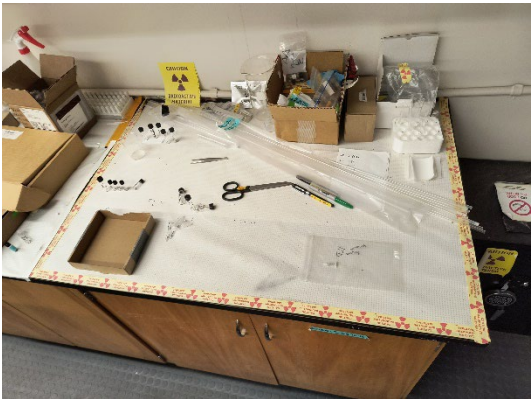
| ID INFO | SAFETY CONCERN | STATUS / RESOLUTION |
|---|---|---|
| <p>7/25/25<br/>Dodgen 21<br/>#9008</p> | <p>Unsealed Rad Material is sitting on the lab bench. It is in a designated rad area, but is just in the open, unsealed and unlabeled. Verified with a GM that it was radioactive.</p> | <p>The Guo Group has been notified and the space was cleaned up.</p> <p>An email went out to the Guo group on 7/31/25 asking them to implement a tray system for RAM work.</p> <p>Picture of Rad area on 8/26/25:</p> <p>Picture of Rad area on 10/3/25</p> |

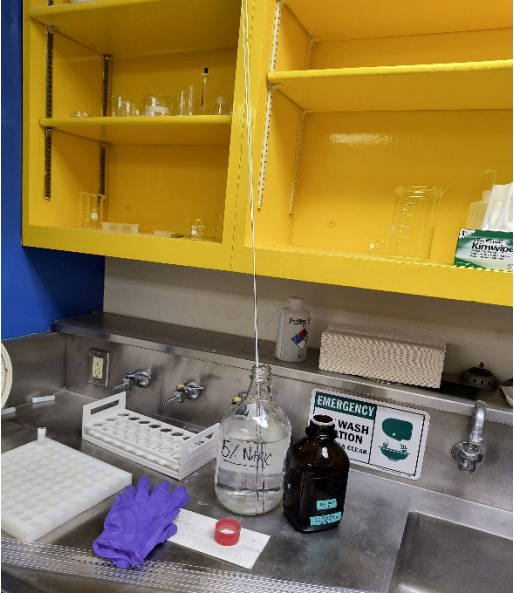
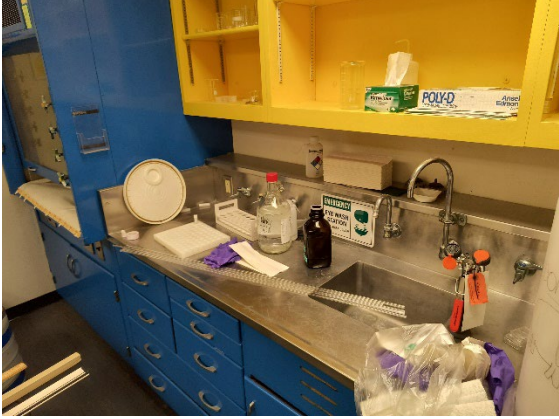
| ID INFO | SAFETY CONCERN | STATUS / RESOLUTION |
|---|---|---|
| <p>8/4/25<br/>Dodgen<br/>121<br/>#9076</p> | <p>There is an open (uncapped) bottle of nitric acid with something hanging out of it (not clamped) with no labels (see picture).</p> | <p>The Guo Group has been notified of the safety concern at 3:30 pm on 8/4/25. The Guo group removed the items in the nitric acid, but the nitric acid bottle remained on the counter and did not address any of the items of concern listed in the message to the Guo group.</p> <p>Picture of area on 8/26/25:</p> <p>No change as of 10/3/25.<br/>An email was sent to Dr. Guo and Eric Roalson.<br/>Was addressed by Guo lab on 11/13/25.</p> |

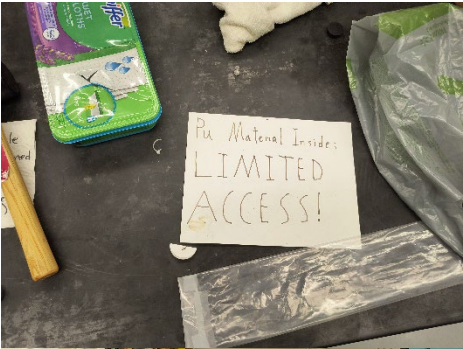
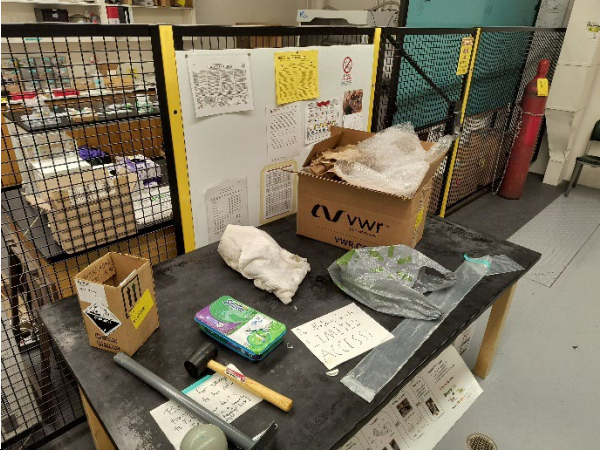
| ID INFO | SAFETY CONCERN | STATUS / RESOLUTION |
|---|---|---|
| <p>8/28/25<br/>Dodgen<br/>B21<br/>#9296</p> | <p>There is a sign saying that "Pu Materials are Inside" on a random desk outside of the Guo lab space (see pictures). It is unclear if the Pu materials are in the plastic bag next to it in an unsecured location or somewhere else.</p> | <p>The sign was removed on 8/28/25 and we were assured by Dr. Guo that no Pu work has been done since 2019.</p> |

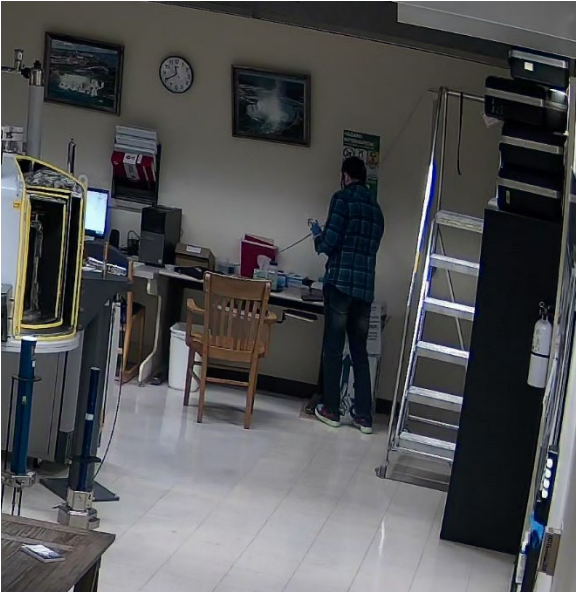
| ID INFO | SAFETY CONCERN | STATUS / RESOLUTION |
|---|---|---|
| <p>10/9/25<br/>Fulmer B3<br/>#9656</p> | <p>A user was found removing unknown NMR tubes from the broken glass container near the DLS.</p> | <p>Ethan told him to not remove the samples from the facility or the glass waste. A message was sent out to users of the NUCS Core Facility telling them to not remove unknown materials from waste containers.</p> |

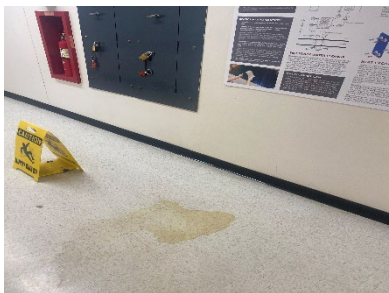
| ID INFO | SAFETY CONCERN | STATUS / RESOLUTION |
|---|---|---|
| 12/19/25<br>Dodgen<br>2 <sup>nd</sup> Floor<br>Hallway | There was a puddle of water in the hallway when I arrived this morning. I surveyed and cleaned it. Thought the facility should know as it's source was from my estimates the roof.<br><br> | Work request submitted to FacOps. FacOps came out during the week of 12/29/25 and 1/5/26 to repair the roof and stop the leaks. |

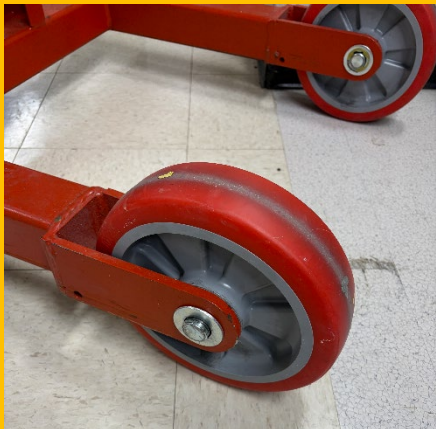
| ID INFO | SAFETY CONCERN | STATUS / RESOLUTION |
|---|---|---|
| 12/19/25<br>Fulmer B3<br>#12480 | A part of the liquid nitrogen dewar cart wheel came off. It is on the outside of the right wheel. It looks like some sort of piece of metal fell off, and now the wheel may not be completely secure.<br><br> | Billy is looking for a retaining clip. |

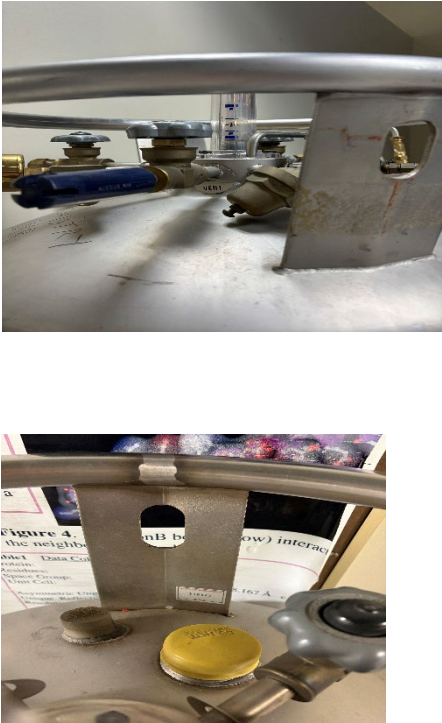
| ID INFO | SAFETY CONCERN | STATUS / RESOLUTION |
|---|---|---|
| 12/19/25<br>Fulmer B3 | One of the liquid nitrogen dewar is not accurately reading the liquid nitrogen level. It states the nitrogen level is half, even though it is empty and completely relieved of pressure | As of 2/26/26, this issue has not resurfaced, and is considered closed. |

| ID INFO | SAFETY CONCERN | STATUS / RESOLUTION |
|---|---|---|
| #12481 | <p>I attached a picture of the gauge, and the WSU number on the dewar.</p> | |

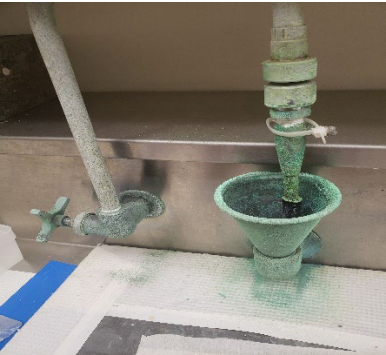
| ID INFO | SAFETY CONCERN | STATUS / RESOLUTION |
|---|---|---|
| 1/29/26<br>#12766<br>Dodgen<br>119 | <p>The services are corroding.</p> | The source of the corrosion was unable to be located. To get an idea if the corrosion was quick or slow, some metal samples were placed next to the services. As of 2/26/26, no corrosion was observed on the metal samples. |

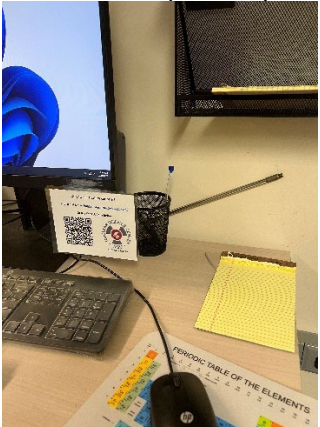
| ID INFO | SAFETY CONCERN | STATUS / RESOLUTION |
|---|---|---|
| 2/24/26<br># 13074<br>Fulmer B3 | NMR Sample found placed in the pen cup at the workstation for the Bruker 500 NMR. | Samples were discarded. User contacted. |

| ID INFO | SAFETY CONCERN | STATUS / RESOLUTION |
|---|---|---|
| | <p>I removed the sample and pen cup for now</p> | |

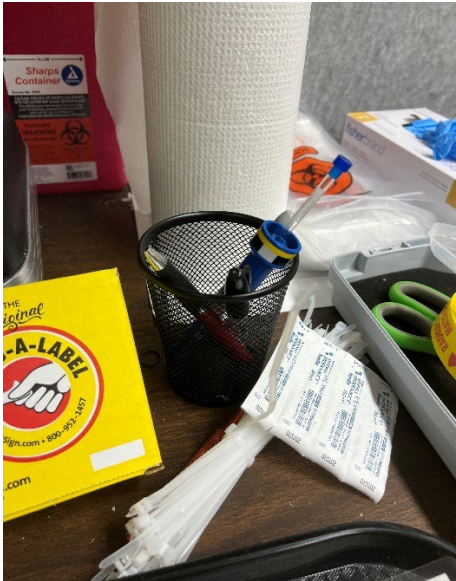
| ID INFO | SAFETY CONCERN | STATUS / RESOLUTION |
|---|---|---|
| <p>2/24/26<br/># 13076<br/>Fulmer B3</p> | <p>I turned around from the workstation and looked at the sample prep bench and saw another sample in the pen cup for the radioactive NMR sample prep pens and sharpie</p> <p>It was checked with the GM to at least verify the outside wasn't contaminated or radioactive.</p> | <p>Samples were discarded. User contacted.</p> |
