# SAFETY, HEALTH, AND SECURITY COMMITTEE MEETING AGENDA AND MINUTES

| 1. MEETING DATE<br>April 23, 2026 | 2. CAMPUS, COLLEGE, AREA, DEPARTMENT, PROGRAM, BUILDING, OR WORK UNIT COMMITTEE OR MEETING NAME<br>Nuclear Science Center | | |

## SAFETY CONCERN & RESOLUTION LOG

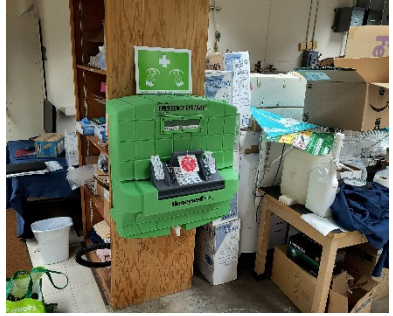
| ID INFO | SAFETY CONCERN | STATUS / RESOLUTION |
|---|---|---|
| 3/15/2023<br>2098<br>FULM-B3 | No eyewash or safety shower is available in Fulmer B3. Work request for quote has been submitted. | <p>Work request 2023-020047 under "estimating". Estimated at \$16,000. A portable eyewash has been ordered and has arrived.</p> <p>Portable eyewash was installed on February 13<sup>th</sup>, 2024</p> |

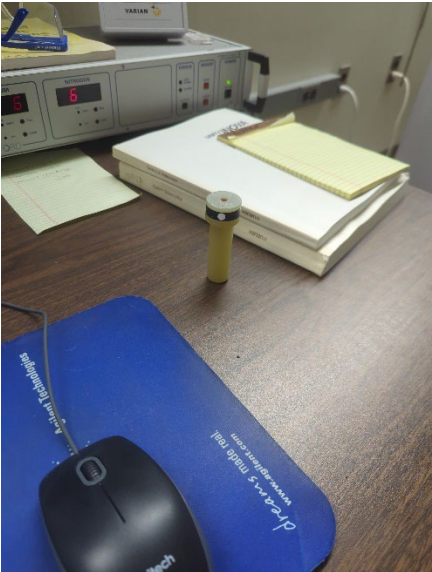
| ID INFO | SAFETY CONCERN | STATUS / RESOLUTION |
|---|---|---|
| 9/18/2023<br>NUCS-Fulmer<br>Varian 500 | <p>Spinner has broken glass inside. I have left the spinner to the right of the computer monitor.</p> | <p>User went to use the machine and found it left in that state. Further investigation needed to determine more information on the broken sample, what potentially caused it, and why it was left as it was.</p> <p>Spinner determined to be non-rad. Broken tube and glass removed. Machine is fully functional. A message about broken NMR tubes in the NUCS Core Facility was sent out to users.</p> |

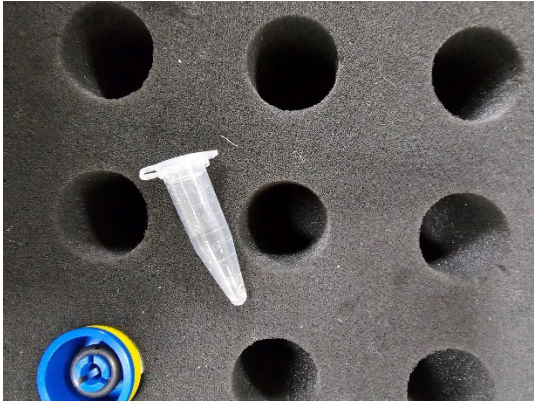
| ID INFO | SAFETY CONCERN | STATUS / RESOLUTION |
|---|---|---|
| 9/29/2023<br>NUCS-Fulmer<br>Bruker 500 | <p>An unlabeled Eppendorf tube containing an unknown material was found at the Bruker 500.</p> | <p>Eppendorf tube determined to be non-rad. Eppendorf tube removed. Machine is fully functional. A message about bringing samples and completing experiments in the NUCS Core Facility was sent out to NMR users.</p> |

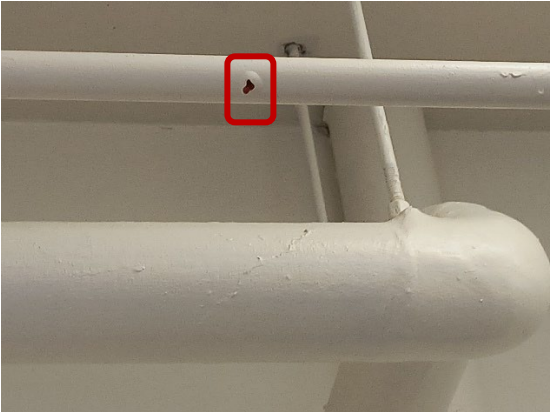
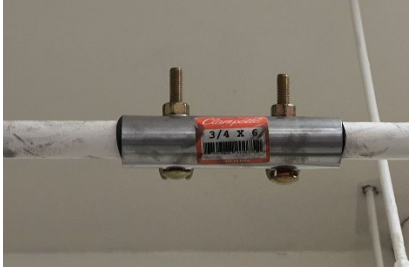
| ID INFO | SAFETY CONCERN | STATUS / RESOLUTION |
|---|---|---|
| 10/30/23<br>DODG-<br>150 | <p>Water dripping from pipe onto floor near TV and large table.</p> | <p>Work Request submitted (#2024-009395). Was repaired 11/1/23 with a sleeve over the leak area. Work request (2024-009395) was closed by FacOps on 7/26/24. Sleeve still remains</p> <p>New pipe was put in. Work Request closed 12/4/24</p> |

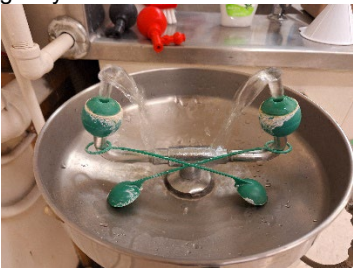
| ID INFO | SAFETY CONCERN | STATUS / RESOLUTION |
|---|---|---|
| 1/29/2024<br>DODG-101 | Water pressure to 101 eyewash station is inadequate to flush eyes in an emergency.<br> | 1/29/2024 - Work request 2024-016117 submitted and completed |

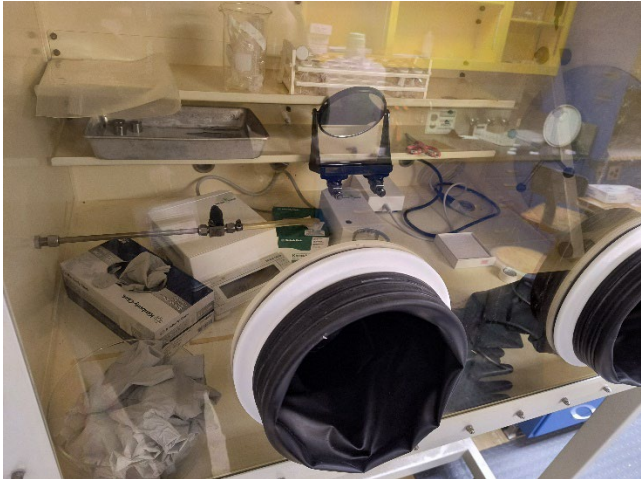
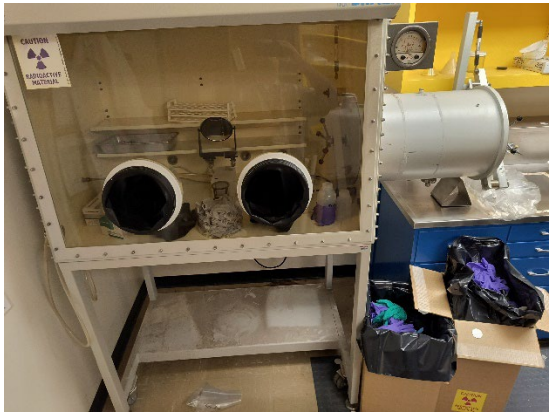
| ID INFO | SAFETY CONCERN | STATUS / RESOLUTION |
|---|---|---|
| 2/12/24<br>DODG-121<br>#5266 | Suspected contamination of the glovebox in Dodgen 121 with plutonium. Also, a suspected hole in one of the gloves on the glovebox.<br> | Draft memo sent to EH&S and RSO. EH&S and RSO worked with Dr. Guo and his students to clean it out. Are about 25% of the way completed as of July 23 <sup>rd</sup> , 2024.<br><br>Met with Guo on February 26 <sup>th</sup> , 2025, about current and future gloveboxes. Have not heard anything after meeting.<br><br>Current picture as of 8/26/25:<br> |

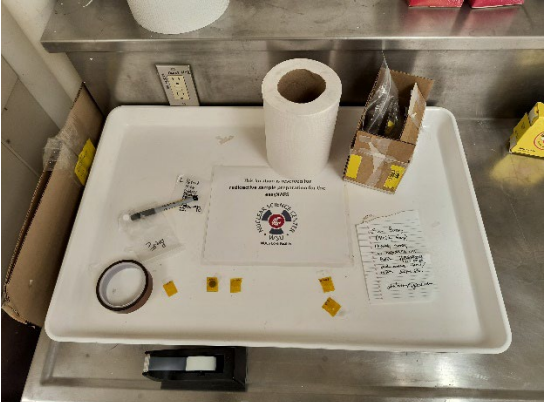
| ID INFO | SAFETY CONCERN | STATUS / RESOLUTION |
|---|---|---|
| 1/16/25<br>Dodgen<br>114<br>#7525 | A user was measuring radioactive samples at the easyXAFS and not following the radioactive sample analysis procedure (no lab paper or radioactive sticker labels).<br> | The user was called and returned to Dodgen about an hour after the phone call to remedy the situation. |

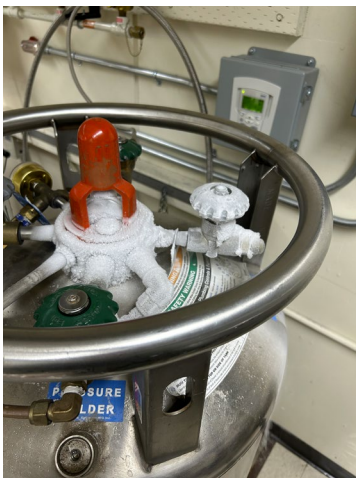
| ID INFO | SAFETY CONCERN | STATUS / RESOLUTION |
|---|---|---|
| 2/5/25 | One of the high pressure dewars was extremely iced up, hissing, and a small amount of liquid nitrogen was dripping out the liquid tap. I tapped the handle with a wrench and tightened it down with | Tightened the liquid valve to stop leak. |

| ID INFO | SAFETY CONCERN | STATUS / RESOLUTION |
|---|---|---|
| Fulmer<br>B3<br>#7644 | <p>a gloved hand. The handle turned a little bit and the leaking and hissing stopped. Issue appears to be resolved, the dewar is currently sitting about 105psi.</p> | |

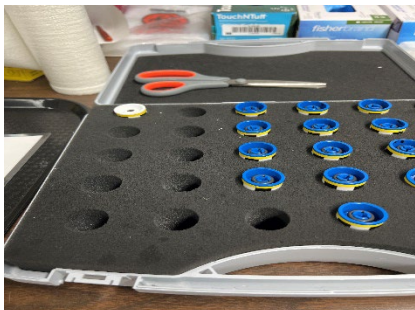
| ID INFO | SAFETY CONCERN | STATUS / RESOLUTION |
|---|---|---|
| 3/6/25<br>Fulmer<br>B3<br>#7958 | <p>The Rad NMR tube sample holder was placed in the case with the non-rad NMR tube holders.</p> | A pencil case is now used to store the Rad NMR tube sample holder and depth gauge. |

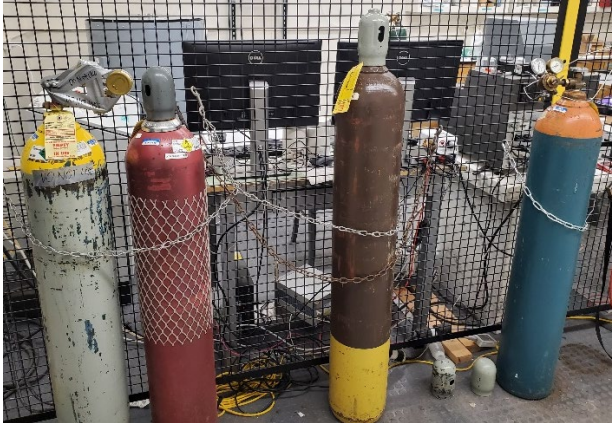
| ID INFO | SAFETY CONCERN | STATUS / RESOLUTION |
|---|---|---|
| 7/21/2025<br>Dodgen<br>21<br>#8964 | <p>There are two concerns related to gas bottle use and storage:</p> <p>1: An attached regulator and cylinder appears to be tagged out with duct tape. Every possible scenario for this type of tag out is concerning: is the regulator damaged - if so, why is it still on the cylinder? Is the regulator stuck - if so, why hasn't help been sought?, Is the cylinder not in use (which is obviously the case) then why is a regulator on it at all? Is there cylinder damage? If so, then why is it in the building at all?</p> <p>2: Very few, if any, of the cylinders are chained with sufficient tension to be certain that they cannot fall over. There may be sufficient slack for a cylinder to fall/slide. A quick test was made and the cylinder leaned to a sharp angle before being slowed to a full stop. I do not believe they are an immediate threat as the chains will reduce falling energy to a minimal level, but they do not meet the definition of secure in the WSU SPPMs or WACs.</p> | The Guo Group has been notified. Graduate students have taken steps to properly secure the gas bottles individually and communication with Central Stores to fix the damaged regulator. The damaged regulator was removed and the cylinders have been chained up appropriately. |

| ID INFO | SAFETY CONCERN | STATUS / RESOLUTION |
|---|---|---|
| | <p>Only one picture was allowed to be attached, but there is also a loosely chained flammable cylinder on the east side of the room. This is urgent but appears to be in a metastable state. Correction may be performed through regular channels rather than on an emergency basis by non-lab personnel.</p> | |

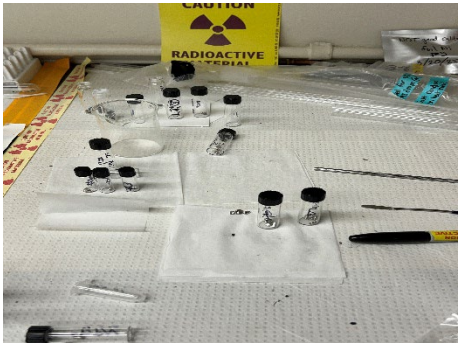
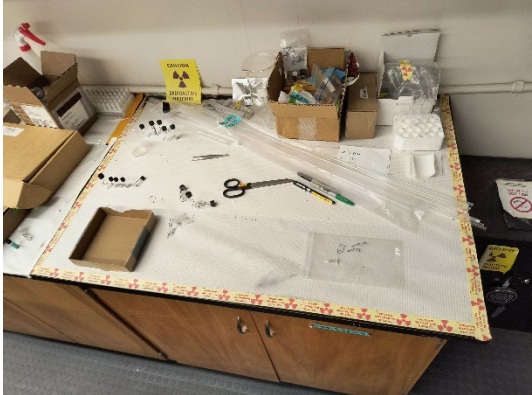
| ID INFO | SAFETY CONCERN | STATUS / RESOLUTION |
|---|---|---|
| <p>7/25/25<br/>Dodgen<br/>21<br/>#9008</p> | <p>Unsealed Rad Material is sitting on the lab bench. It is in a designated rad area, but is just in the open, unsealed and unlabeled. Verified with a GM that it was radioactive.</p> | <p>The Guo Group has been notified and the space was cleaned up.</p> <p>An email went out to the Guo group on 7/31/25 asking them to implement a tray system for RAM work.</p> <p>Picture of Rad area on 8/26/25:</p> <p>Picture of Rad area on 10/3/25</p> |

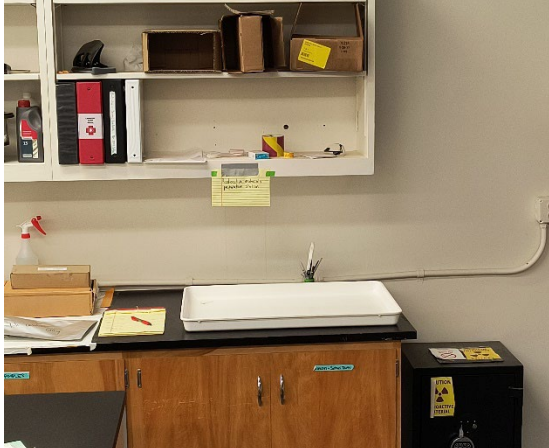
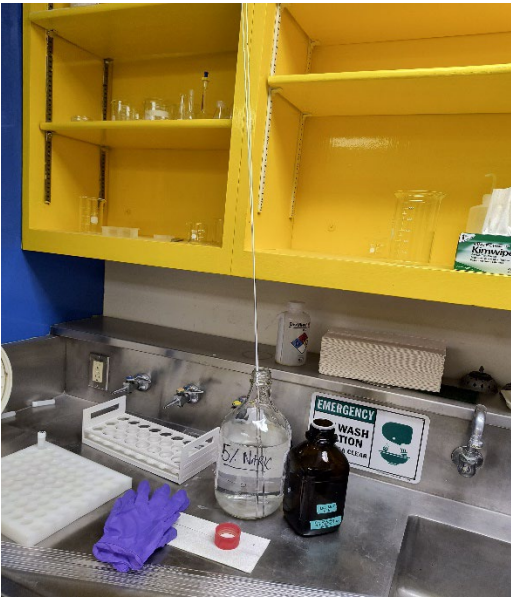
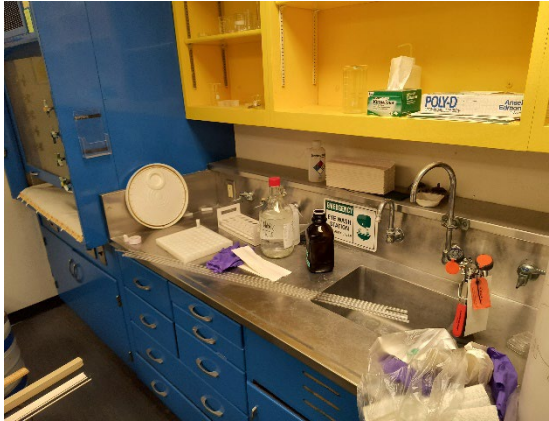
| ID INFO | SAFETY CONCERN | STATUS / RESOLUTION |
|---|---|---|
| <p>8/4/25<br/>Dodgen<br/>121<br/>#9076</p> | <p>There is an open (uncapped) bottle of nitric acid with something hanging out of it (not clamped) with no labels (see picture).</p> | <p>The Guo Group has been notified of the safety concern at 3:30 pm on 8/4/25. The Guo group removed the items in the nitric acid, but the nitric acid bottle remained on the counter and did not address any of the items of concern listed in the message to the Guo group.</p> <p>Picture of area on 8/26/25:</p> <p>No change as of 10/3/25.<br/>An email was sent to Dr. Guo and Eric Roalson.<br/>Was addressed by Guo lab on 11/13/25.</p> |

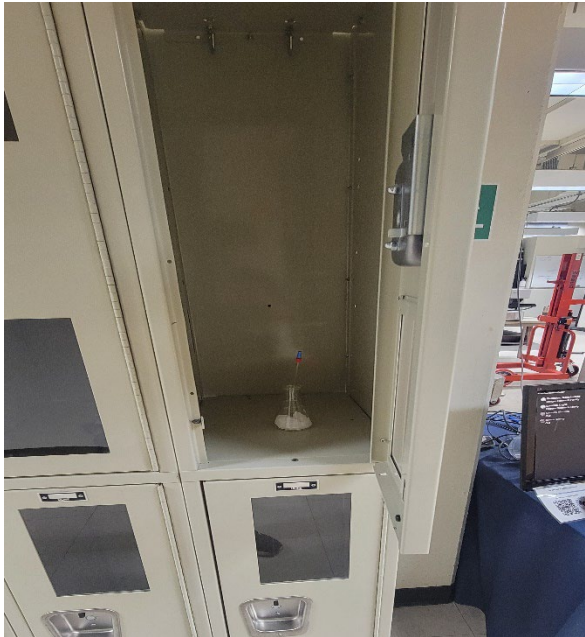
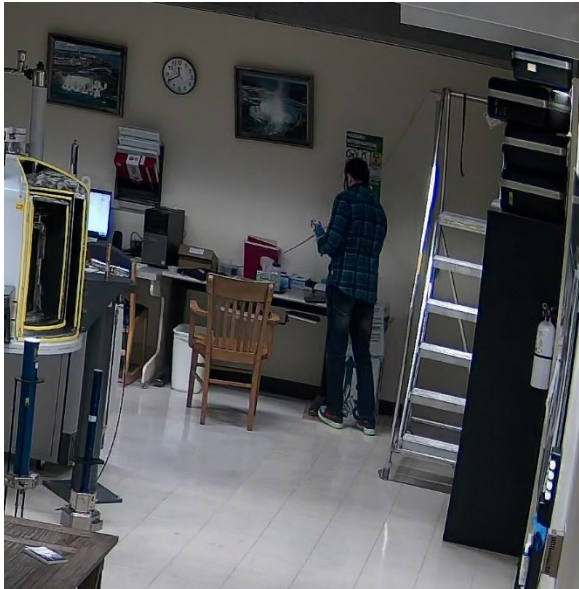
| ID INFO | SAFETY CONCERN | STATUS / RESOLUTION |
|---|---|---|
| <p>10/9/25<br/>Fulmer<br/>B3<br/>#9656</p> | <p>A user was found removing unknown NMR tubes from the broken glass container near the DLS.</p> | <p>Ethan told him to not remove the samples from the facility or the glass waste. A message was sent out to users of the NUCS Core Facility telling them to not remove unknown materials from waste containers.</p> |

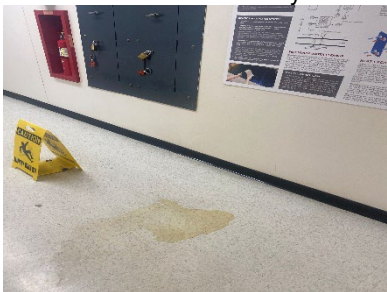
| ID INFO | SAFETY CONCERN | STATUS / RESOLUTION |
|---|---|---|
| 12/19/25<br>Dodgen 2 <sup>nd</sup> Floor<br>Hallway | There was a puddle of water in the hallway when I arrived this morning. I surveyed and cleaned it. Thought the facility should know as it's source was from my estimates the roof.<br> | Work request submitted to FacOps. FacOps came out during the week of 12/29/25 and 1/5/26 to repair the roof and stop the leaks. |

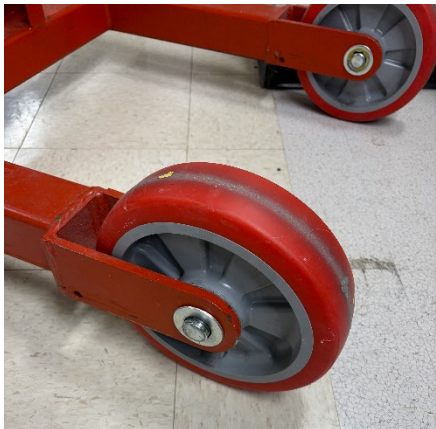
| ID INFO | SAFETY CONCERN | STATUS / RESOLUTION |
|---|---|---|
| 12/19/25<br>Fulmer B3<br>#12480 | A part of the liquid nitrogen dewar cart wheel came off. It is on the outside of the right wheel. It looks like some sort of piece of metal fell off, and now the wheel may not be completely secure.<br> | The clip was replaced on 4/22/26. |

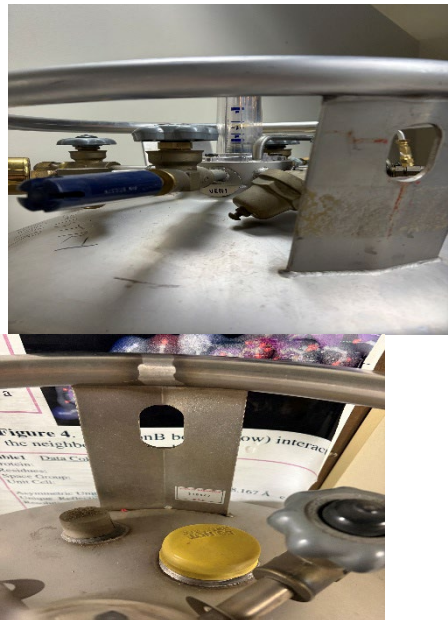
| ID INFO | SAFETY CONCERN | STATUS / RESOLUTION |
|---|---|---|
| 12/19/25 | One of the liquid nitrogen dewar is not accurately reading the liquid nitrogen level. It states the nitrogen level is half, even | As of 2/26/26, this issue has not resurfaced, and is considered closed. |

| ID INFO | SAFETY CONCERN | STATUS / RESOLUTION |
|---|---|---|
| Fulmer<br>B3<br>#12481 | <p>though it is empty and completely relieved of pressure I attached a picture of the gauge, and the WSU number on the dewar.</p> | |

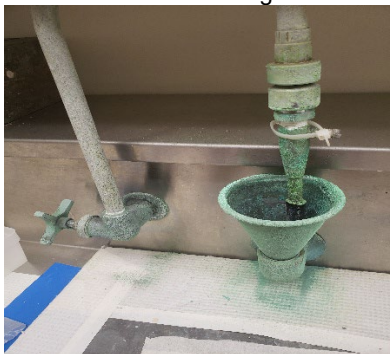
| ID INFO | SAFETY CONCERN | STATUS / RESOLUTION |
|---|---|---|
| 1/29/26<br>#12766<br>Dodgen<br>119 | <p>The services are corroding.</p> | The source of the corrosion was unable to be located. To get an idea if the corrosion was quick or slow, some metal samples were placed next to the services. As of 2/26/26, no corrosion was observed on the metal samples. |

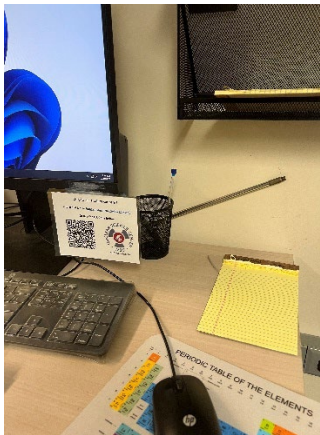
| ID INFO | SAFETY CONCERN | STATUS / RESOLUTION |
|---|---|---|
| 2/24/26<br># 13074<br>Fulmer<br>B3 | NMR Sample found placed in the pen cup at the workstation for the Bruker 500 NMR. | Samples were discarded. User contacted. |

| ID INFO | SAFETY CONCERN | STATUS / RESOLUTION |
|---|---|---|
| | <p>I removed the sample and pen cup for now</p> | |

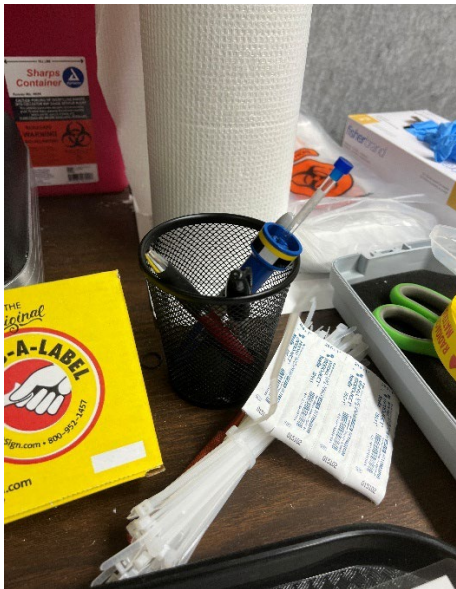
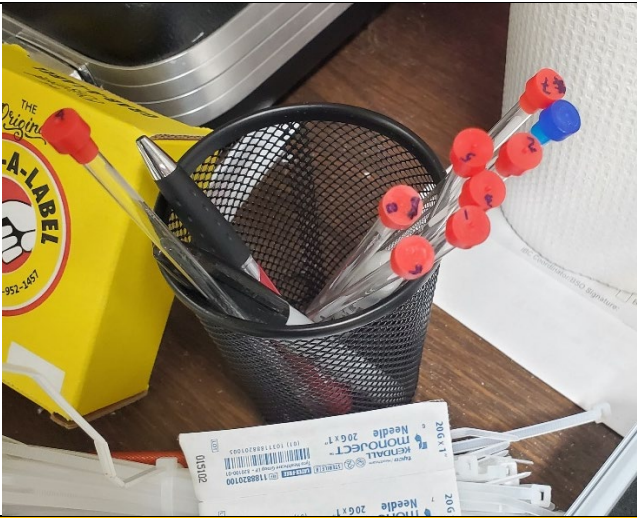
| ID INFO | SAFETY CONCERN | STATUS / RESOLUTION |
|---|---|---|
| <p>2/24/26<br/># 13076<br/>Fulmer<br/>B3</p> | <p>I turned around from the workstation and looked at the sample prep bench and saw another sample in the pen cup for the radioactive NMR sample prep pens and sharpie</p> <p>It was checked with the GM to at least verify the outside wasn't contaminated or radioactive.</p> | <p>Samples were discarded. User contacted.</p> |

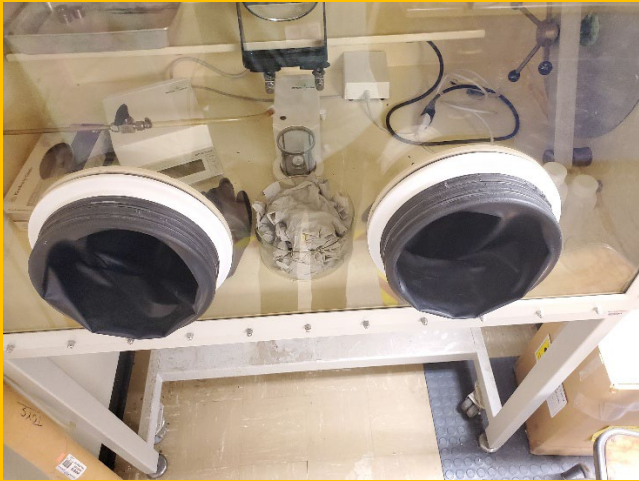
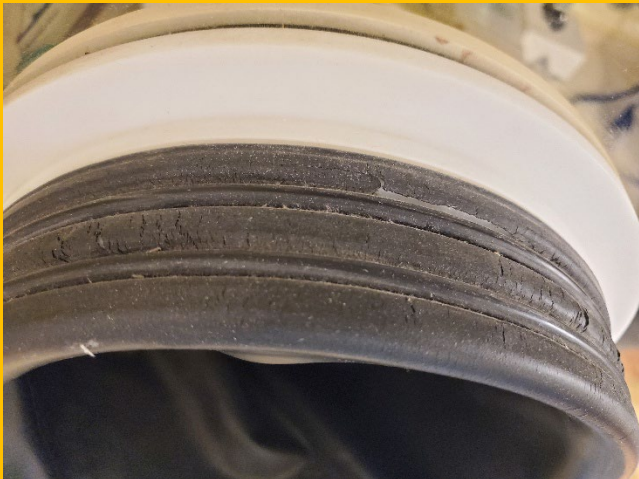
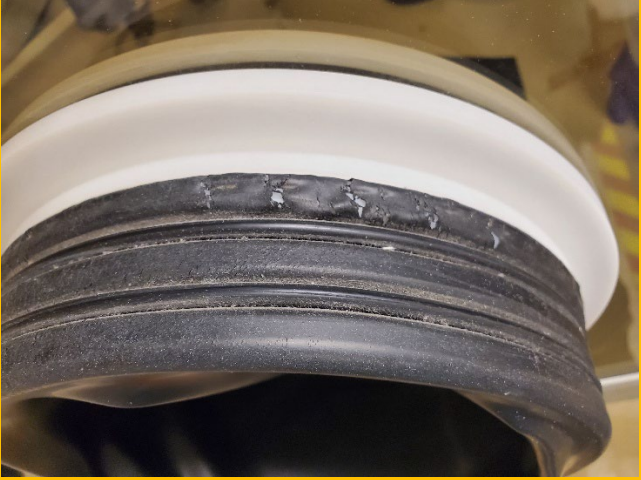
| ID INFO | SAFETY CONCERN | STATUS / RESOLUTION |
|---|---|---|
| <p>3/17/26<br/>#13264<br/>Dodgen<br/>121</p> | <p>The gloves attached to the glove box in Dodgen 121 show visible signs of degradation. It is uncertain whether they would successfully isolate the interior and exterior atmosphere or prevent contamination from crossing the gloved boundary. There is no signage indicating a decontaminated/decommissioned or tagged out status of the glove box.</p> | <p>The Guo group was contacted to determine if the glovebox is to be used again.</p> <p>4/23/26 – Dr. Guo wants the lab to be in inactive status.</p> |

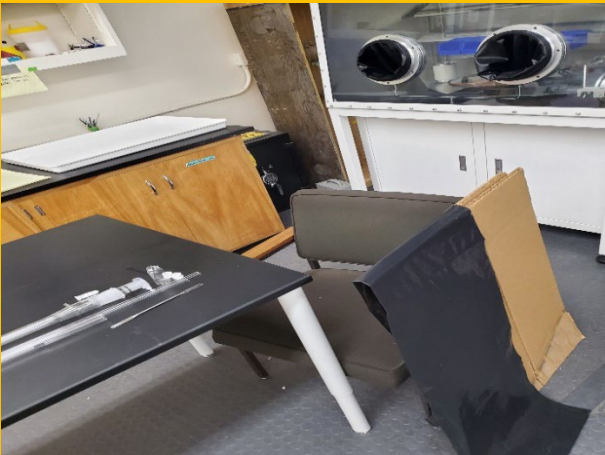
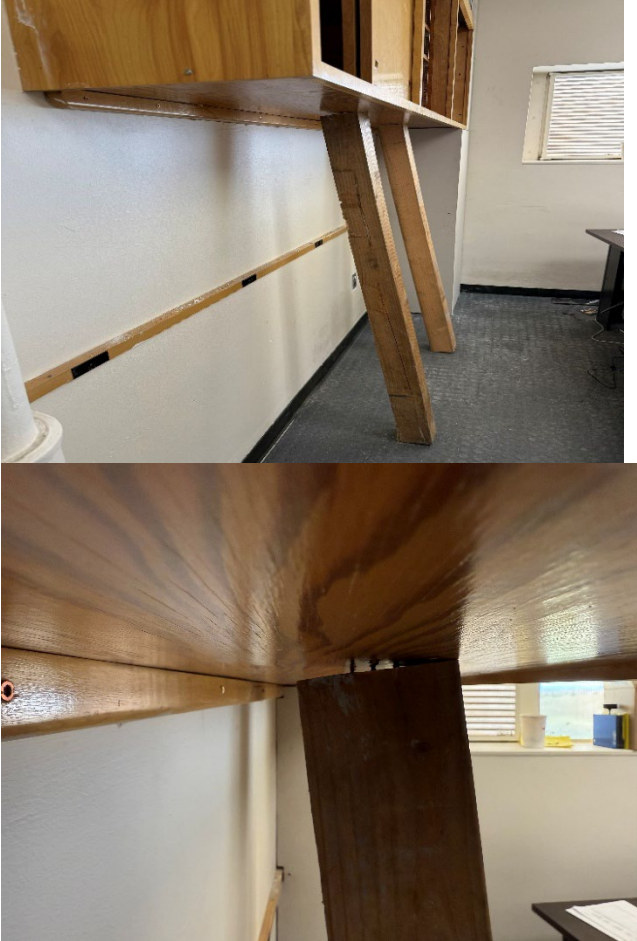
| ID INFO | SAFETY CONCERN | STATUS / RESOLUTION |
|---|---|---|
| <p>3/17/26<br/>#13265<br/>Dodgen<br/>G0021</p> | <p>There is a fabric upholstered padded chair in the radiation work area located in Dodgen G0021 hidden behind some flattened boxes. It is extremely porous and would be very difficult to decontaminate.</p> | <p>Dr. Guo was contacted and was ask to remove the chair from the lab.</p> |

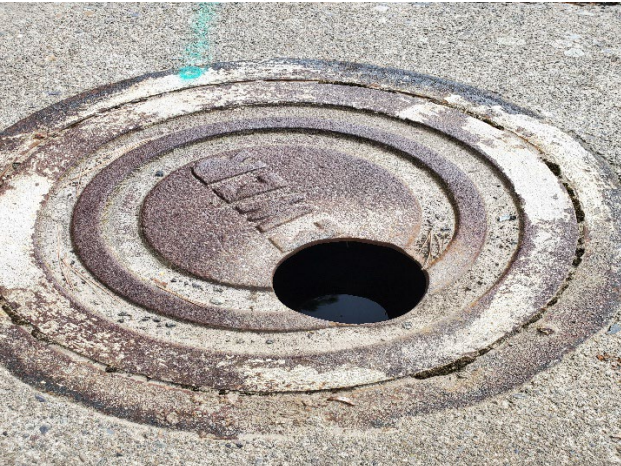
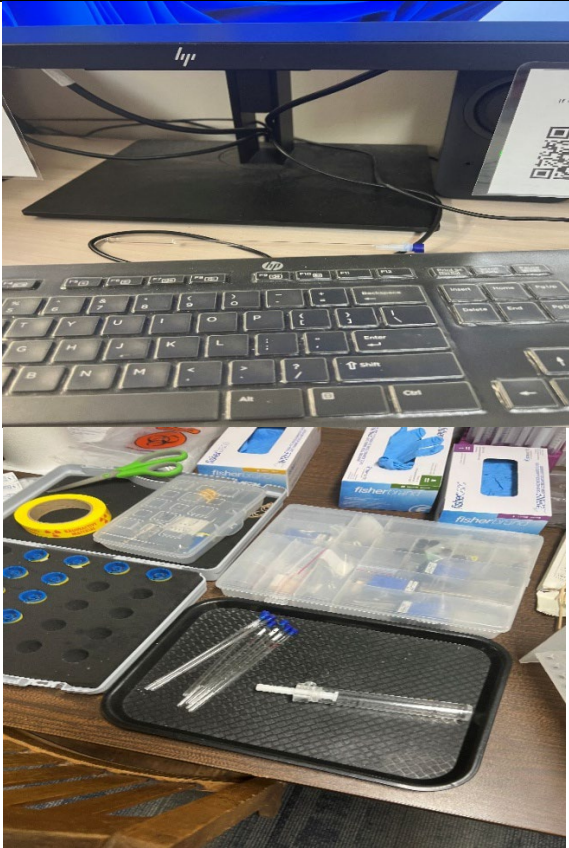
| ID INFO | SAFETY CONCERN | STATUS / RESOLUTION |
|---|---|---|
| <p>3/23/26<br/>#13301<br/>Dodgen<br/>Exterior<br/>(by<br/>Dumpster<br/>)</p> | <p>There is a cap for a sewer manhole which appears to have gone missing (perhaps in a recent storm) and now presents a hole of about four to five inches across. This is a trip/fall hazard. A work request was submitted to facilities (WR # 2026-020296).</p> | <p>Fac Ops created a plug for the hole which is now properly covered.</p> |

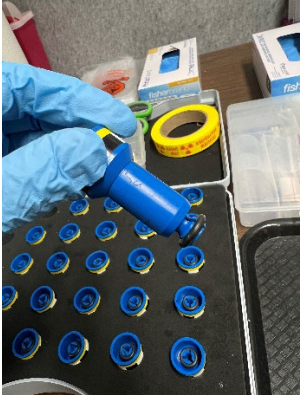
| ID INFO | SAFETY CONCERN | STATUS / RESOLUTION |
|---|---|---|
| <p>4/6/26<br/>#13429<br/>Fulmer<br/>B3</p> | <p>Plastic spinner for radioactive samples is missing. Looked in the case with all of the non-rad spinners, but it is not there. Radioactive depth gauge has not been moved. No other safety concerns at this time.</p> | <p>The spinner was found among the other spinners. The labeling on the spinner was faded (see below picture), making it not clear that it was the spinner designated for radioactive samples. The spinner was relabeled and placed with the radioactive sample analysis materials.</p> |
