# SAFETY, HEALTH, AND SECURITY COMMITTEE MEETING AGENDA AND MINUTES

| 1. MEETING DATE<br>July 23, 2026 | 2. CAMPUS, COLLEGE, AREA, DEPARTMENT, PROGRAM, BUILDING, OR WORK UNIT COMMITTEE OR MEETING NAME<br>Nuclear Science Center | | |

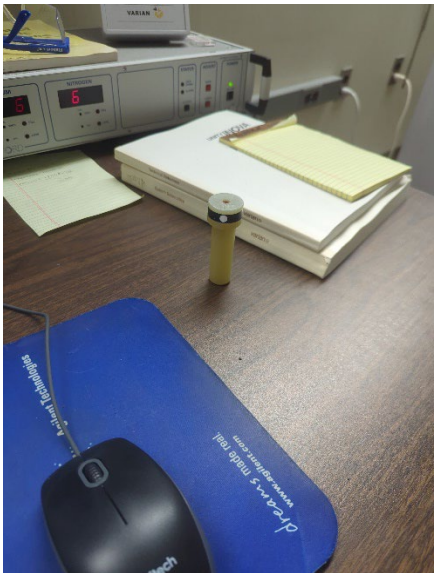
| ID INFO | SAFETY CONCERN | STATUS / RESOLUTION |
|---|---|---|
| 9/18/2023<br>NUCS-Fulmer<br>Varian 500 | <p>Spinner has broken glass inside. I have left the spinner to the right of the computer monitor.</p> | <p>User went to use the machine and found it left in that state. Further investigation needed to determine more information on the broken sample, what potentially caused it, and why it was left as it was.</p> <p>Spinner determined to be non-rad. Broken tube and glass removed. Machine is fully functional. A message about broken NMR tubes in the NUCS Core Facility was sent out to users.</p> |

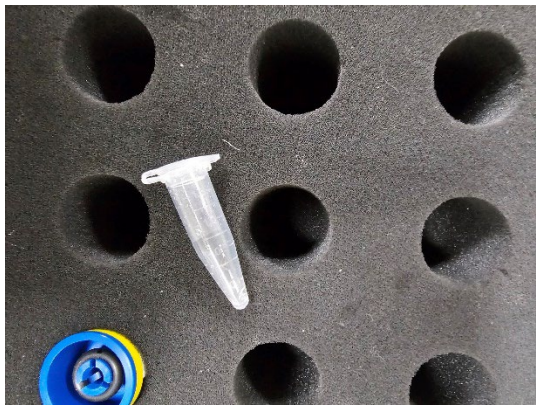
| ID INFO | SAFETY CONCERN | STATUS / RESOLUTION |
|---|---|---|
| 9/29/2023<br>NUCS-Fulmer<br>Bruker 500 | <p>An unlabeled Eppendorf tube containing an unknown material was found at the Bruker 500.</p> | <p>Eppendorf tube determined to be non-rad. Eppendorf tube removed. Machine is fully functional. A message about bringing samples and completing experiments in the NUCS Core Facility was sent out to NMR users.</p> |

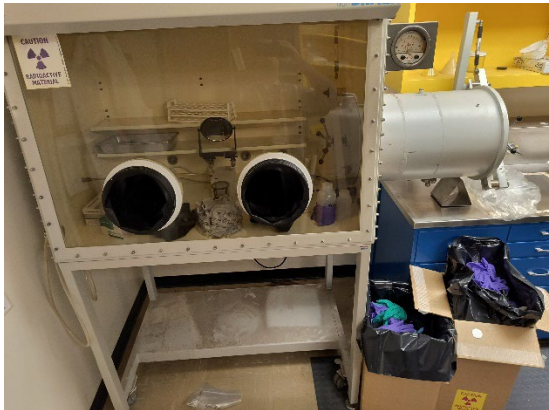
| ID INFO | SAFETY CONCERN | STATUS / RESOLUTION |
|---|---|---|
| 2/12/24<br>DODG-121<br>#5266 | Suspected contamination of the glovebox in Dodgen 121 with plutonium. Also, a suspected hole in one of the gloves on the glovebox.<br> | Draft memo sent to EH&S and RSO. EH&S and RSO worked with Dr. Guo and his students to clean it out. Are about 25% of the way completed as of July 23 <sup>rd</sup> , 2024.<br><br>Met with Guo on February 26 <sup>th</sup> , 2025, about current and future gloveboxes. Have not heard anything after meeting.<br><br>Current picture as of 8/26/25:<br> |

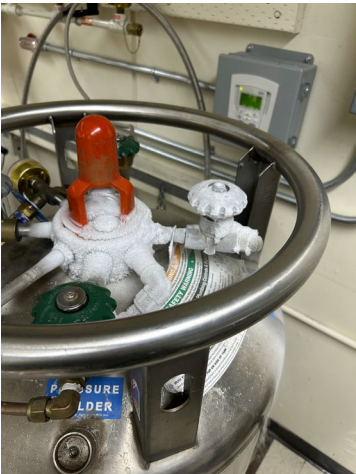
| ID INFO | SAFETY CONCERN | STATUS / RESOLUTION |
|---|---|---|
| 2/5/25<br>Fulmer<br>B3<br>#7644 | <p>One of the high pressure dewars was extremely iced up, hissing, and a small amount of liquid nitrogen was dripping out the liquid tap. I tapped the handle with a wrench and tightened it down with a gloved hand. The handle turned a little bit and the leaking and hissing stopped. Issue appears to be resolved, the dewar is currently sitting about 105psi.</p> | Tightened the liquid valve to stop leak. |

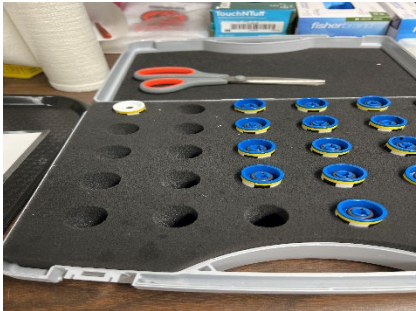
| ID INFO | SAFETY CONCERN | STATUS / RESOLUTION |
|---|---|---|
| 3/6/25<br>Fulmer<br>B3<br>#7958 | <p>The Rad NMR tube sample holder was placed in the case with the non-rad NMR tube holders.</p> | A pencil case is now used to store the Rad NMR tube sample holder and depth gauge. |

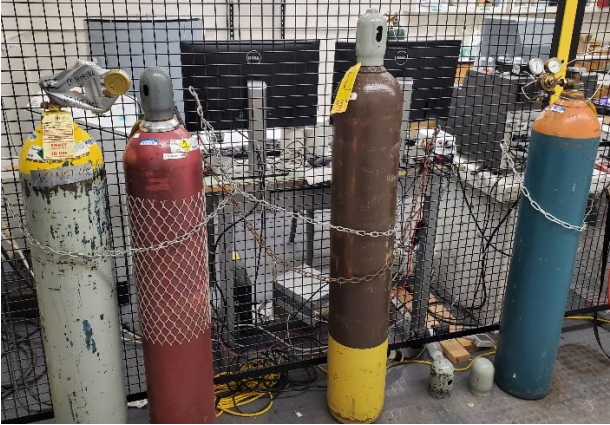
| ID INFO | SAFETY CONCERN | STATUS / RESOLUTION |
|---|---|---|
| <p>7/21/2025<br/>Dodgen<br/>21<br/>#8964</p> | <p>There are two concerns related to gas bottle use and storage:</p> <p>1: An attached regulator and cylinder appears to be tagged out with duct tape. Every possible scenario for this type of tag out is concerning: is the regulator damaged - if so, why is it still on the cylinder? Is the regulator stuck - if so, why hasn't help been sought?, Is the cylinder not in use (which is obviously the case) then why is a regulator on it at all? Is there cylinder damage? If so, then why is it in the building at all?</p> <p>2: Very few, if any, of the cylinders are chained with sufficient tension to be certain that they cannot fall over. There may be sufficient slack for a cylinder to fall/slide. A quick test was made and the cylinder leaned to a sharp angle before being slowed to a full stop. I do not believe they are an immediate threat as the chains will reduce falling energy to a minimal level, but they do not meet the definition of secure in the WSU SPPMs or WACs.</p> <p>Only one picture was allowed to be attached, but there is also a loosely chained flammable cylinder on the east side of the room. This is urgent but appears to be in a metastable state. Correction may be performed through regular channels rather than on an emergency basis by non-lab personnel.</p> | <p>The Guo Group has been notified. Graduate students have taken steps to properly secure the gas bottles individually and communication with Central Stores to fix the damaged regulator. The damaged regulator was removed and the cylinders have been chained up appropriately.</p> |

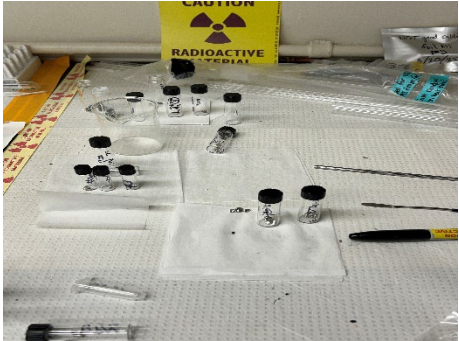
| ID INFO | SAFETY CONCERN | STATUS / RESOLUTION |
|---|---|---|
| <p>7/25/25<br/>Dodgen<br/>21<br/>#9008</p> | <p>Unsealed Rad Material is sitting on the lab bench. It is in a designated rad area, but is just in the open, unsealed and unlabeled. Verified with a GM that it was radioactive.</p> | <p>The Guo Group has been notified and the space was cleaned up.</p> <p>An email went out to the Guo group on 7/31/25 asking them to implement a tray system for RAM work.</p> <p>Picture of Rad area on 8/26/25:</p> |

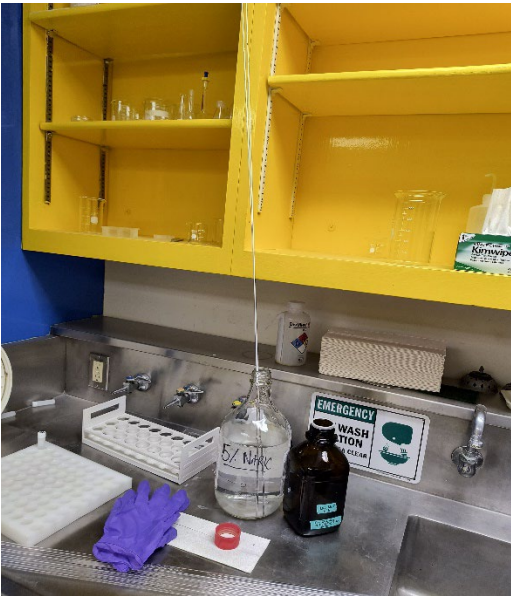
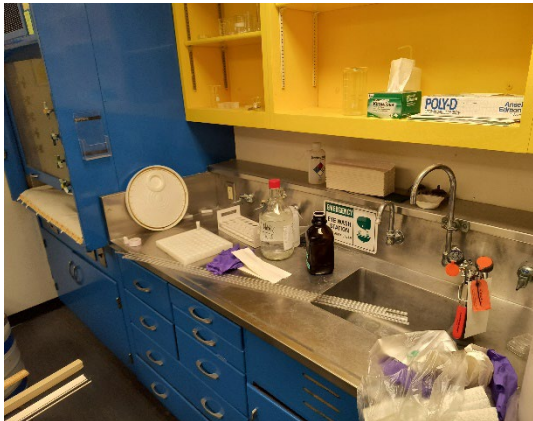
| ID INFO | SAFETY CONCERN | STATUS / RESOLUTION |
|---|---|---|
| <p>8/4/25<br/>Dodgen<br/>121<br/>#9076</p> | <p>There is an open (uncapped) bottle of nitric acid with something hanging out of it (not clamped) with no labels (see picture).</p> | <p>The Guo Group has been notified of the safety concern at 3:30 pm on 8/4/25. The Guo group removed the items in the nitric acid, but the nitric acid bottle remained on the counter and did not address any of the items of concern listed in the message to the Guo group.</p> <p>Picture of area on 8/26/25:</p> <p>No change as of 10/3/25.<br/>An email was sent to Dr. Guo and Eric Roalson.</p> |

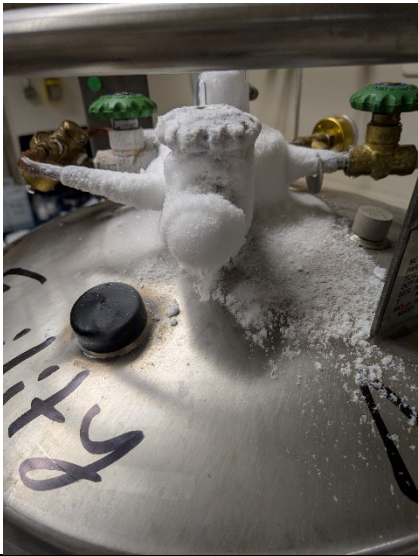
| ID INFO | SAFETY CONCERN | STATUS / RESOLUTION |
|---|---|---|
| 8/13/25<br>Fulmer<br>B3<br>#9160 | <p>Liquid N2 dewar supplying house N2 had liquid N2 coming out of liquid dispenser port.</p> | <p>Liquid dispensing valve was tightened, and liquid stopped coming out.</p> |

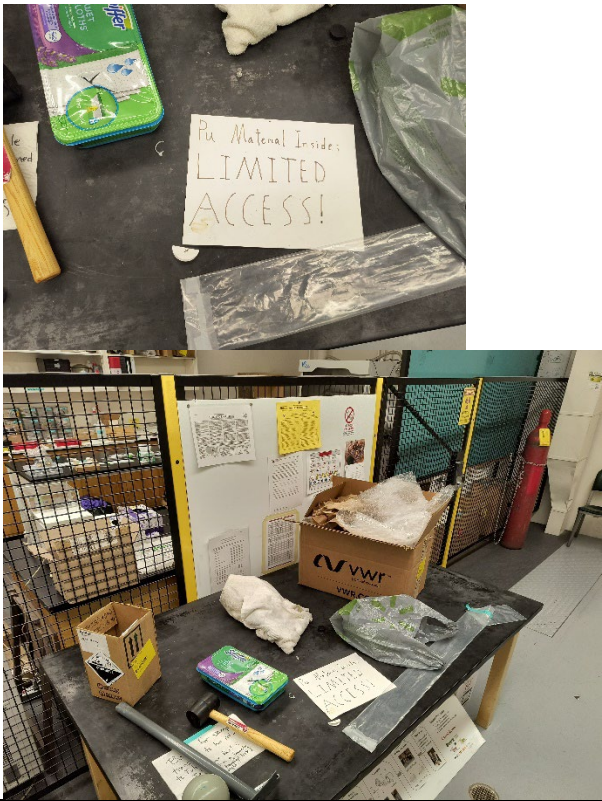
| ID INFO | SAFETY CONCERN | STATUS / RESOLUTION |
|---|---|---|
| 8/28/25<br>Dodgen<br>B21<br>#9296 | <p>There is a sign saying that "Pu Materials are Inside" on a random desk outside of the Guo lab space (see pictures). It is unclear if the Pu materials are in the plastic bag next to it in an unsecured location or somewhere else.</p> | <p>The sign was removed on 8/28/25 and we were assured by Dr. Guo that no Pu work has been done since 2019.</p> |

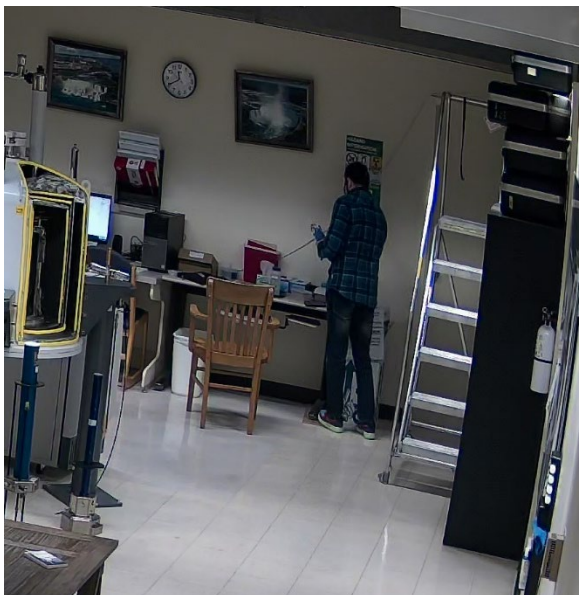
| ID INFO | SAFETY CONCERN | STATUS / RESOLUTION |
|---|---|---|
| 10/9/25<br>Fulmer<br>B3<br>#9656 | <p>A user was found removing unknown NMR tubes from the broken glass container near the DLS.</p> | <p>Ethan told him to not remove the samples from the facility or the glass waste. A message was sent out to users of the NUCS Core Facility telling them to not remove unknown materials from waste containers.</p> |

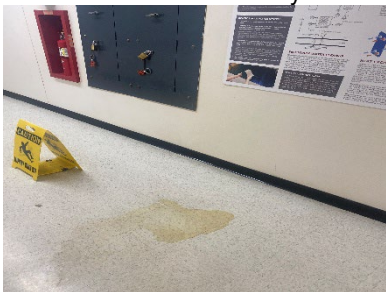
| ID INFO | SAFETY CONCERN | STATUS / RESOLUTION |
|---|---|---|
| 12/19/25<br>Dodgen 2 <sup>nd</sup> Floor<br>Hallway | There was a puddle of water in the hallway when I arrived this morning. I surveyed and cleaned it. Thought the facility should know as it's source was from my estimates the roof.<br> | Work request submitted to FacOps. FacOps came out during the week of 12/29/25 and 1/5/26 to repair the roof and stop the leaks. |

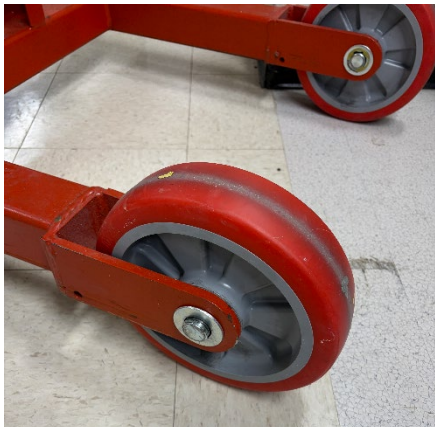
| ID INFO | SAFETY CONCERN | STATUS / RESOLUTION |
|---|---|---|
| 12/19/25<br>Fulmer B3<br>#12480 | A part of the liquid nitrogen dewar cart wheel came off. It is on the outside of the right wheel. It looks like some sort of piece of metal fell off, and now the wheel may not be completely secure.<br> | Retaining clip was replaced. |

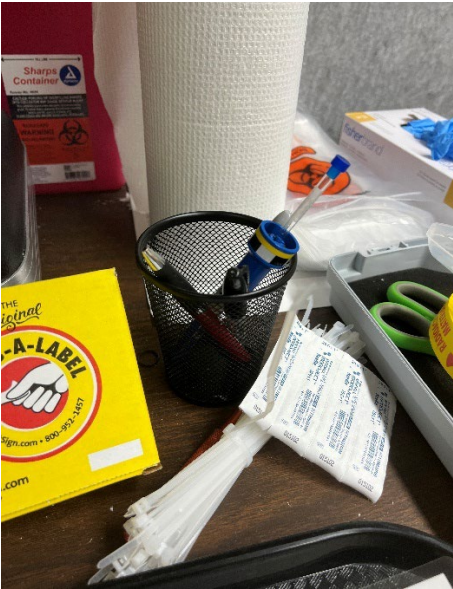
| ID INFO | SAFETY CONCERN | STATUS / RESOLUTION |
|---|---|---|
| <p>2/24/26<br/># 13076<br/>Fulmer<br/>B3</p> | <p>I turned around from the workstation and looked at the sample prep bench and saw another sample in the pen cup for the radioactive NMR sample prep pens and sharpie</p> <p>It was checked with the GM to at least verify the outside wasn't contaminated or radioactive.</p> | <p>Samples were discarded. User contacted.</p> |

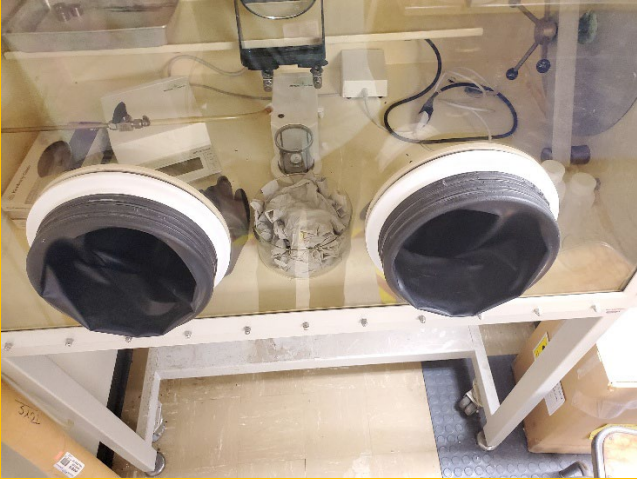
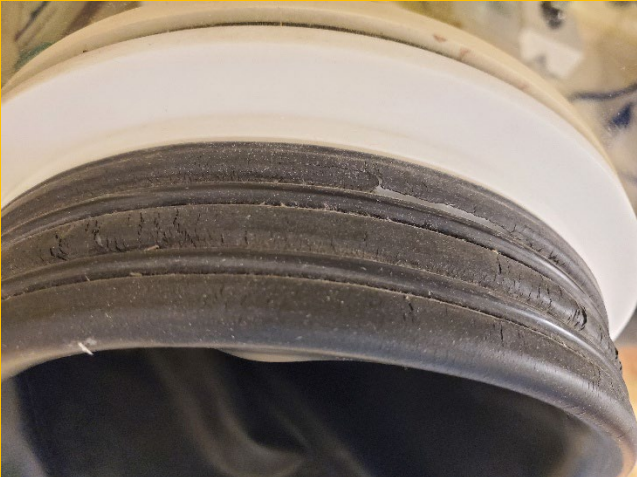
| ID INFO | SAFETY CONCERN | STATUS / RESOLUTION |
|---|---|---|
| <p>3/17/26<br/>#13264<br/>Dodgen<br/>121</p> | <p>The gloves attached to the glove box in Dodgen 121 show visible signs of degradation. It is uncertain whether they would successfully isolate the interior and exterior atmosphere or prevent contamination from crossing the gloved boundary. There is no signage indicating a decontaminated/decommissioned or tagged out status of the glove box.</p> | <p>The Guo group was contacted to determine if the glovebox is to be used again.</p> <p>4/23/26: Dr. Guo said he would like to have the lab placed in inactive status.</p> <p>7/13/26: RSP was contacted about rendering the glovebox safe. RSP is working with chemistry about funding the cleanup project to deal with the Am-241 contamination.</p> |

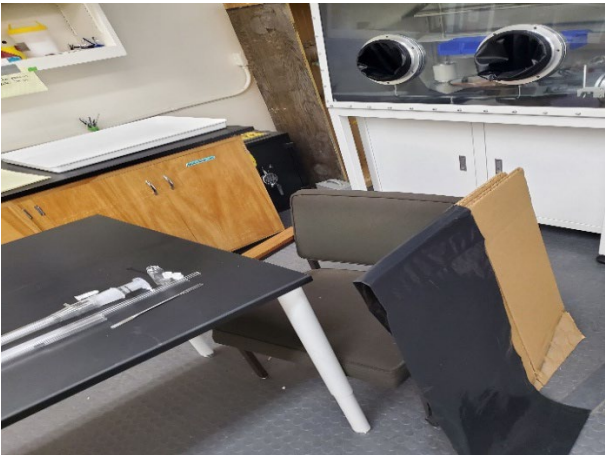
| ID INFO | SAFETY CONCERN | STATUS / RESOLUTION |
|---|---|---|
| <p>3/17/26<br/>#13265<br/>Dodgen<br/>G0021</p> | <p>There is a fabric upholstered padded chair in the radiation work area located in Dodgen G0021 hidden behind some flattened boxes. It is extremely porous and would be very difficult to decontaminate.</p> | <p>Dr. Guo was contacted and his students removed the chair within 24 hours.</p> |

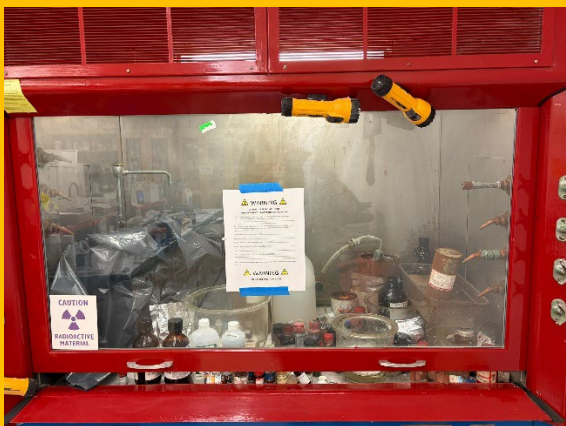
| ID INFO | SAFETY CONCERN | STATUS / RESOLUTION |
|---|---|---|
| 6/3/26<br>#13854<br>Dodgen<br>221 | <p>Laboratory is potentially unsafe due to large amounts of aggregated hazardous chemicals, storage, handling, and inventory practices for &gt;18 months. See attached pictures. Director would like laboratory cleared of at least 80% of chemical inventory and any aggregate quantities that pose risk to the building due to unsafe storage and/or condition of storage ASAP. Please notify EHS.</p> | <p>Fumehood has been cleaned out, and many chemicals have been sent to EH&amp;S for disposal.</p> <p>Two bins of chemicals are waiting for EH&amp;S pickup.</p> <p>The lab is currently waiting for EH&amp;S to come out and look at. EH&amp;S should be coming out before the end of July.</p> |
