IMPROVING IRRIGATION EFFICIENCIES IN PEARS CASE STUDIES

Orchard A Case Study

TB97E

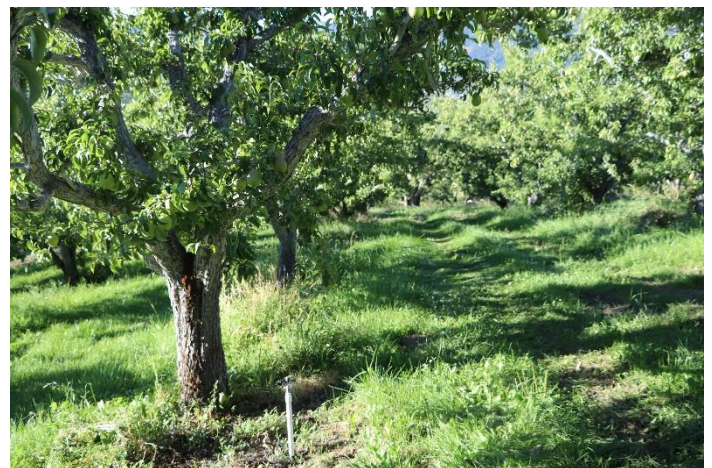
Figure 1. The standard system created runoff in order to maintain sufficient moisture at the top of the slope.

The system design was impact sprinklers (Rainbird) on a 36 foot by 36 foot spacing (Figure 1; Table 1). Managers generally run one row at a time, skipping a row as they go across the field, and return to irrigate alternate rows, taking nine days to irrigate the five-acre field.

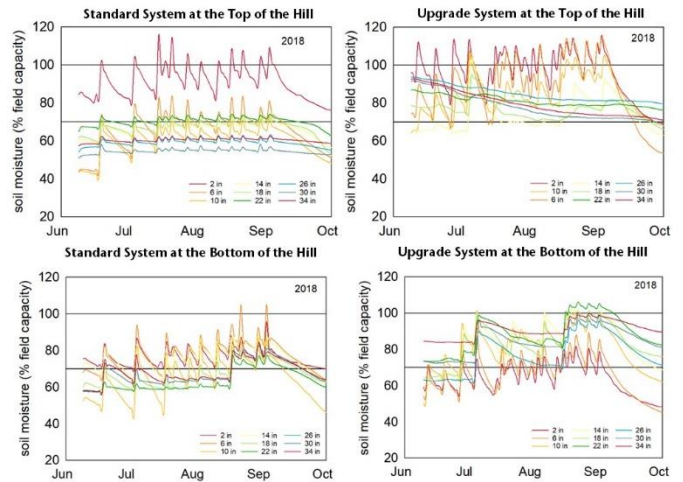
Figure 2. Soil moisture during the 2018 growing season at Orchard A from June to October illustrated as percent of field capacity.

In the standard system it was difficult to maintain adequate soil moisture at the top of the hill while the bottom of the hill tends to be oversaturated. This is because of runoff, low-pressure draining of water when the system is turned off, and often differences in the water tables from the top to the bottom of the orchard. The system upgrade allowed the managers to maintain soil moisture in the optimum zone, between 70% and 100% of field capacity (Figure 2).

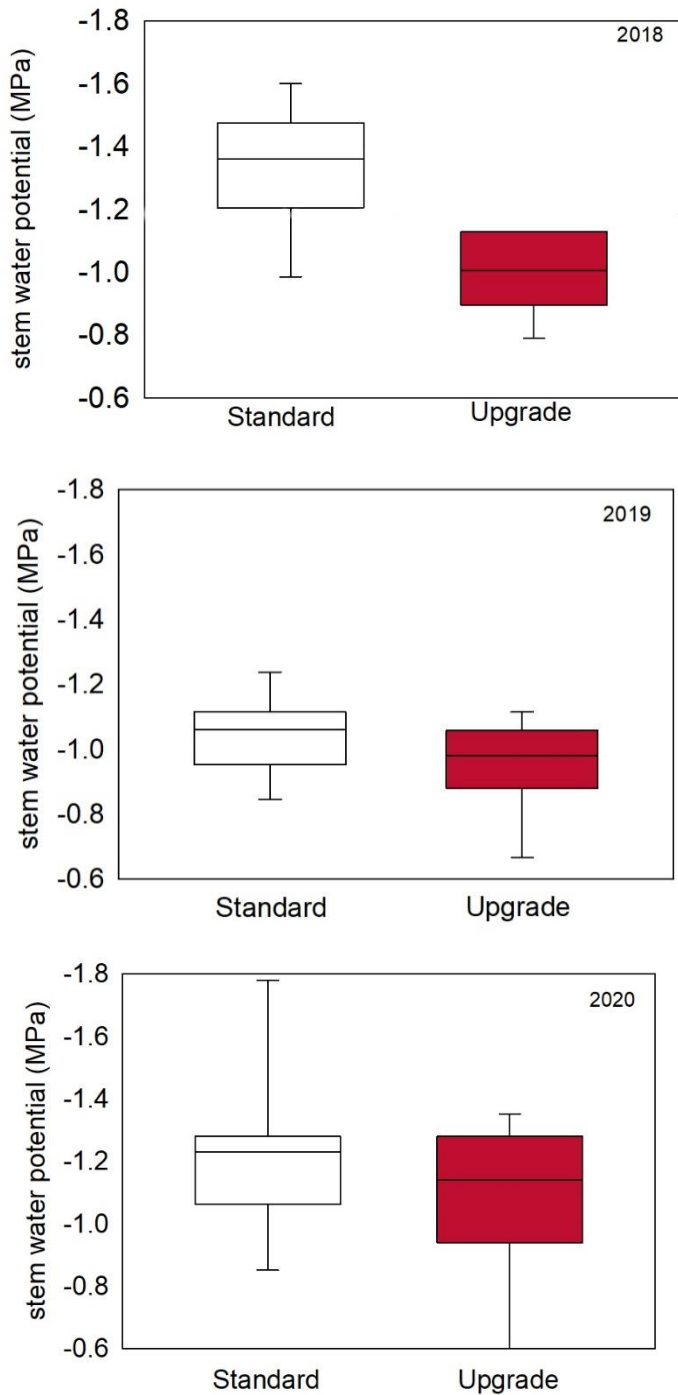
Figure 3. Tree water stress measured by stem water potential for 2018 (top), 2019 (middle), and 2020 (bottom).

A pressure chamber was used to measure water tension from nine trees in July 2018 and six in August 2019 and 2020 along the top of the hill in the block near solar noon. Measured leaves were bagged with silver reflective bags for at least one hour to equalize leaf and xylem water potential before measurements were taken.

Tree water limitation measured by stem water potential was lower in the upgraded block varying from -0.79 to -1.13 MPa compared to -0.81 to -1.7 MPa in the standard block at the top of the hill in July 2018; from -1.12 to -0.6 MPa in the upgrade compared to -1.25 to -0.84 MPa in the standard in August 2019; and from -1.36 to -0.51 MPa in the upgrade and -1.96 to -0.8 MPa in the upgrade on in August 2020 (Figure 3). Of note is the grower ran the upgraded system the same number of hours in 2019 as the standard system and there was less stress in the upgraded system. Additionally, soil moisture information from the sensors influenced grower watering decisions in the standard block, likely helping to reduce tree stress in the standard system in 2019 and 2020 (Figure 4).

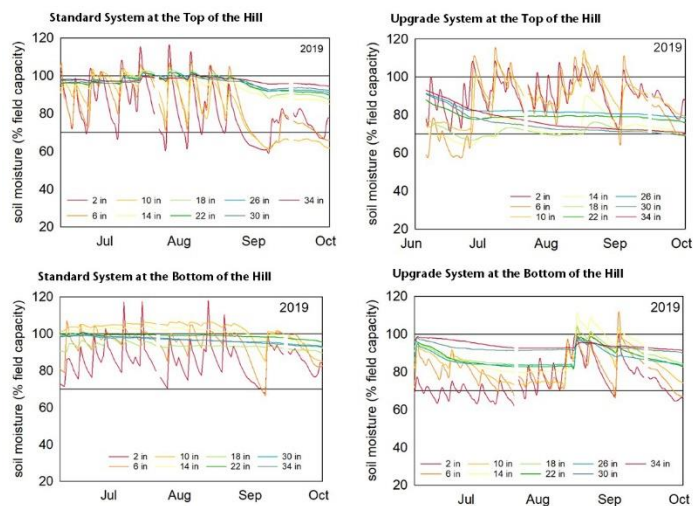
Figure 4. Soil moisture during the 2019 growing season at Orchard A from June to October, illustrated as percent of field capacity.

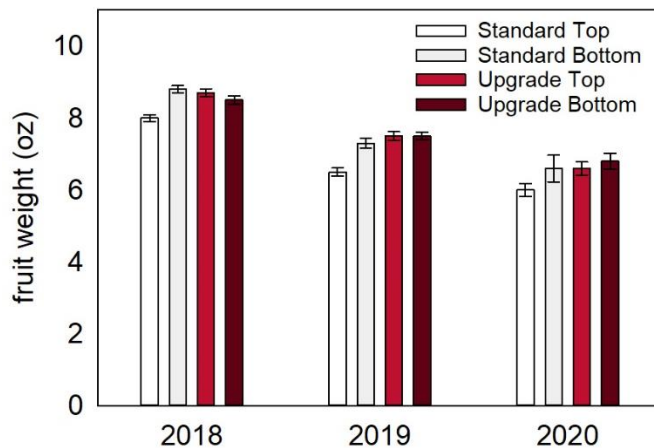
Figure 5. Fruit weight at harvest.

Fruit size was more uniform in the upgraded block compared to the block irrigated using the standard system. In the standard block fruit weight measured the week of harvest was generally smaller at the top of the hill compared to at the bottom of the hill. In the upgraded block fruit size was uniform between the top and bottom of the hill with size similar to the top of the hill in the standard block (Figure 5). At the top of the hill the fruit size distribution in the upgraded block tended toward larger fruit than in the standard block (Figure 6).

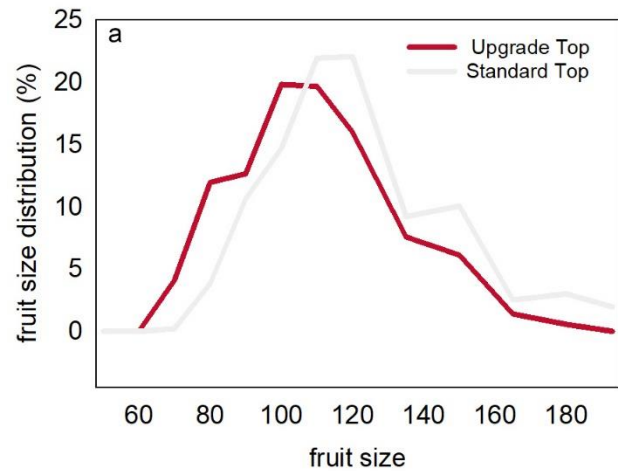
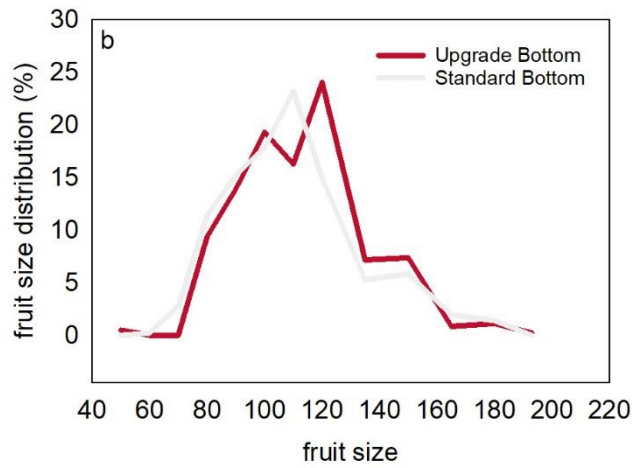
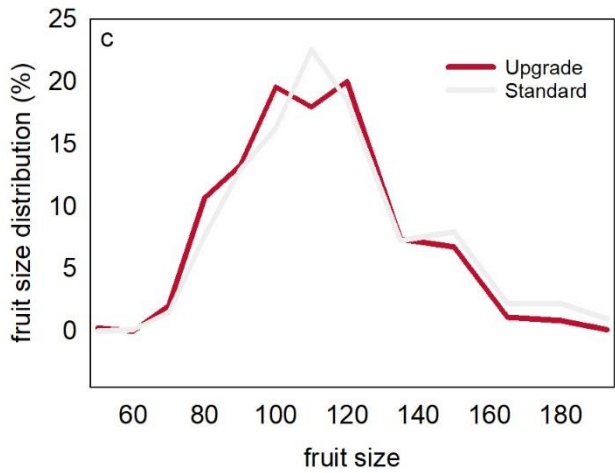
Figure 6. Fruit size distribution top of the hill (a), bottom of the hill (b), and average (c) for 2018 to 2020 crop years.

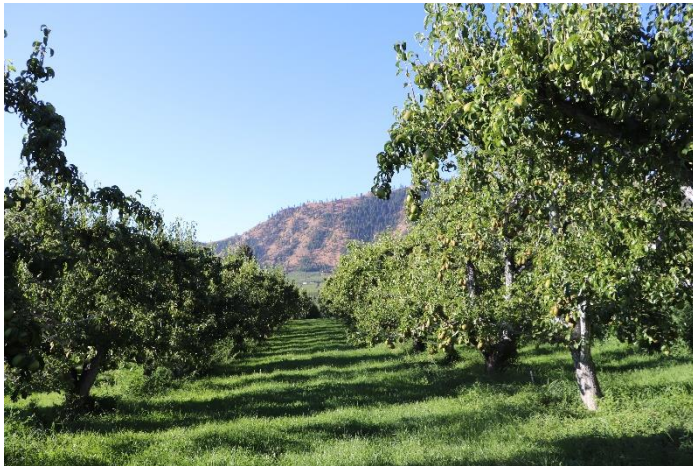
Figure 7. Orchard B.

The five acre block was located on a moderate slope with 76 sprinklers per acre (Figure 7; Table 4). Multiple types of irrigation sprinkler heads were used in the block (Figure 8). Due to lack of pressure at the top of the hill and variation in sprinkler heads used throughout the block, trees received insufficient and uneven irrigation (Table 5), likely resulting in increased cork spot.

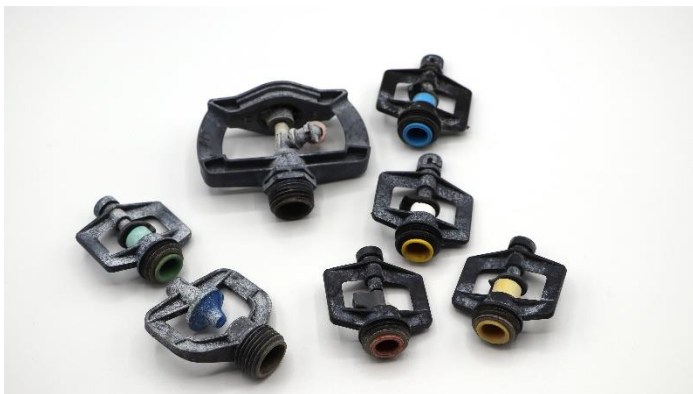
Figure 8. Multiple types of sprinkler nozzles were used in the standard block.

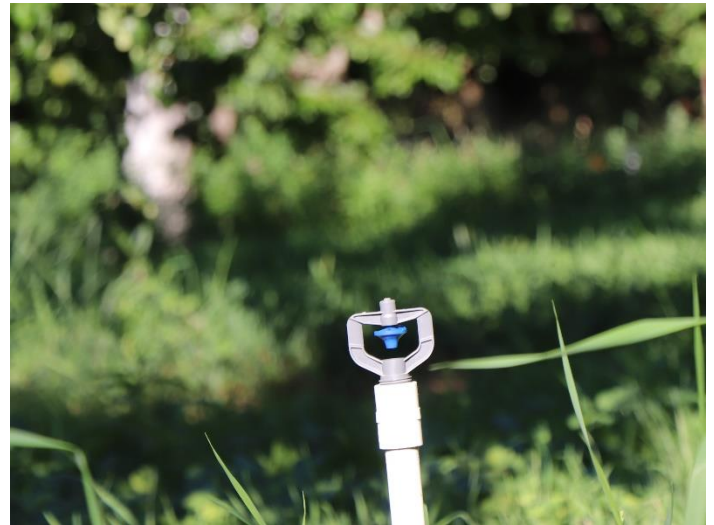
Figure 9. Irrigation upgrades included microsprinklers with flow regulators.

In order to increase pressure to sufficient levels and provide even outputs across the block a small booster pump was installed at the canal, and R10 microsprinklers with flow regulators were installed in the upgrade portions of the block (Figures 9 and 10). Resulting pressure and flow changes increased irrigation output (Table 6).

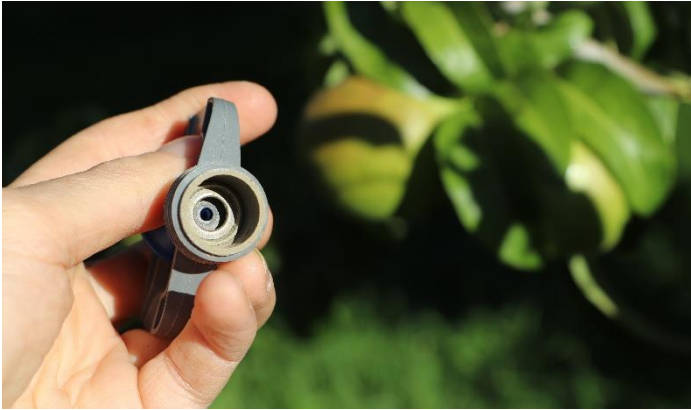
Figure 10. Flexible flow washers in flow control nozzles reduce the orifice opening and size and emit a constant flow over a wide range of pressure.

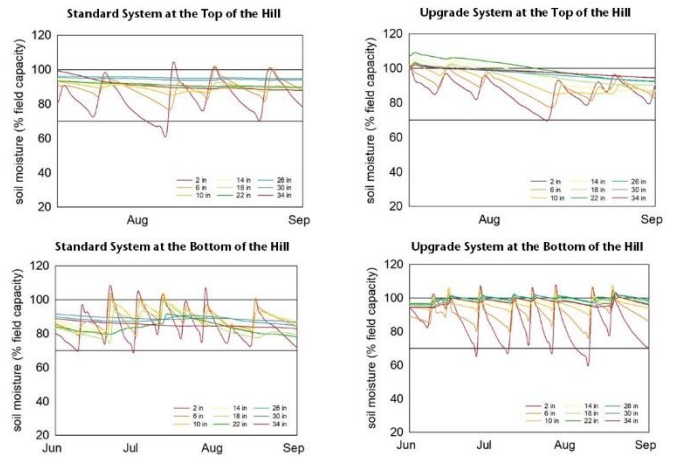
Figure 11. Soil moisture during the 2020 growing season.

The system upgrade at Orchard B was designed to improve the distribution of water. The standard system provided insufficient water at the top of the hill due to insufficient pressure to run the sprinklers installed, and distribution was uneven due to multiple types of sprinkler heads across the field. A booster pump increased pressure and flow at the top of the hill in the upgraded system. Installation of standardized sprinkler heads made water distribution uniform across upgraded sections of the block. System upgrades were completed June 19, 2020. The soil moisture sensors at the top of the hill were originally installed in areas blocked to irrigation by the trees and was moved on July 17. Due to nonrepresentative early readings soil moisture interpretation is difficult (Figure 11). During the critical fruit sizing period in August, soil moisture at the top of the hill appeared to be higher in the upgraded system.

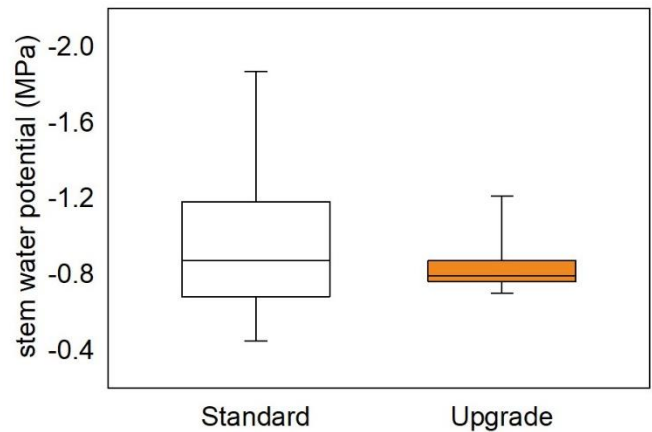
Figure 12. Tree water limitation measured by stem water potential.

Water limitation measured by stem water potential was lower and less variable in the areas of the orchard with an upgraded system (-1.25 MPa to -0.35) compared to the standard system (-1.96 to -0.68 MPa) measured in August 2020 (Figure 12). Narrow distribution of stem water potential and thus water limitation is important for uniformity in the block.

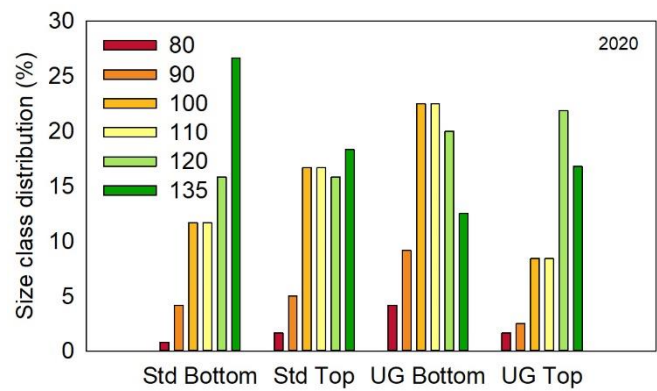
Figure 13. Percentage of fruit in different box size classifications for the standard system at the lower and upper elevations of the field (left) and in the upgraded block at the lower and upper elevations of the field.

Fruit size was slightly larger in the upgraded section of the block than the standard section of the block (average 5.7 versus 5.6 oz). However, the upgraded sections of the block trees had smaller fruit in the upper elevation of the block than in the lower section (Figure 13). This may be due to problems with irrigation sensors early in the season which led to inaccurate readings and thus nonideal irrigation sets at a critical timing.

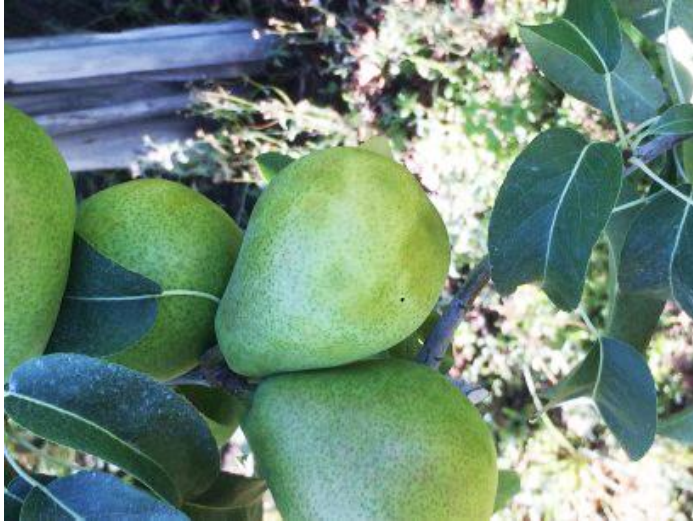
Figure 14. Cork is a challenge at Orchard C.

- Severe cork (Figure 14).
- Did not pick block in 2017 due to 80% cork (Figure 15).

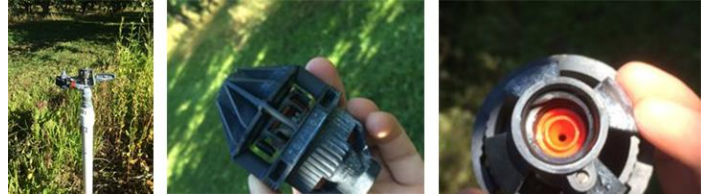
Figure 16. Rainbird sprinklers (left) and R2000 sprinklers (center and right).

In the standard system impact sprinklers (Rainbird and R2000) were on a 24 foot by 20 foot spacing (Figure 16). Grower's standard irrigation was 12 to 24 hr sets weekly (Table 7).

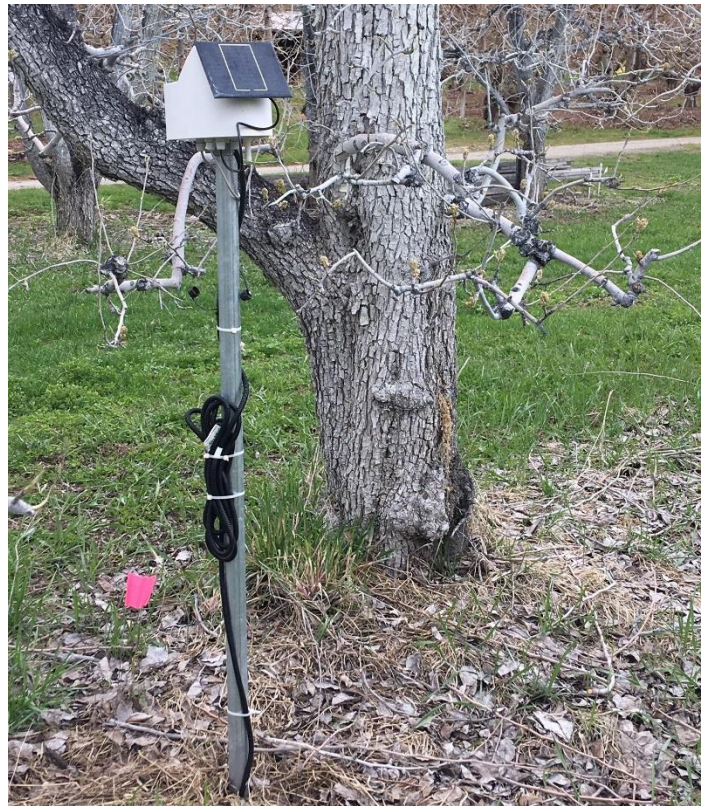
Figure 17. Telemetry for soil moisture probe installed in upgrade block.

Sentek soil moisture sensors were installed in April 2019 (Figure 17). Irrigation in 2019 in the upgrade block was done according to soil moisture needs rather than a standard schedule.

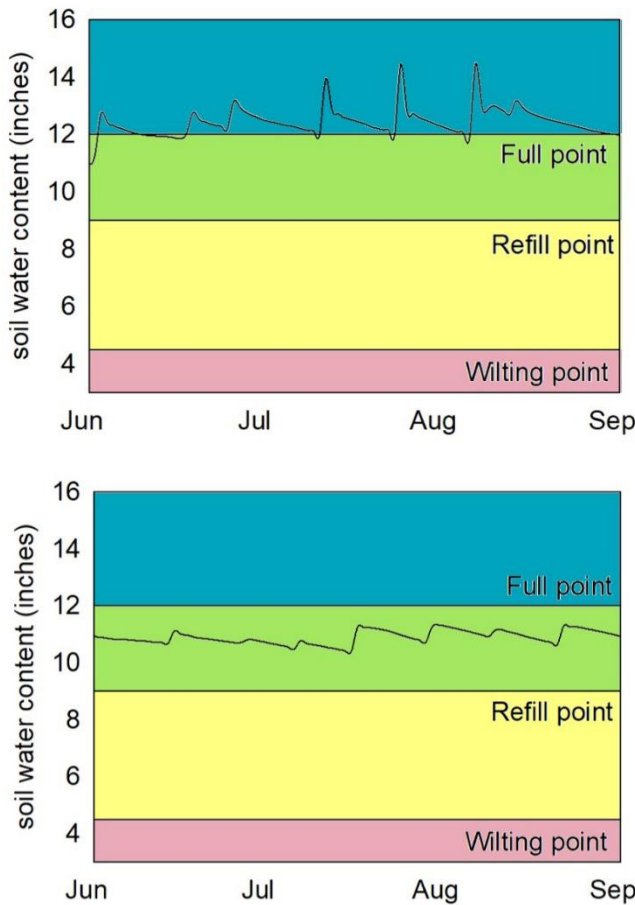
Figure 18. Soil moisture stayed above the full point (field capacity) for most of the season in the standard irrigated block (top graph). In comparison where the grower irrigated according to soil moisture sensors moisture levels maintained between refill and full (bottom graph).

Using outputs from the irrigation sensors the grower was able to maintain soil moisture between the full and refill points in the area of the block designated as experimental. In comparison the grower standard of irrigating weekly using 12 or 24 hr sets kept soil overly moist with moisture above the full point (field capacity) (Figure 18).

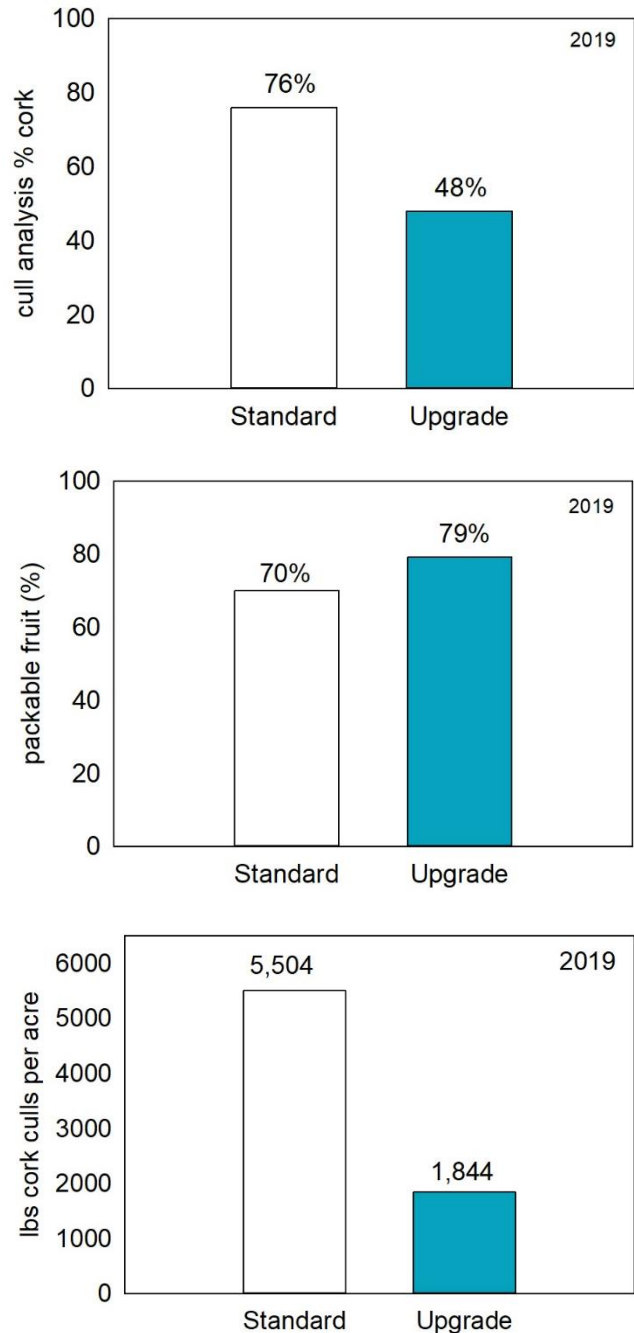
Figure 19. Fruit quality information from commercial pack-out.

Fruit quality was measured from commercial pack-out of east and west sections with standard or sensor-based irrigation. In the section of the field where irrigation sensors were used to determine watering frequency the amount of cork was reduced resulting in higher pack-outs (79% versus 70%) and 3,660 lb fewer culls due to cork (Figure 19).

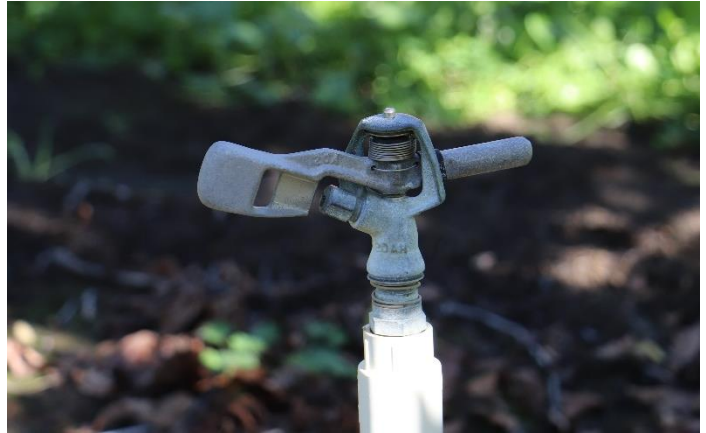
Figure 21. Rainbird sprinklers (pictured) and R2000 sprinklers were standard at this site.

The standard system was impact sprinklers with 50 sprinklers per acre at block P and 39 sprinklers per acre at block W (Figures 20–22).

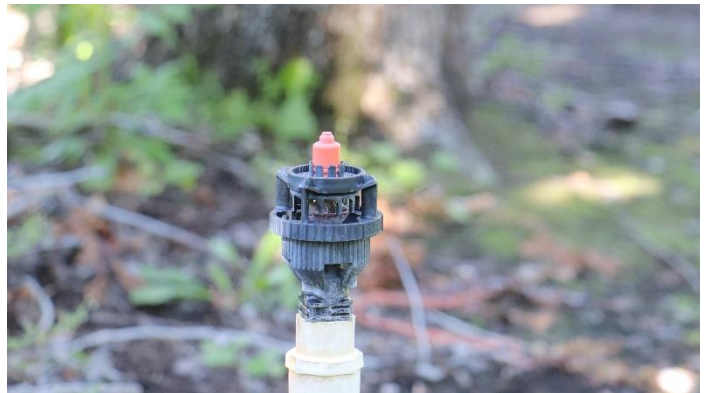
Figure 22. R2000 sprinkler.

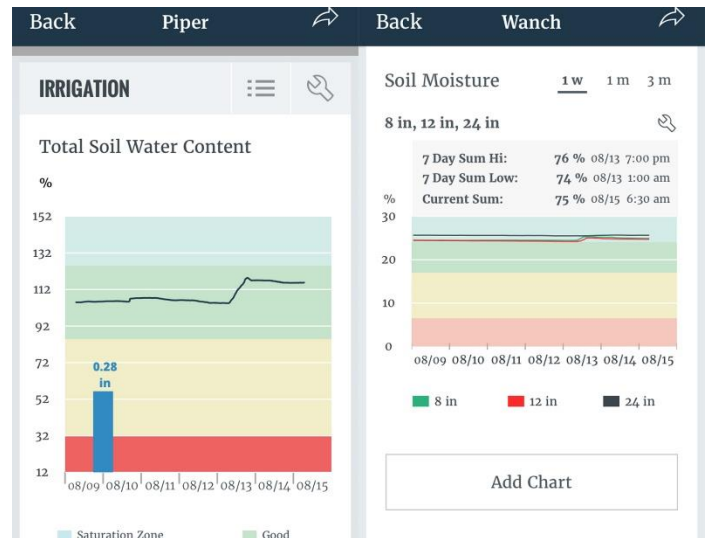
Figure 23. Irrigation application soil moisture information. The black line indicates current water status. Where the green shaded area meets the yellow shaded area is considered the refill point. The red shaded area indicates the wilting point. When the black line is in the blue area the soil is oversaturated.

Three acres were switched from old impact sprinkler (Rainbirds) to similar volume sprinklers (Nelson R2000) with uniform output and new nozzles (block P). Soil moisture sensors were installed in April 2019 (Figure 23). Irrigation in both blocks was done with fewer 24 hr sets starting in 2018. The grower waited longer between sets and reduced 24 hr sets based on sensors starting in 2019.

The irrigation sensor provided soil moisture information updated hourly. The interface shows soil moisture levels relative to field capacity and maximum allowable depletion levels input by the user (Figures 23 and 24). Levels are displayed as an average and for 8-, 12-, and 24-inch depths. See *Using Soil Moisture Sensors in Pears* (DuPont et al. 2021) for more sensor information.

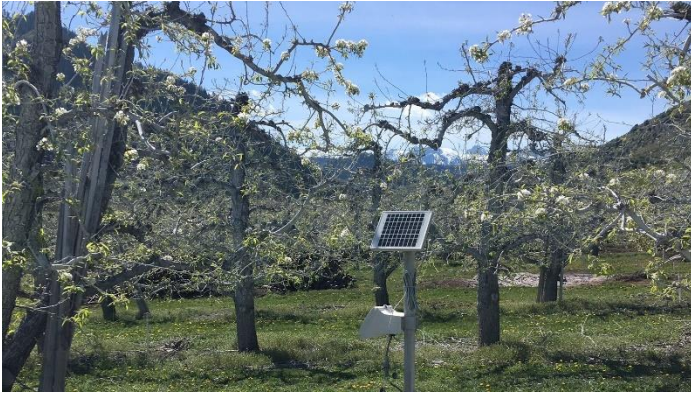
Figure 24. Irrigation sensor telemetry.

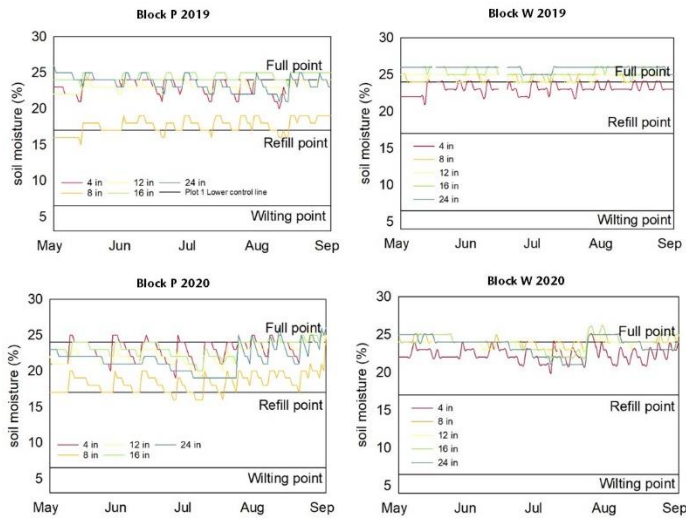
Figure 25. Soil moisture from 4 to 24 inches.

Moving to fewer 24 hr sets and using soil moisture information kept soil moisture between the refill and full points in both blocks in 2019 and 2020 (Figure 25).

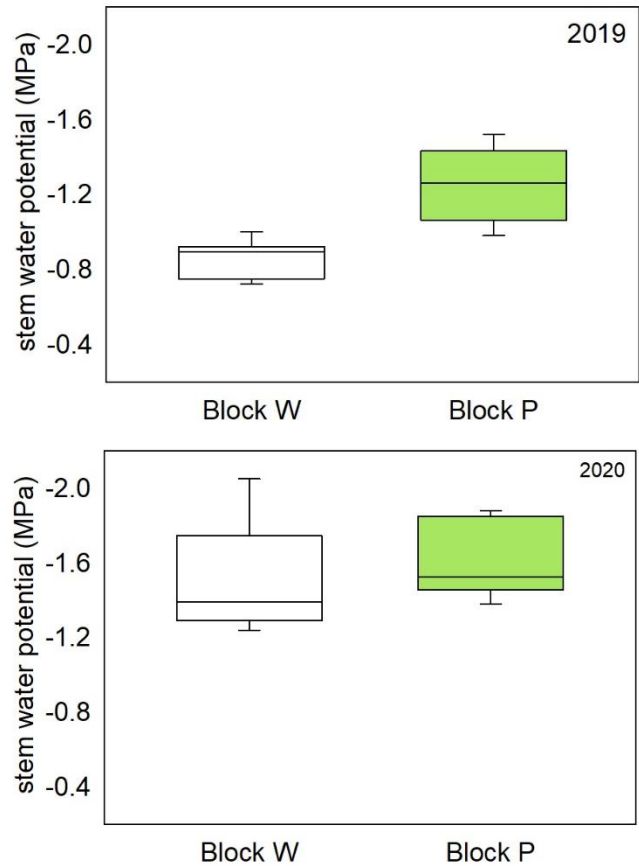
Figure 26. Tree water stress measured by stem water potential for 2019 (top) and 2020 (bottom).

While soil moisture as measured by the irrigation sensors was generally between the full and refill points, tree stress as measured by stem water potential was high in block P in 2019 and in both blocks W and P in 2020 at the date of July measurements (Figure 26).

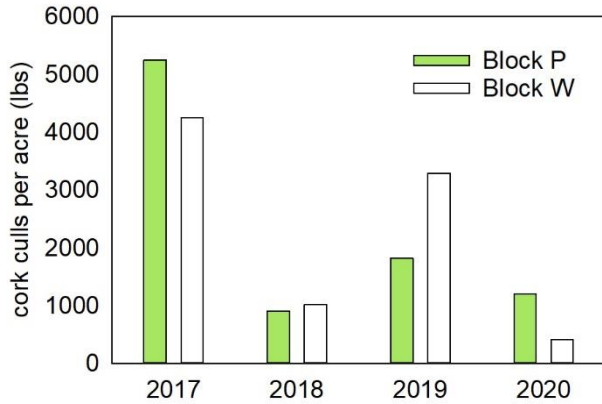
Figure 27. Effect of irrigation change on cullage from cork in blocks P and W when 24 hr sets were used (2017) versus 12 hr sets (2018 to 2020) when soil moisture sensor information was used. Cork culls per acre estimated based on commercial packing reports for each block assuming a standardized 40 bin per acre yield.

cork dropped on average. In 2017 before irrigation changes were made the pack-out was 61% and 73% for blocks W and P, respectively, with 29% and 52% cork. This resulted in 4,250 and 5,240 lb per acre of culls due to cork for blocks W and P, respectively (at 40 bins per acre). After the grower moved from a standard of 24 hr sets to 12 hr sets and used irrigation sensor information to lengthen the time between sets, culls per acre from cork in d'Anjou pears dropped to an average of 1,575 and 1,312 lb per acre of culls due to cork for blocks W and P, respectively (at 40 bins per acre) (Figure 27). A reduction in culls due to cork translates to increased returns. Assuming \$20

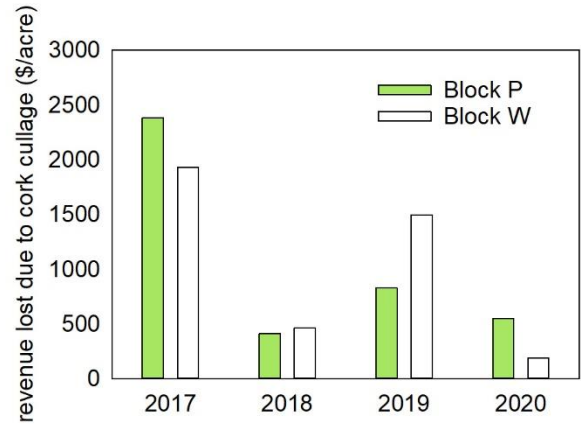
Figure 28. Revenue lost to cork cullage in 2017 when 24 hr sets were employed and 2018 to 2020 when 12 hr sets for two commercial blocks P and W where soil moisture sensor information was used assuming 40 bins per acre and \$20 per 44 lb box.

per 44 lb box and 40 bins per acre, revenue lost to cork culls was \$1,932 and \$2,382 per acre for blocks W and P, respectively, in 2017. After the move to 12 hr sets and changing length between sets, lost revenue to culls averaged \$716 and \$596 per acre for blocks W and P, respectively, between 2018 and 2020 (Figure 28). It is important to note that weather and other year-to-year differences could also have influenced cork, pack-out, and revenue changes. Additionally, the orchardist took over management of the block in 2017 and more aggressive pruning and other horticultural practices likely impacted the fruit quality over time.

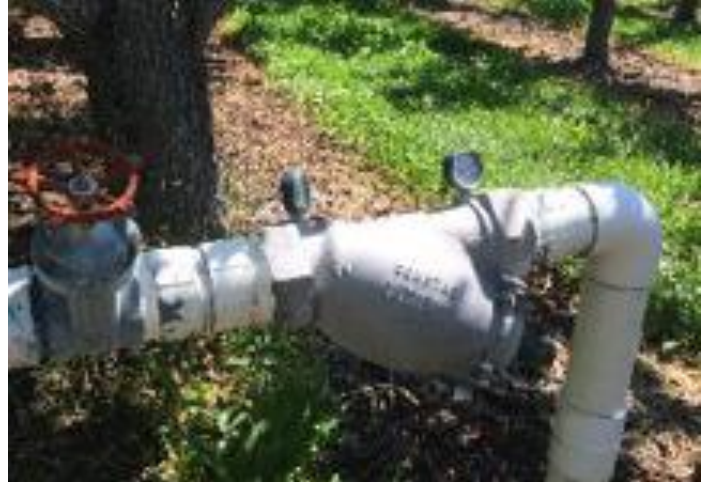
Figure 30. Sontag filter.

The site has a standard filter out of the irrigation canal (Figure 29) and a standard Sontag filter before the block (Figure 30). Brush filters that can be cleaned without opening are also used on the farm in other blocks (Figure 31).

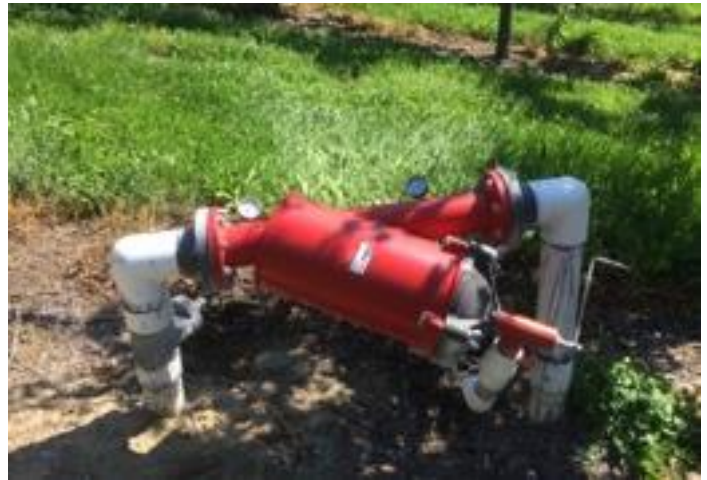
Figure 31. Brush filter can be cleaned by turning handle and opening valve.

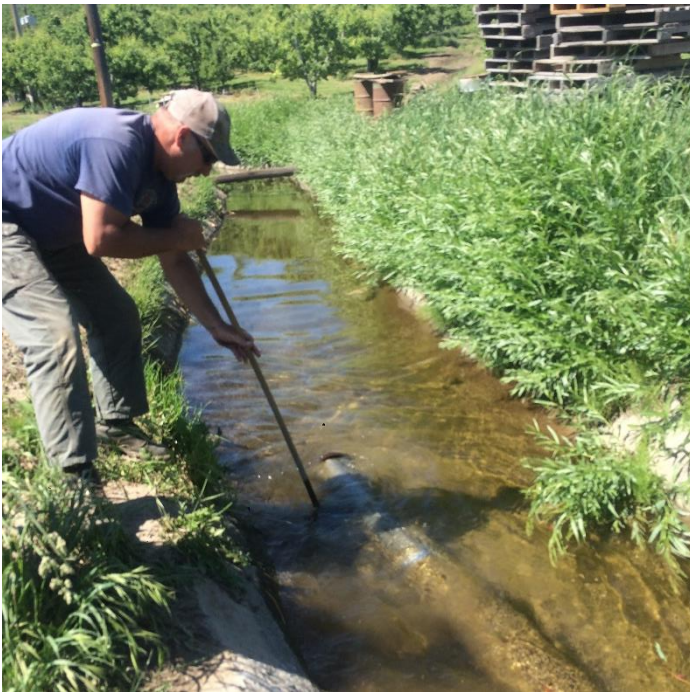
Figure 29. Grower cleaning irrigation canal filter.

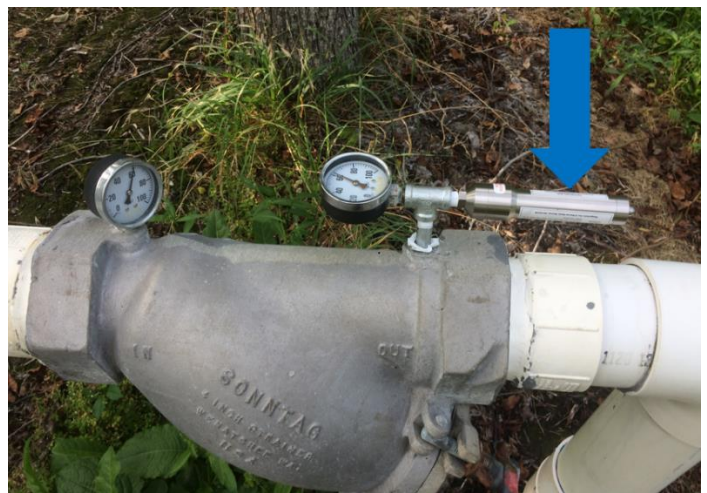
Figure 32. Pressure gauge data logger indicated by blue arrow was installed to track water pressure.

A pressure gauge with a data logger was installed on the filter at the beginning of the growing season in order to track potential drops in pressure when filters clog (Figure 32). Pounds per square inch of pressure was measured every 15 minutes continuously from May 23 to August 15, 2019. In June the irrigation system was often turned off, especially at night, due to the wet spring, which meant watering was not always necessary. Water pressure dropped overnight occasionally during the peak irrigation season of July (Figure 33). For example, on July 19 pressure dropped to 42 psi at 6 a.m., presumably before the filter was cleaned at 7 a.m., and pressure returned to 62 psi. However, it is unclear whether pressure drops were significant enough to produce substantially reduced irrigation outputs.

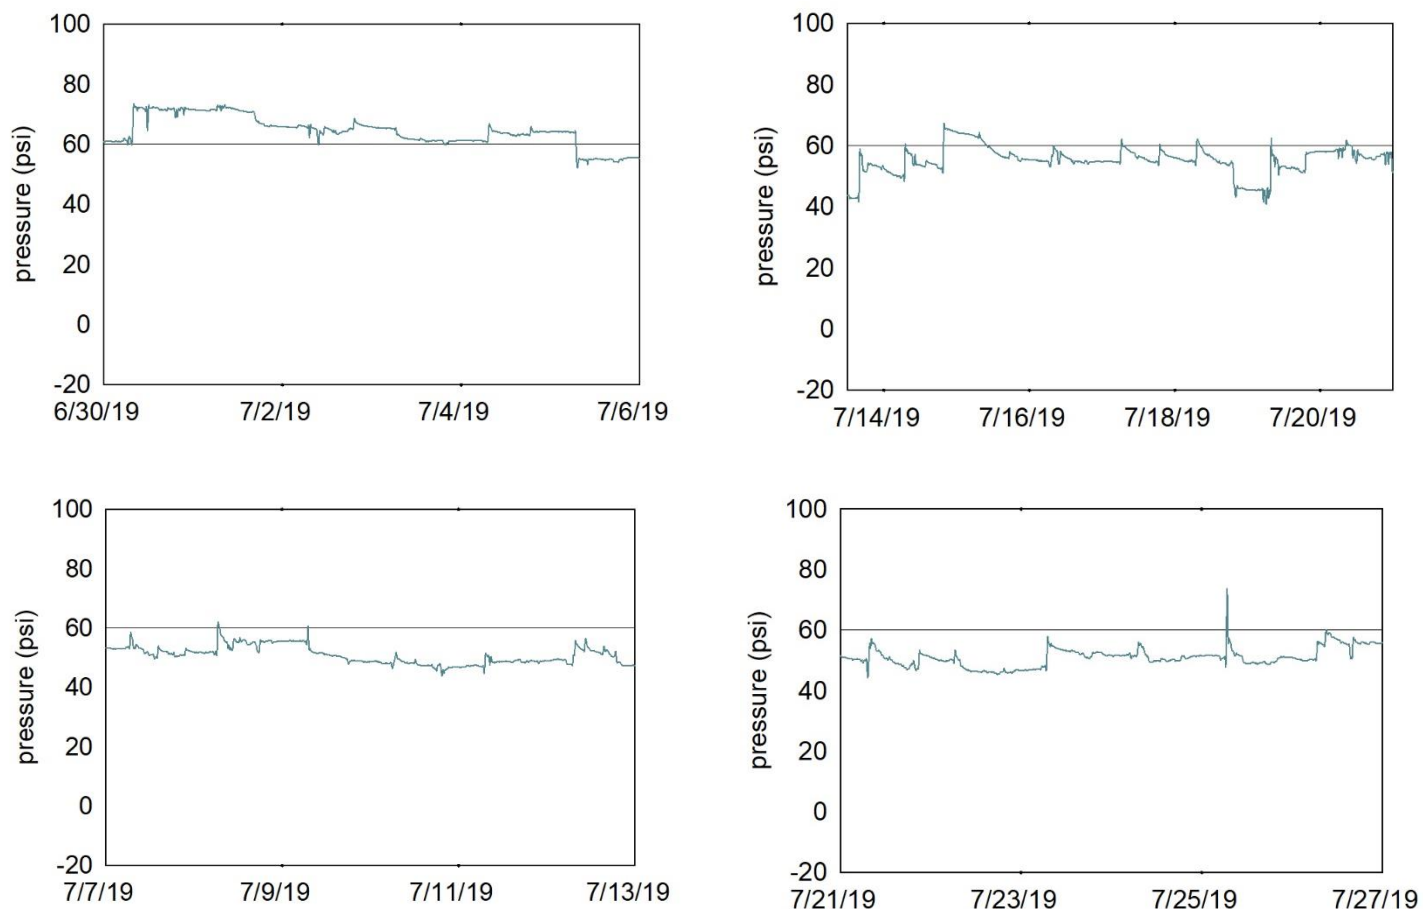
Figure 33. Filter pressure measured in pounds per square inch (psi) for the month of July.
