2020 PROJECT PROPOSAL CHECKLIST
2021-23 Biennium Four-year Higher Education Scoring Process

WSU INSTITUTION	CAMPUS LOCATION
365 - Washington State University	Pullman
PROJECT TITLE	FPMT UNIQUE FACILITY ID # (OR NA)
Johnson Hall Demolition	A00267
PROJECT CATEGORY	PROJECT SUBCATEGORY
Replacement	Standalone
PROPOSAL IS	
New or Updated Proposal (for scoring)	Resubmitted Proposal (retain prior score)
<input checked="" type="checkbox"/> New proposal <input type="checkbox"/> Resubmittal to be scored (more than 2 biennia old or significantly changed)	<input type="checkbox"/> Resubmittal from 2017-19 biennium <input type="checkbox"/> Resubmittal from 2019-21 biennium
CONTACT	PHONE NUMBER
Jason Baerlocher	509-335-9012

Problem Statement - Washington State University requests \$8,000,000 in the 2021-23 Capital Budget for the demolition of Johnson Hall on the Pullman campus to capitalize on the rare appropriation of federal funds to replace the aged building with a new 105,000 square foot state-of-the-art research facility.

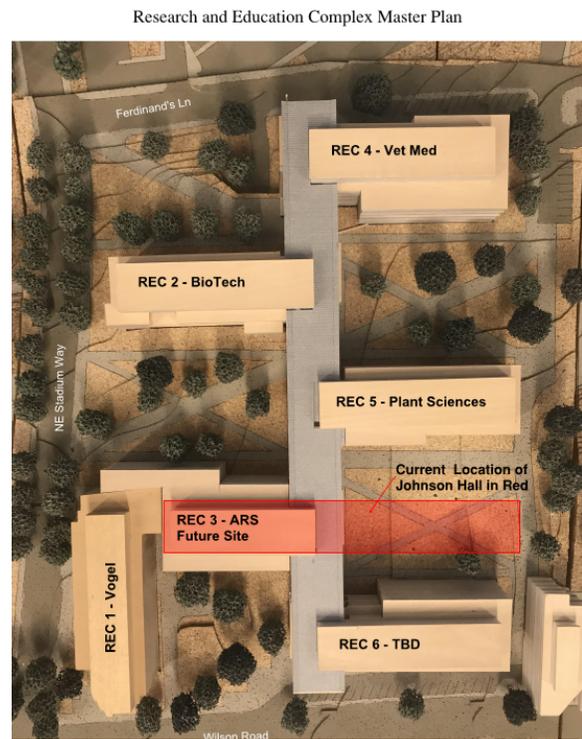
Figure 1 – Research and Education Complex Master Plan

History - The WSU Campus Master Plan includes the development of a research and graduate education core on the east side of the Pullman campus. The Research and Education Complex plays prominently in this master plan by supporting molecular science from CAHNRS, the College of Veterinary Medicine, and the College of Arts and Sciences. (Figure 1)

part of the Research and Education Complex with connections to the core spine collaboration area and Vogel. As shown in Figure 1, the new USDA/ARS Plant Biosciences Building was planned to be sited on the current location of Johnson Hall.

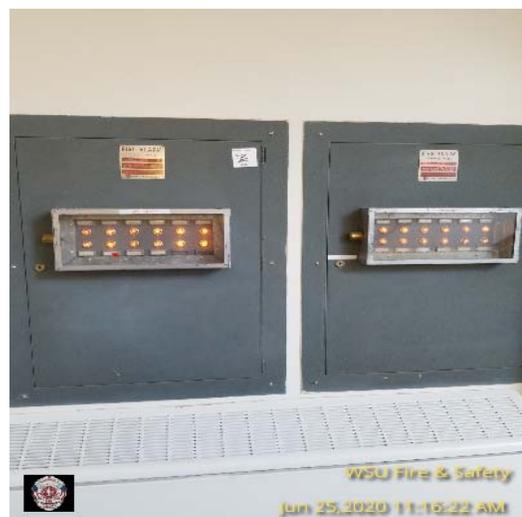
Figure 2 - Johnson Hall Fire Alarm Panel

Johnson Hall contains many critical building systems that have past their useful life and are in need replacement. Examples include:

- Air Handling Units
- Primary Electrical Service
- Building Electrical Distribution
- Cooling Tower
- Building Controls and IT Infrastructure
- Mechanical Distribution System
- Elevators
- 500 ton chiller (currently not operational)
- Building Envelope (windows, cladding, doors)
- Fire Alarm System (Figure 2)

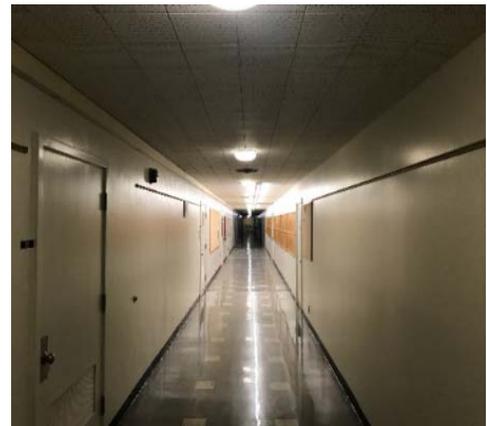
Figure 3 - Johnson Hall Corridor

- Johnson Hall was constructed prior to the formation of the National Fire Protection Association, and as such, the items listed below are not compliant with this code:
 - Existing visual and audible fire alarm notifications.
 - Existing fire alarm coverage.
 - No fire sprinklers in the building.
 - Fire separation – long corridors with no fire separation (Figure 3) and stairwells are open with windows and no standpipes.
- Asbestos Containing Materials – ducting, insulation, flooring and other finishes are insulated or made with asbestos-containing materials as was common at the time of construction.

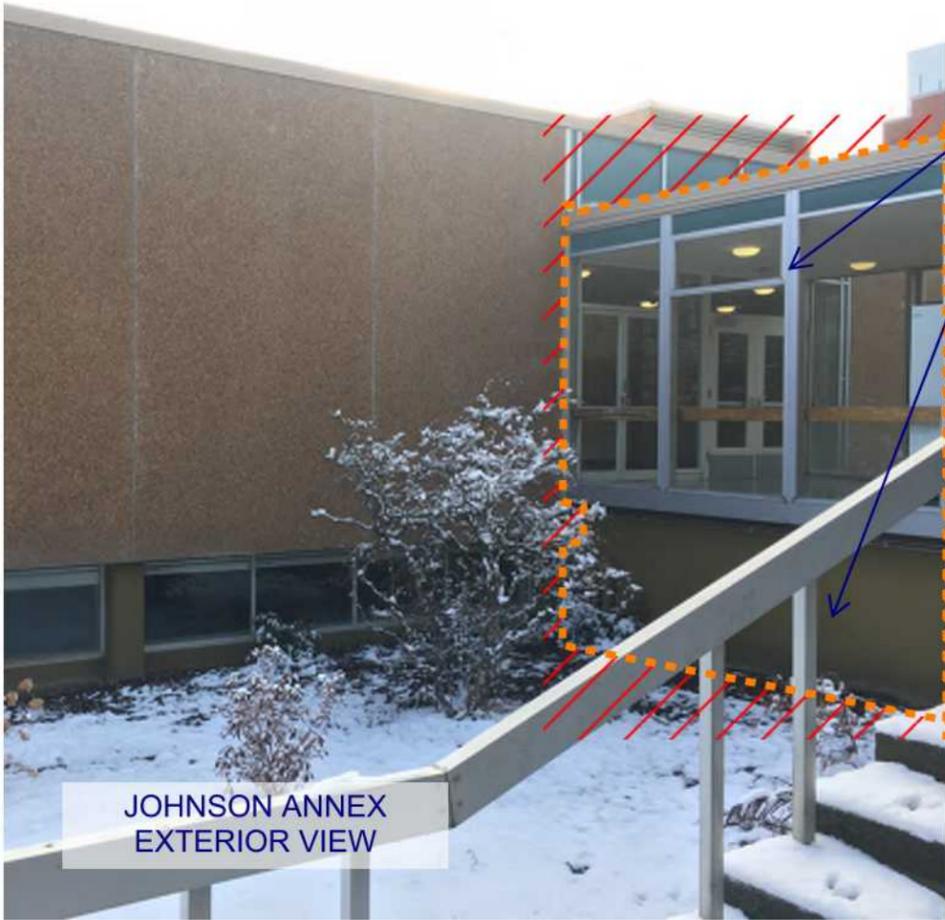
JOHNSON ANNEX EXTERIOR VIEW

DEMOLISH GROUND LEVEL, AND LEVEL 1 OF JOHNSON ANNEX CONNECTION.

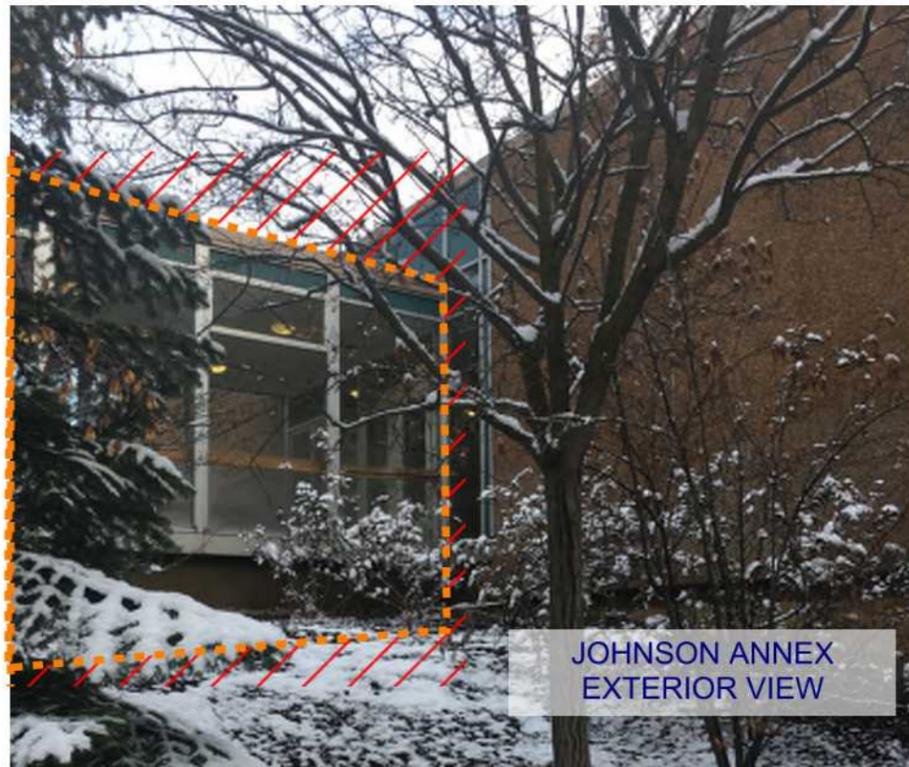
JOHNSON ANNEX EXTERIOR VIEW

JOHNSON HALL ANNEX CONNECTION TO JOHNSON HALL

DEMOLISH JOHNSON ANNEX CONNECTION.

DEMOLISH INTERIOR GLAZING. INFILL OPENING WITH MTL STUD EXTERIOR WALL, AND METAL PANEL CLADDING.

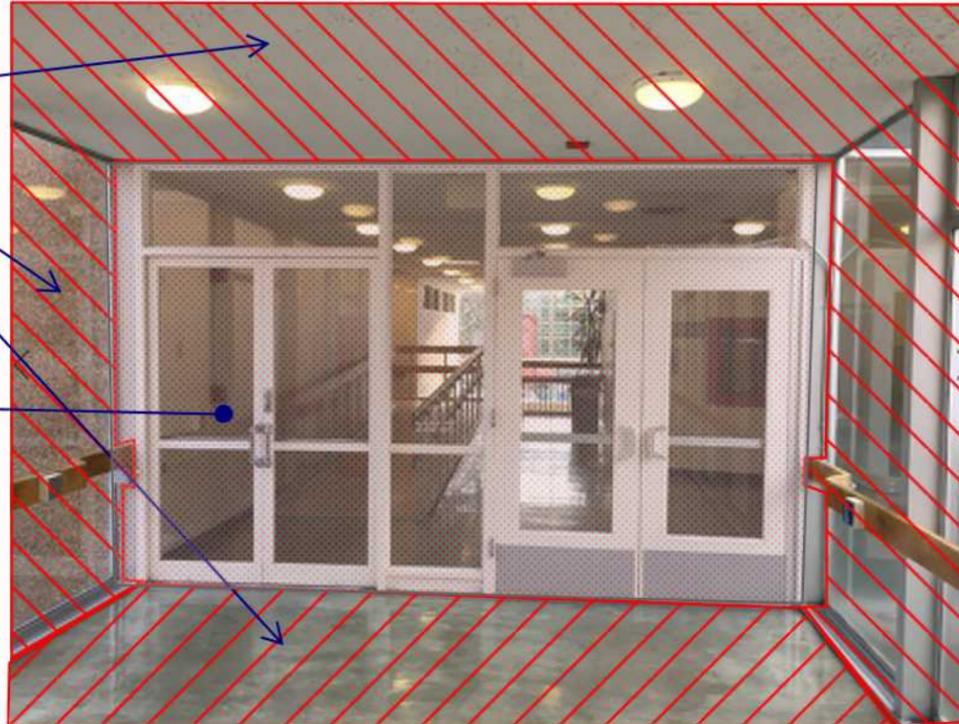
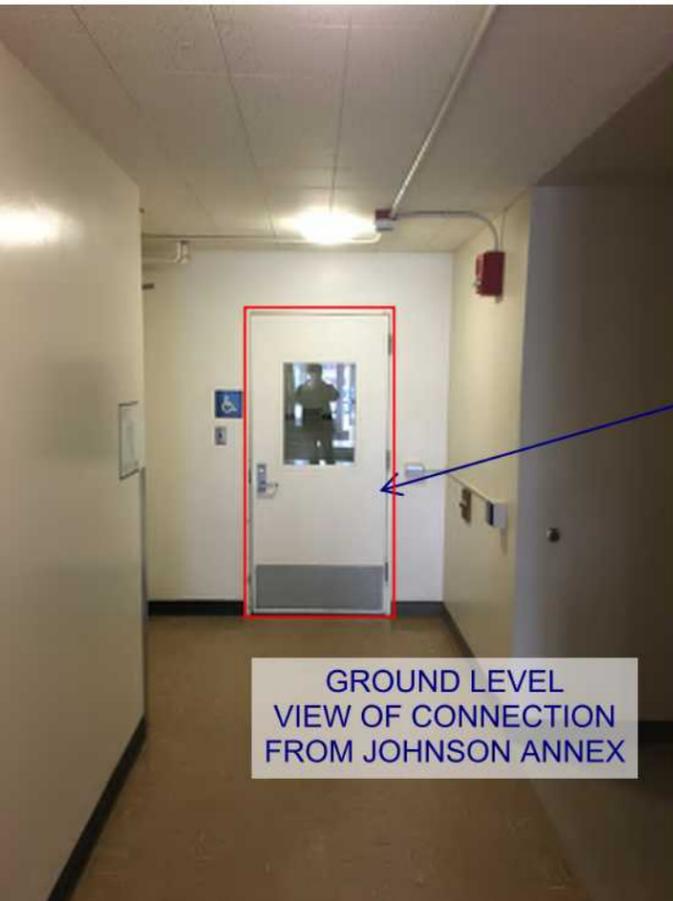
GROUND LEVEL VIEW OF CONNECTION FROM JOHNSON ANNEX

DEMOLISH JOHNSON ANNEX CONNECTION.

-REMOVE DOOR.
-INFILL OPENING WITH INSULATED METAL STUD WALL.

NEW CAST IN PLACE WALL. WATERPROOFING AT BELOW GRADE PORTIONS OF WALL. EXPOSED CONCRETE AT ABOVE GRADE PORTIONS.

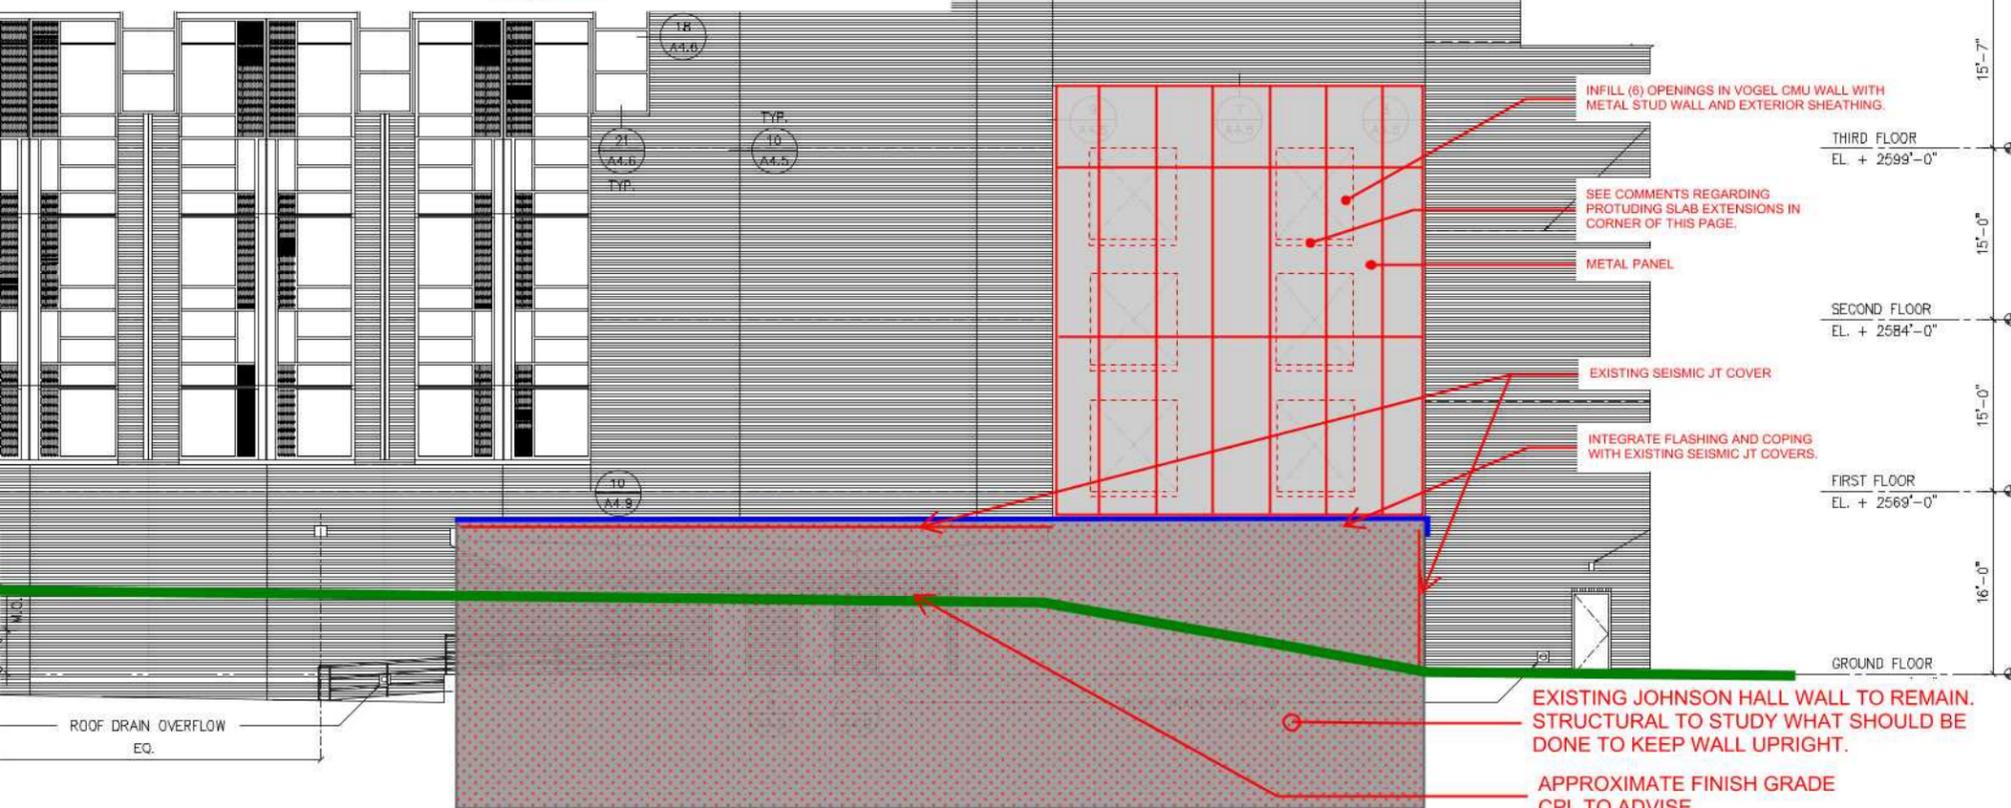
1 EAST ELEVATION
SCALE: 1/8" = 1'-0"

OPTION 1-KEEP GROUND FLR WALLS

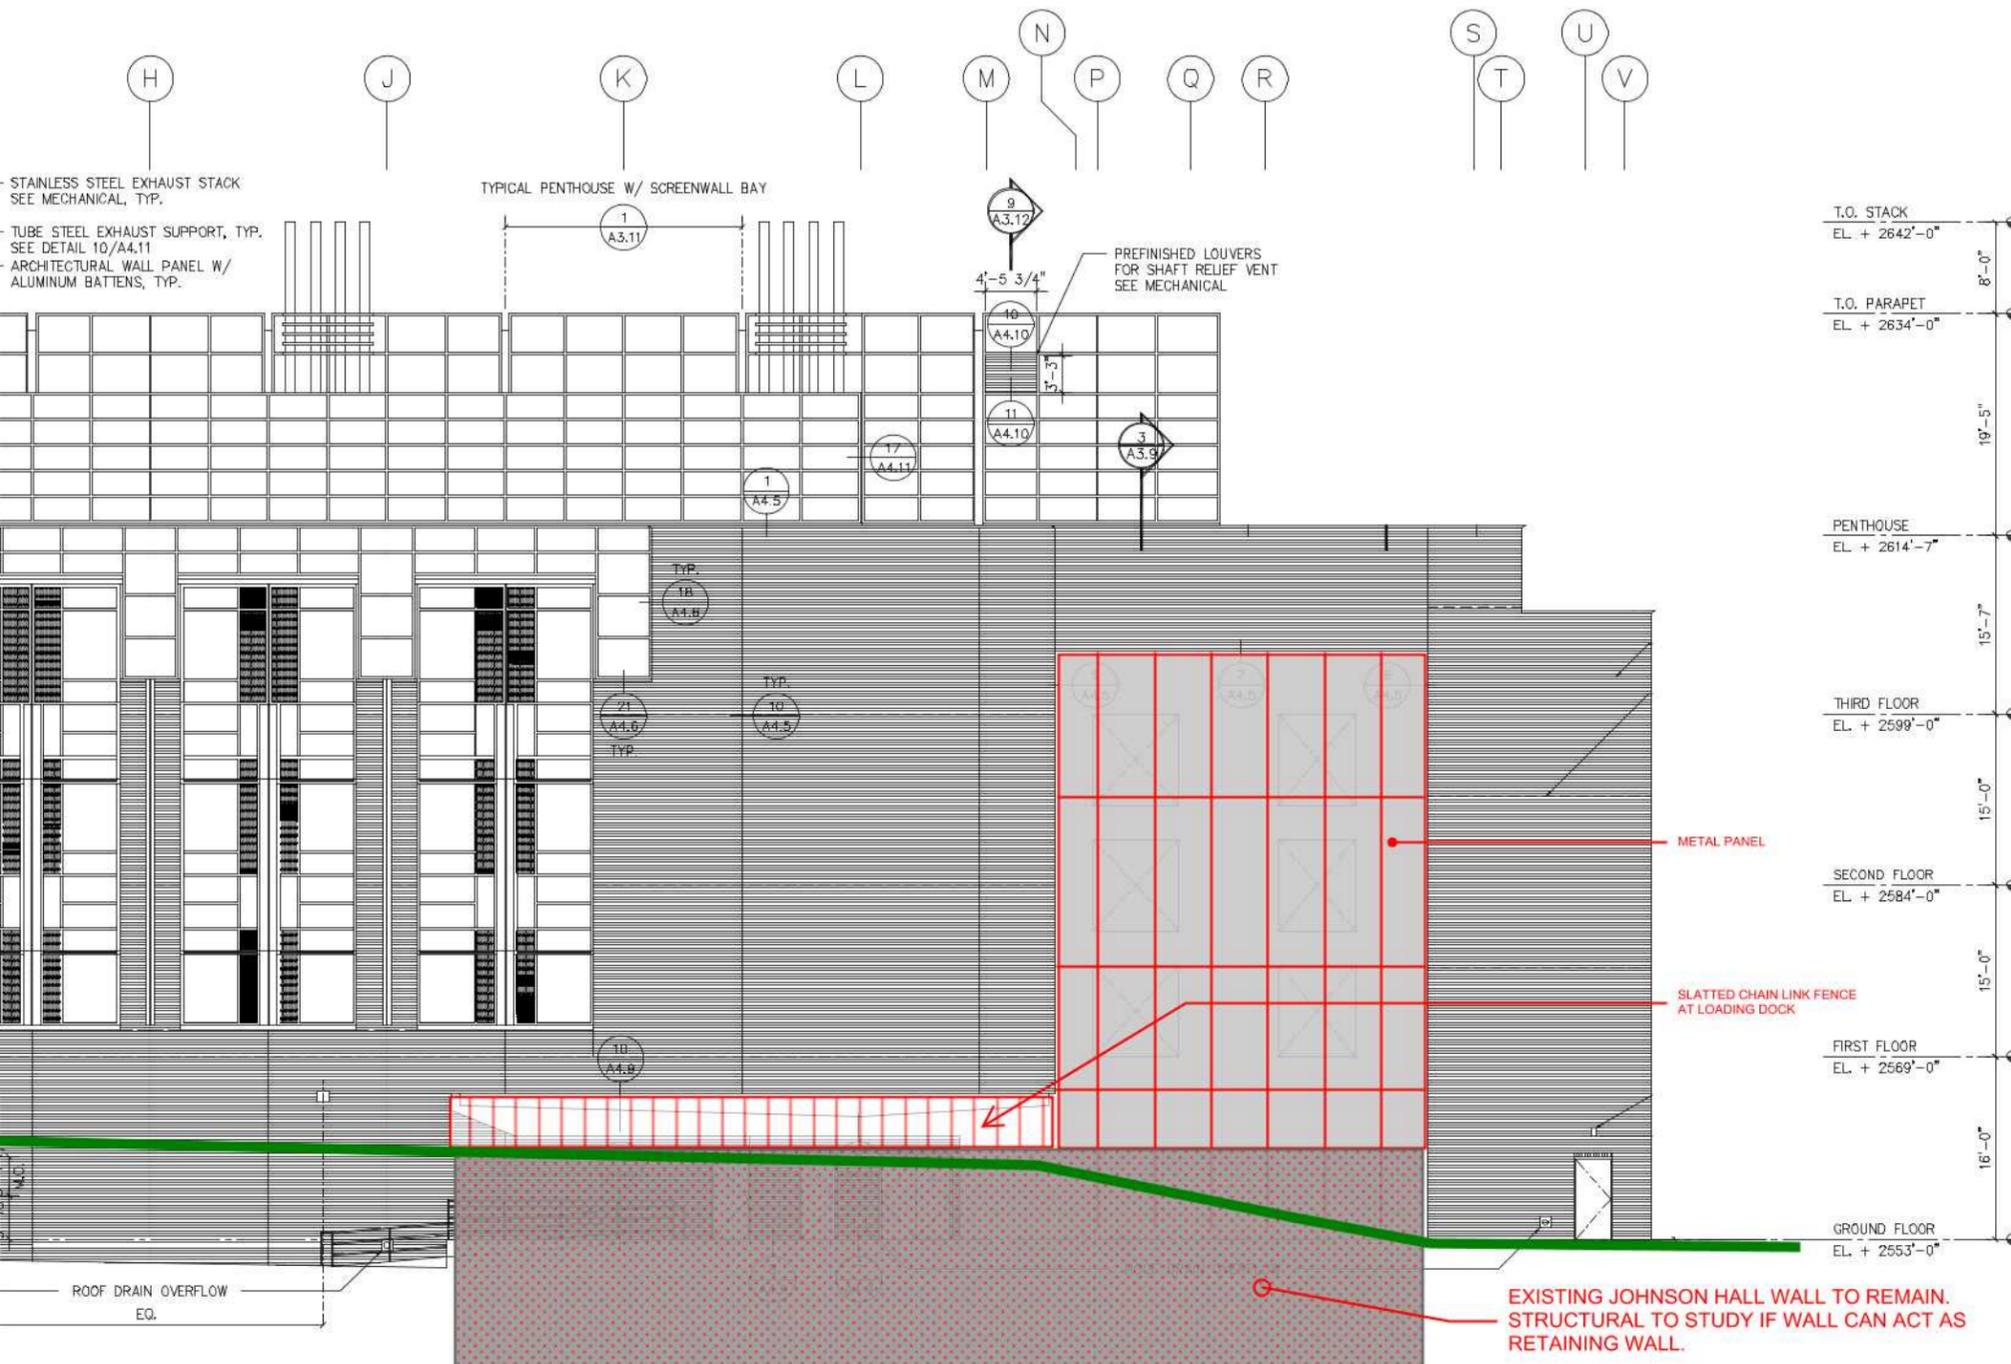
1 EAST ELEVATION
LMN ARCHITECTS
1/16/2020

OPTION 2- SHORTEN GROUND FLR WALLS

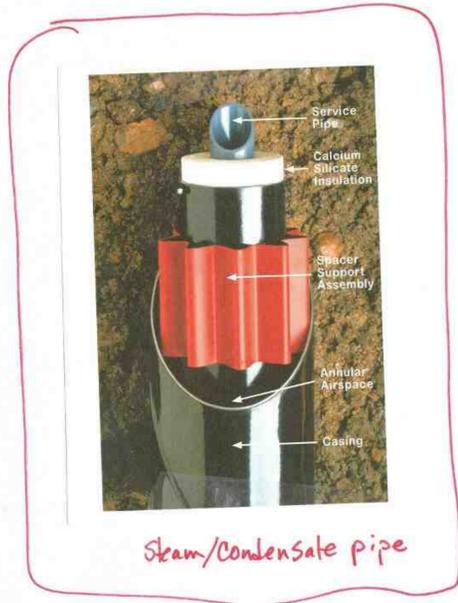
1. Create vault at tunnel intersection. Existing feeds to Johnson Hall are 6" HPS, 4" high pressure steam and 2 1/2" pumped condensate.
 - a. Provide a T and isolation valve in the pumped condensate line for a 1 1/2" feed PC to the Annex. Sleeve new direct buried pumped condensate conduit through the vault wall with link seal around pipe for water seal.

3. Anchor in HPS and PC pipe. Install anchors in concrete blocks. Anchor blocks to be physically separated from chilled water lines by several feet.
4. Expansion joint located in manhole. Provide full size drip leg in high pressure steam line high pressure condensate trap and pipe condensate into the steam line with a sparge tube.

5. Vault formed at intersection of east tunnel and east end of Johnson Hall.
6. 2" water service

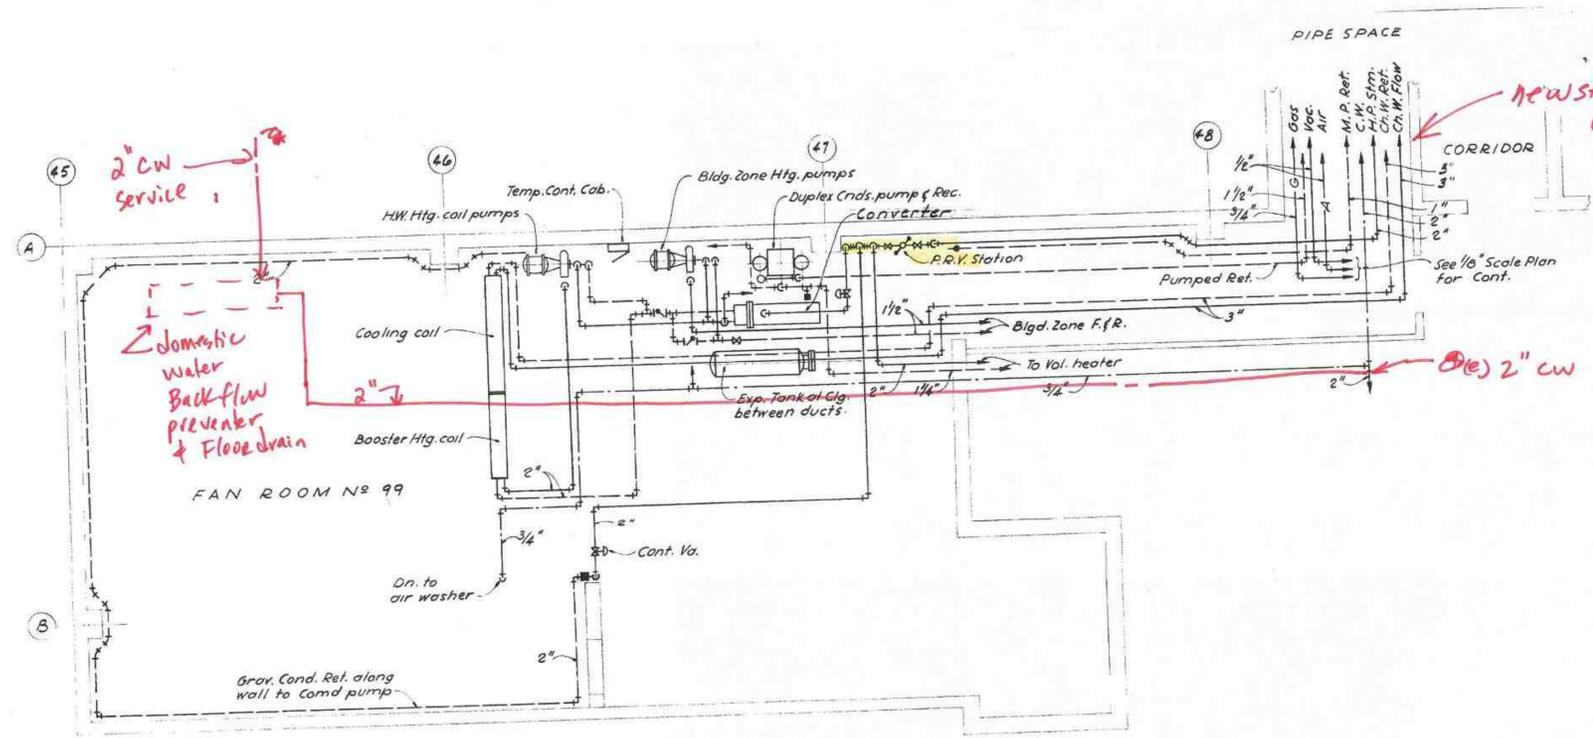
PLAN OF FAN ROOM PIPING ONLY
SCALE: 1/4" = 1'-0"

new steam, pumped condensate, gravity condensate, chilled water supply & return connections.
Link seal at wall penetrations.

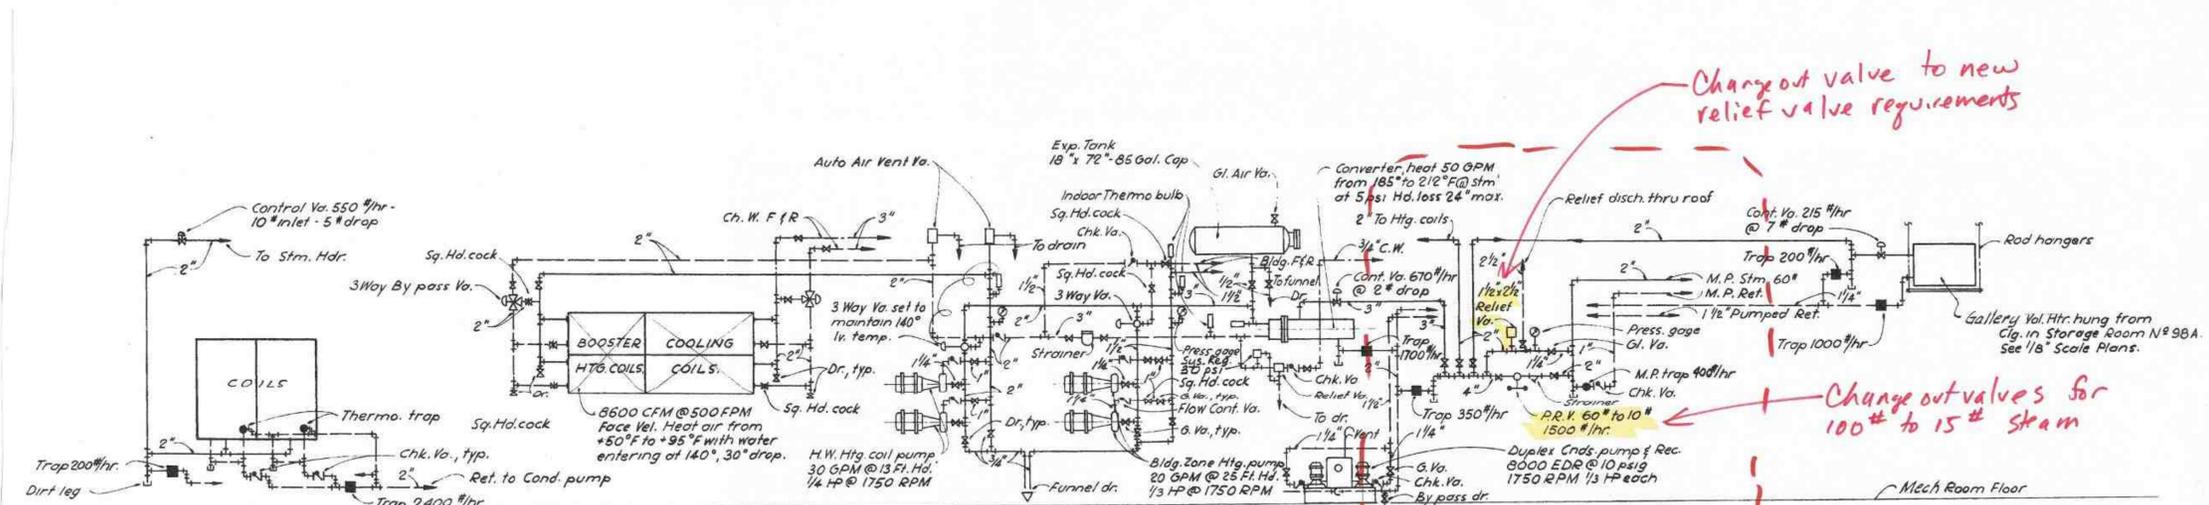
Change out valve to new relief valve requirements

Change out valves for 100# to 15# steam

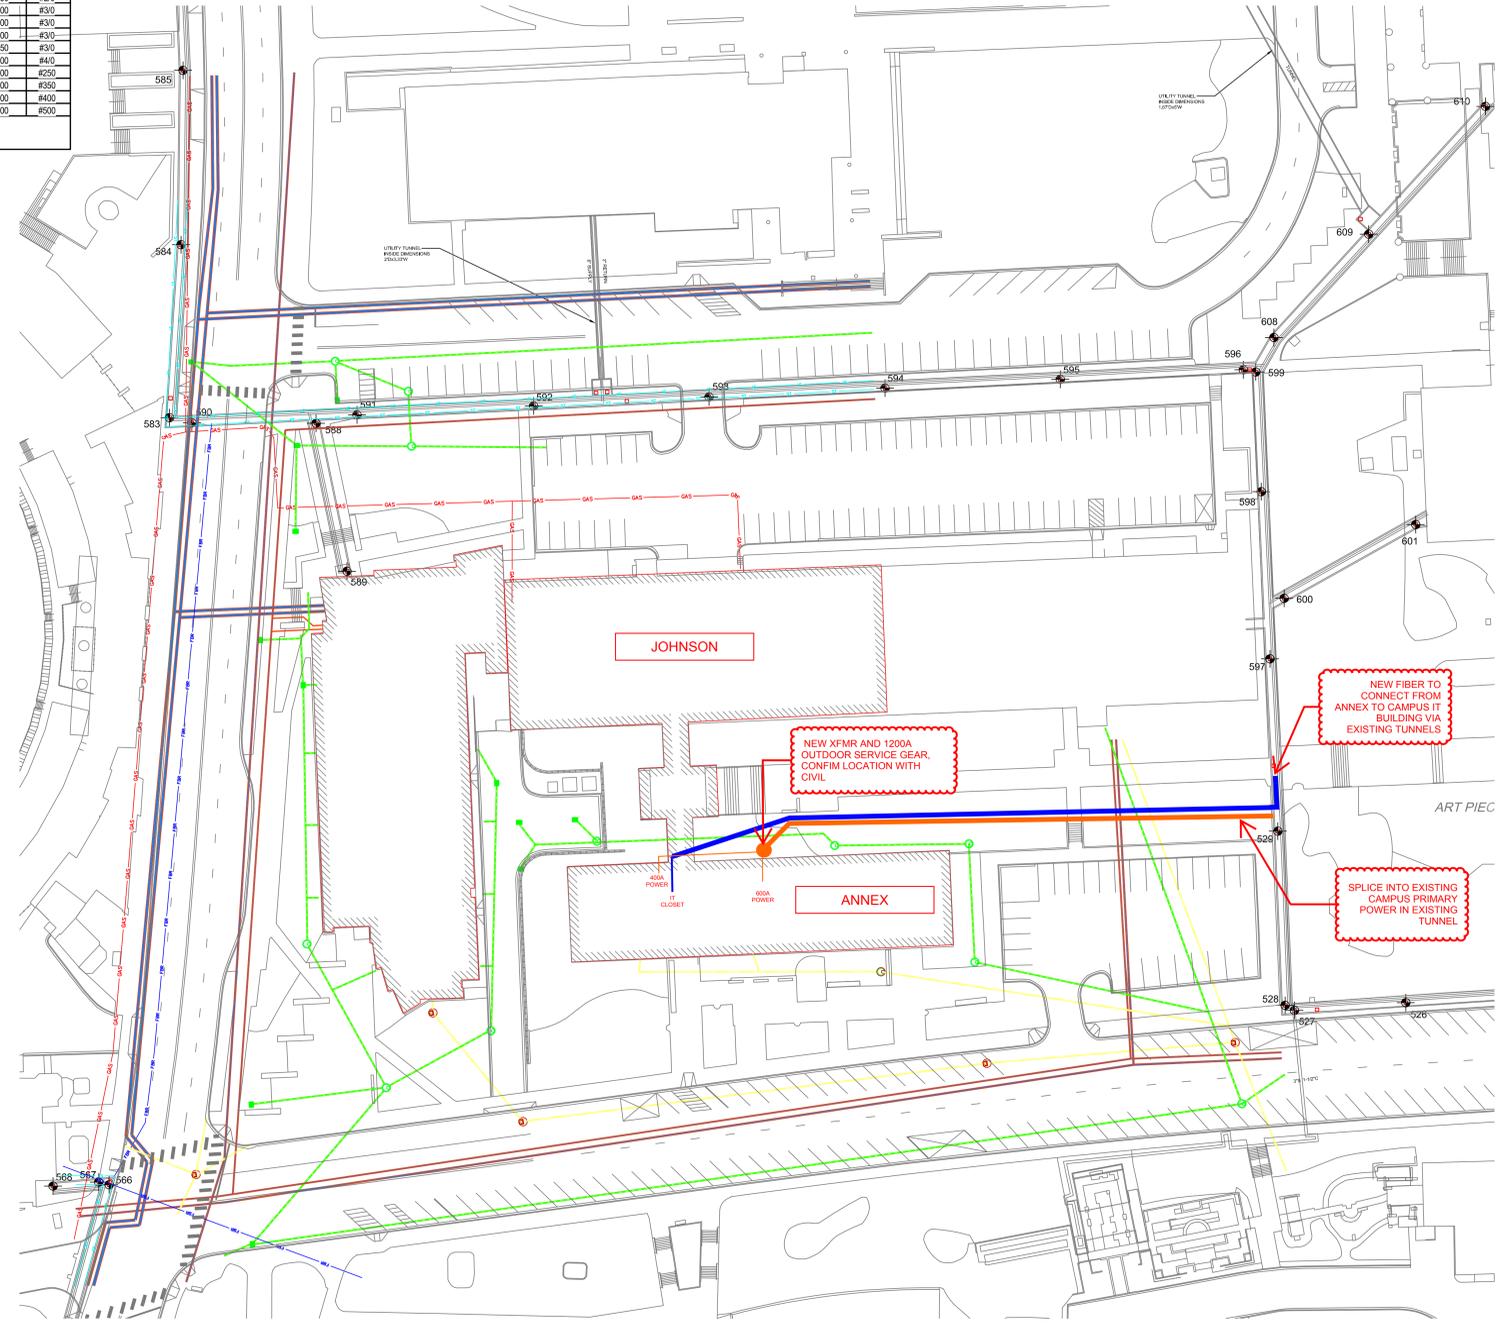
Johnson Hall Demo Cost Scoping Study - Electrical

- NEW BURIED POWER, (1)4"C W/ MV CABLE
- NEW BURIED COMM, (1)4"C W/ FIBER
- NEW BURIED/SURFACE POWER CONDUIT W/ CABLING, AMPERAGE SIZE AS NOTED
- NEW BURIED/SURFACE COMM CONDUIT, (1)4"C W/ FIBER

General Notes:
1. The electrical systems for Johnson Hall & the Annex have both exceeded their useful service life. Minor improvements have been made where noted below.

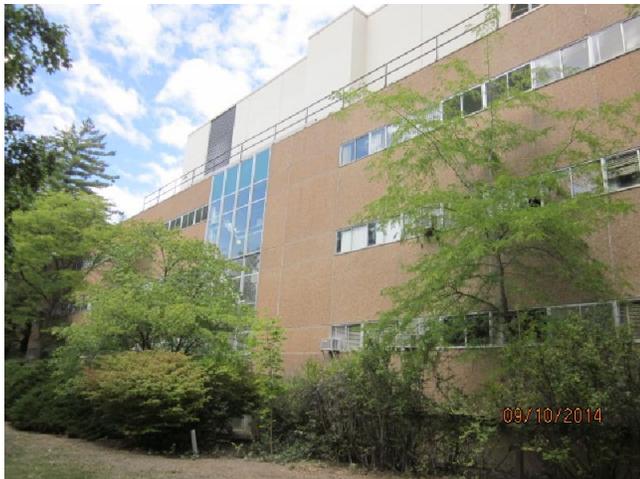
JOHNSON HALL

Type	Building	Construction Type	IBC - Type II A
Area	194,017 SF	Historical Category	None
Use	ACADEMIC INSTRUCTION	City	PULLMAN
Floors	5	State/Province/Region	UNITED STATES OF AMERICA
Address 1	1820 WILSON RD	Zip/Postal Code	99164
Address 2	-	Architect	-
Year Constructed	1961	Commission Date	-
Year Renovated	-	Decommission Date	-
Ownership	Client Owned
