Best Practices to Evaluate, Rehabilitate, and Replace Local Road Bridges

Lucas Bohn, Zach Carnahan, Michael Mingo, Sandip Rimal, Mostafa Tazarv, & Nadim Wehbe
 Department of Civil and Environmental Engineering
 South Dakota State University

Presentation Prepared for:
TriDurLE Webinar

March 19, 2020,
 Brookings, SD

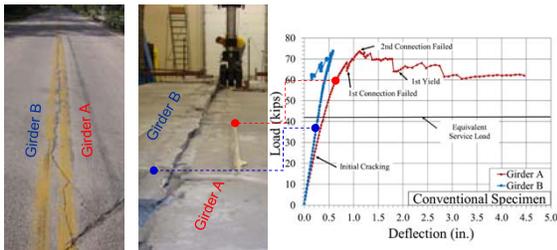
Current DT Long. Joint Detailing

In-Service **Laboratory**

(Wehbe et al., 2016)

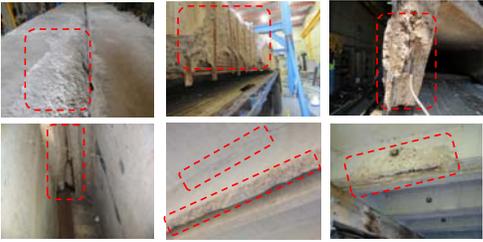
Damage of DT Girders

What is the **safe live load capacity** of distressed double-tee bridges?

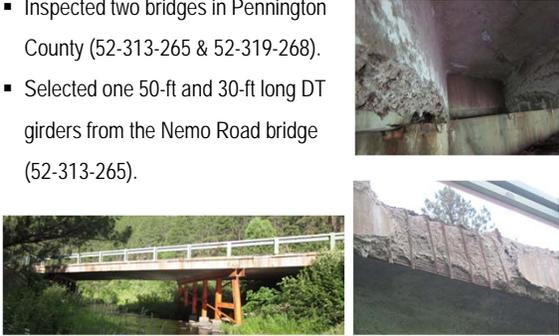
Salvaged Double-Tee Girders

- Inspected two bridges in Pennington County (52-313-265 & 52-319-268).
- Selected one 50-ft and 30-ft long DT girders from the Nemo Road bridge (52-313-265).

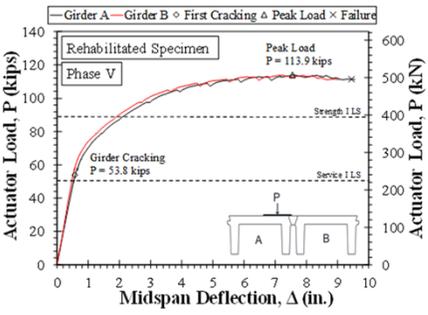
Rehabilitated Bridge Strength Test Results and Costs

- Pocket joint rehabilitation cost is **28%** of that of replacement.
- Continuous joint rehabilitation cost is **57%** of that of replacement.
