**National Center for Transportation
Infrastructure Durability & Life-Extension**

Project ID: 2020-UU-01

**PERFORMANCE OF ABC COLUMNS AND COST-EFFECTIVE
RETROFIT STRATEGIES SUBJECTED TO SYNERGISTIC DISTRESS
RESULTING FROM CORROSION AND SEISMIC LOADING: PART II**

June 2024

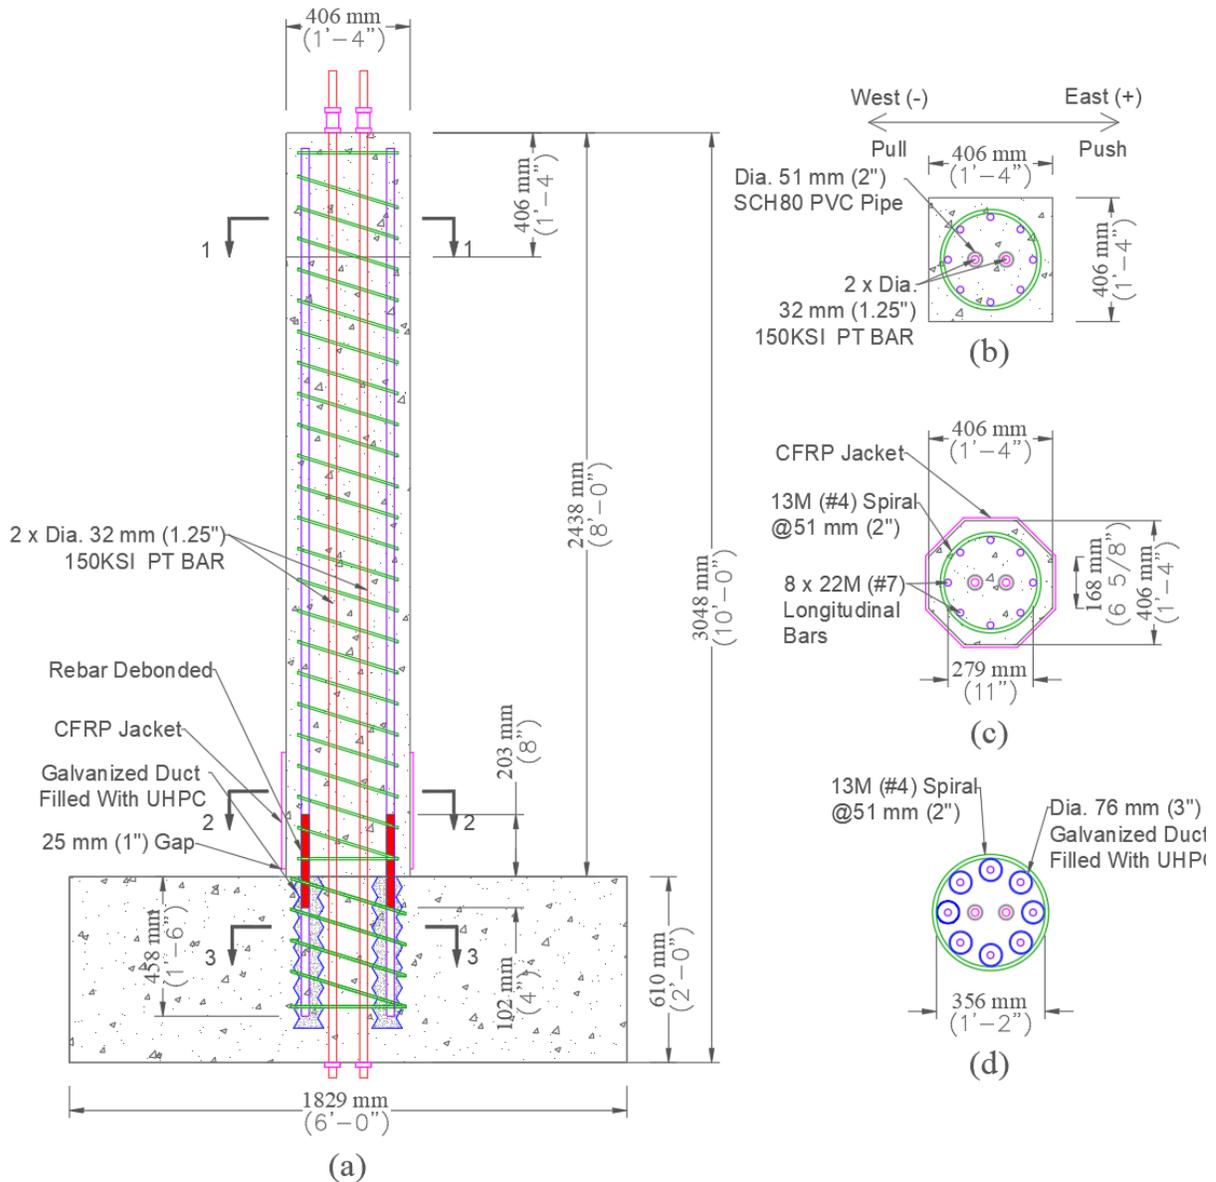
Figure 1. Specimen details: (a) column elevation; (b) section 1-1; (c) section 2-2; and (d) section 3-3.

strength of 6 ksi (41.4 MPa) used for all the specimens is provided in **Table 1**. An octagonal CFRP jacket, one layer thick, was applied for the bottom 610 mm (24 in.) of the column as shown in **Fig. 1**. The purpose of the CFRP jacket was to confine the bottom 610 mm (24 in.) of the column and postpone crushing and spalling to the column concrete.

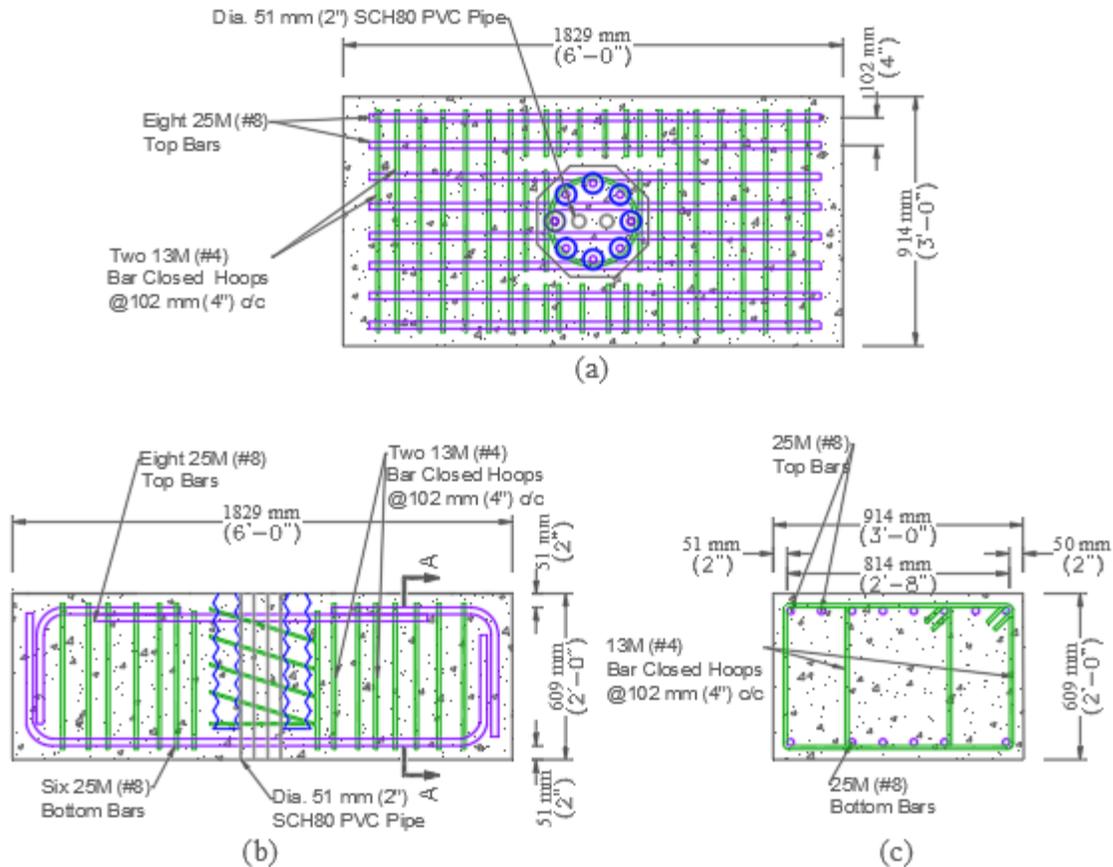
Figure 2. ABC footing details and section: (a) top view, (b) elevation, and (c) section A-A.

The column design inhibits shear failure from occurring in the column; the column failure mode is set to be either flexural or splice failure. The footing was designed to remain elastic; it was designed as a 01.83 m x 0.91 m x 0.61 m (6ft x 3ft x 2ft) precast concrete element reinforced with 25M (No. 8) longitudinal bars enclosed by 13M (No. 4) double hoops, as shown in **Fig. 2**. The footing core had eight galvanized ducts to enable joining the column to the footing. Additionally the footing and column had two PVC pipes to accommodate the PT bars after casting.

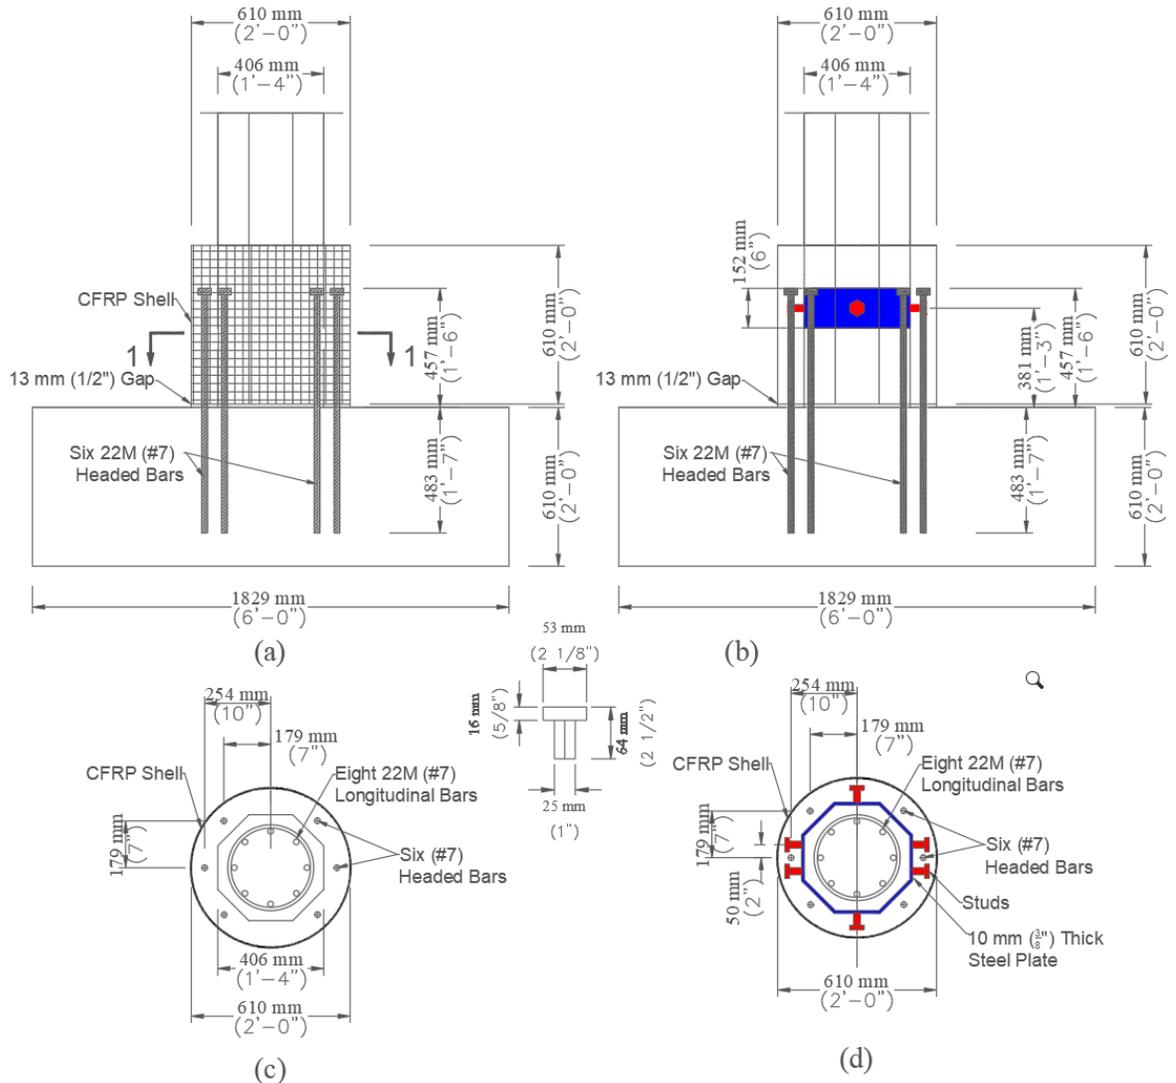
Figure 3. Column seismic repair details: (a) setup; (b) steel collar setup; (c) section 1-1; and (d) plan view.

The fifth specimen was constructed as an ABC column-to-footing specimen with a grouted connection, similar to the details shown in Figs. 1-3 but without post-tensioning bars (Shrestha and Pantelides 2024a; b). After it was corroded, this specimen was repaired using a CFRP shell filled with concrete; vertical-headed steel bars were epoxied into the footing to transfer tension forces to the column, as shown in **Fig. 3**. In this repair, six 22M (#7) headed steel bars were embedded 483 mm (19 in.) into the footing using high strength epoxy satisfying the development length criteria of ACI 318 (ACI 318-14). The headed steel bars' yield strength and ultimate strength were 427 MPa (62 ksi) and 593 MPa (86 ksi) respectively. Five CFRP hoop layers and two vertical CFRP layers were used to create a 610 mm (24 in.) diameter CFRP shell that was filled with concrete, as shown in **Fig. 3**; this design was based on previous research (Wu and Pantelides 2017). The CFRP composite's ultimate tensile strength and modulus of elasticity were 780 MPa (113 ksi) and 65 GPa (9430 ksi). The 28-day compressive strength of the concrete used inside the CFRP shell was 46.2 MPa (6.7 ksi). A 610 mm (24 in.) height was chosen for the CFRP shell since damage to the corroded specimen was concentrated in this area. A CFRP shell diameter of 610 mm (24 in.) was used to accommodate the 51 mm (2 in.) diameter head of the headed steel bars and create a clear cover to avoid contact with the column or CFRP shell. The CFRP shell was prepared separately and lowered on the column. The steel collar with steel studs was attached to the column to better bond the new concrete inside the CFRP shell to the original column concrete.

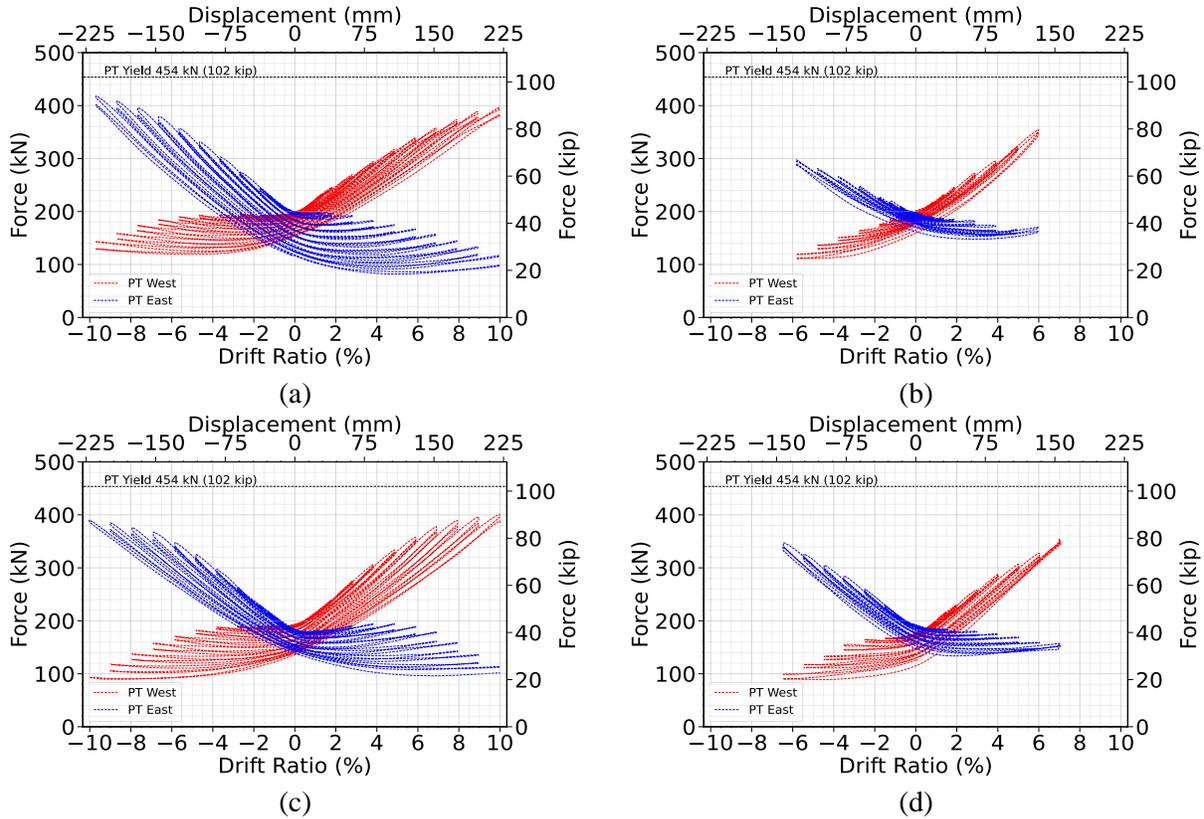
Figure 4. PT forces in the four specimens: (a) AS control; (b) AS corroded; (c) HYB control; and (d) HYB corroded.

The actual applied forces in the PT bars are shown in **Table 3**. The variation in the PT force during the test is illustrated in **Fig. 4**. It's evident that the maximum PT force falls below the yield force of the PT.

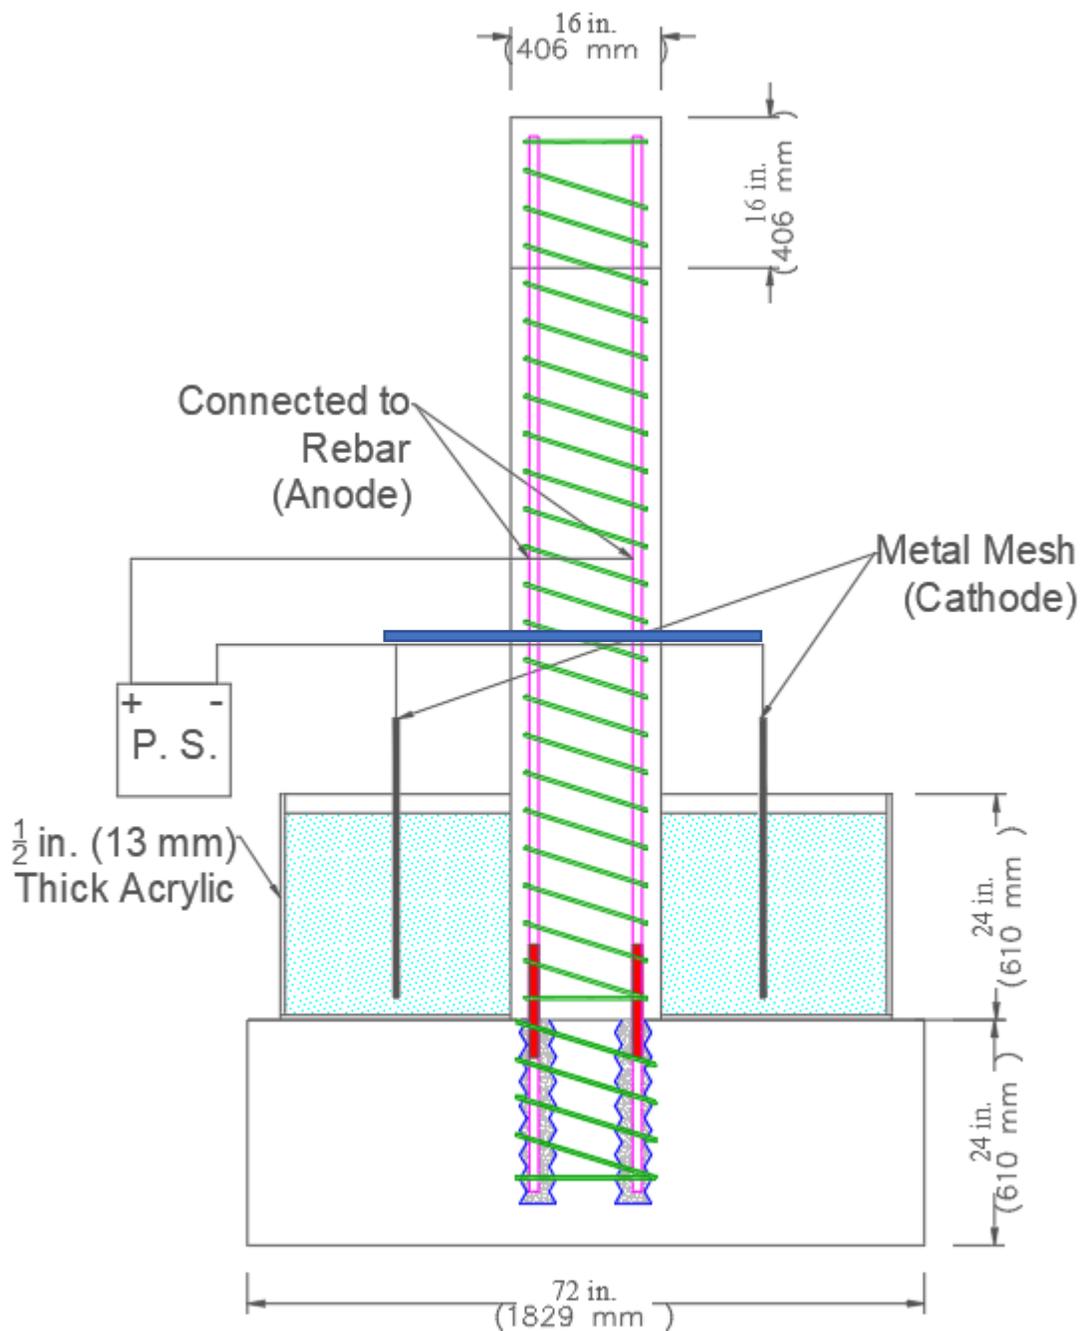
Figure 5. Accelerated corrosion setup.

The accelerated corrosion setup is shown in **Figure 5 5**. A 5% NaCl-water solution by weight was placed around the base of the column; to facilitate this, five plexiglass (four vertical and one horizontal) plates were used to create a water-tight seal around the column. To achieve the accelerated corrosion

process, the column longitudinal steel reinforcing bars were connected to the anode, and the salt solution was connected to the cathode of the power supply. A constant direct current was applied via a power supply for 114 days. This time duration was chosen since that was the time taken for RC columns to be severely corroded with a 25.0% target mass loss of longitudinal steel bars (Shrestha and Pantelides 2024a).

The height of the plexiglass container was 610 mm (24 in.) to ensure that the plastic hinge length of the column would be inside the zone where corrosion was taking place. This is especially important since under seismic load steel bars achieve the highest strain in the plastic hinge region.

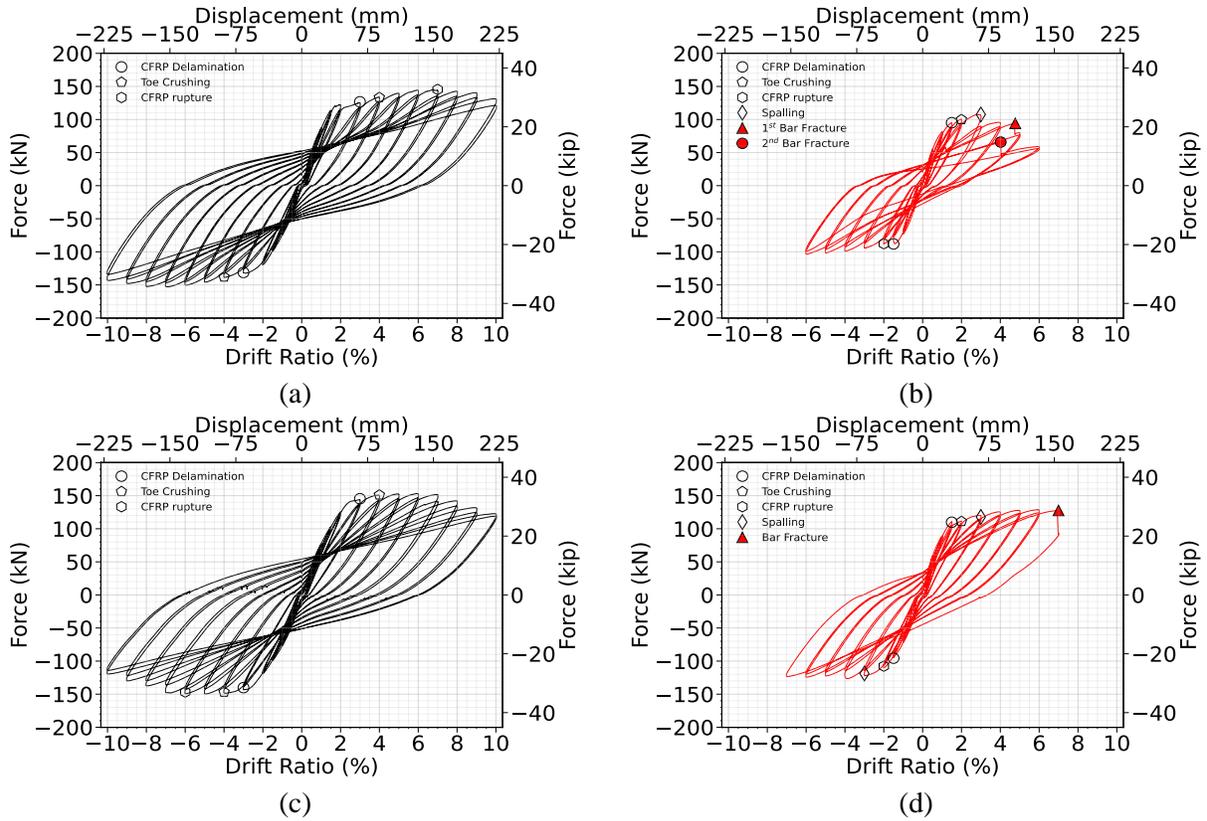
Figure 6. Hysteretic performance of specimens: (a) AS control; (b) AS corroded; (c) HYB control; and (d) HYB corroded.

The experiments involved subjecting the reinforced concrete columns to cyclic loading until the longitudinal steel bars fractured. The hysteresis curves in **Figure 6 6** demonstrate wide and stable behavior for the four post-tensioned specimens. Notable events such as CFRP delamination, toe crushing, CFRP rupture, concrete spalling, and steel bar fracture are marked. The construction materials used in the specimens were tested during the day of the experiment. The reinforcing bars had an average yield strength of 469 MPa (68ksi) and ultimate strength of 641 MPa (93ksi). Compression tests were performed using concrete and ultrahigh performance grout (UHPG) cylinders which were prepared during casting and grouting of the specimens, respectively.

The hysteric response of the AS control specimen is shown in Fig 6(a). The control specimen was able to reach a drift of 10.0% with a maximum lateral force of 145 kN (32.5 kip). The lateral force of the column reached a plateau after achieving the maximum value without a significant drop in capacity until the end of the experiment. Vertical and horizontal cracking of the CFRP jacket could be observed at a drift ratio of 3.0%. Additionally, cracking of the concrete exposed near the toe of the column was seen at a drift ratio of 2.0%. At a drift ratio of 7.0% the CFRP layer ruptured which lead to a decrease in concrete confinement of the column. The unconfined concrete which had cracked below the CFRP layer started to spall after the CFRP jacket started to rupture near the base of the column. The spalling continued to increase till the steel spirals were exposed. The forces in the PT bars kept increasing up-to a max value of 418 kN (94.0 kip)at the 10.0% drift ratio. The experiment was stopped after the 10.0% drift cycle to prevent yielding of the PT bars used for self-centering. The condition of the specimen at the end of the test is shown in **Fig. 8(a)**. The longitudinal rebar could be observed due to the spalling of the concrete near the base of the column.

The hysteric response of the AS corroded specimen is shown in Fig. 6(b) . The specimen had` been damaged due to the accelerated corrosion process. Cracks could be seen in the exposed part of the column near the column-to-footing connection. Similarly, brown patches could be seen on the surface of the CFRP jacket which indicate that corrosion of the steel bars had occurred , as shown in **Fig. 7 (a)**. The corroded AS specimen reached a drift ratio of 5.0% before the first longitudinal bar fractured. A second longitudinal bar fractured at a drift ratio of 6.0%. The maximum lateral force was 107 kN (24.2 kip) during the 3.0% drift ratio cycle after which the lateral force resisting capacity of the column dropped significantly. The CFRP jacket started to delaminate at a drift ratio of 1.5% and ruptured at a drift of 2.0%. After the CFRP jacket ruptured, loss in concrete confinement of the column coupled with cracks due to corrosion caused massive spalling of concrete. The spiral reinforcement had corroded significantly thus reducing confinement of the core concrete which decreased the lateral force and displacement capacity of the column. Spalling started during the 3.0% drift ratio and continued until the end of test at which all the cover concrete had spalled exposing the corroded spiral reinforcement. The experiment was terminated after the second cycle of the 6.0% drift ratio during which the two longitudinal reinforcing bars had fractured. The maximum force in the PT bars was 373 kN (84.0 kip). The condition of the specimen at the end of the test is shown in **Fig. 8(c)**.

The HYB control specimen had a hysteresis with wide stable loops as shown in **Fig. 6(c)** . The specimen reached a drift equal to 10.0% with a maximum lateral force of 153 kN (34.44 kip) before the experiment was terminated. The hysteresis curves show a plateau of lateral force after the peak which starts to drop after the 7.0% drift ratio cycle. The CFRP layer started to delaminate during the 3.0% drift ratio cycle and ruptured during the 6.0% drift ratio. Cracks at the toe of the column were observed at a drift ratio of 4.0% after which concrete spalling started. After the CFRP jacket ruptured at 6.0% drift ratio, the concrete above the exposed part, which was previously confined by the CFRP jacket started to spall. A drop in the lateral force occurred after the unconfined concrete had cracked and started to spall. The PT forces

The HYB corroded specimen reached a maximum drift of 7.0% before a longitudinal reinforcing bar fractured and a maximum lateral force reached 129 kN (28.9 kip), as shown in the hysteresis curves of **Fig. 6(d)**. The column had been damaged during the accelerated corrosion process. Cracks could be seen in the exposed concrete near the column-to-footing connection, as shown in **Fig. 7 (b)**. The CFRP jacket started to delaminate at 1.5% drift ratio and ruptured at the 2.0% drift ratio. However, the lateral force continued to increase; this can be attributed to the confinement provided by the GFRP spiral which was not affected by corrosion. Spalling of the cover concrete started at 3.0% drift ratio after the CFRP jacket had ruptured which continued until the GFRP spiral was exposed. The maximum force in the PT bars was 380 kN (85.5 kip). The experiment was terminated after the first cycle of the 7.0% drift ratio after the longitudinal steel bar had fractured and the lateral force had dropped. The GFRP spiral was exposed at the end of the test; the GFRP spiral was not affected by the corrosion and continued to provide confinement to the core concrete. However, the longitudinal steel bars had corroded, and the cover concrete had cracked, which resulted in a reduction of lateral force and displacement capacity of the column. The condition of the specimen at the end of the test is shown in **Fig. 8(d)**.

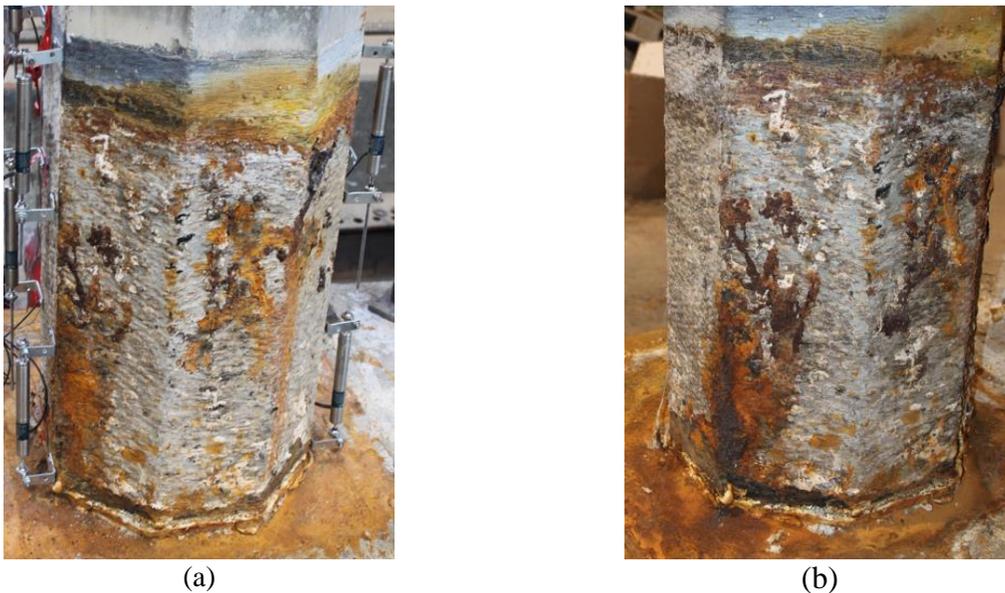
Figure 7. Start of test state of corroded specimens: (a) AS; and (b) HYB.

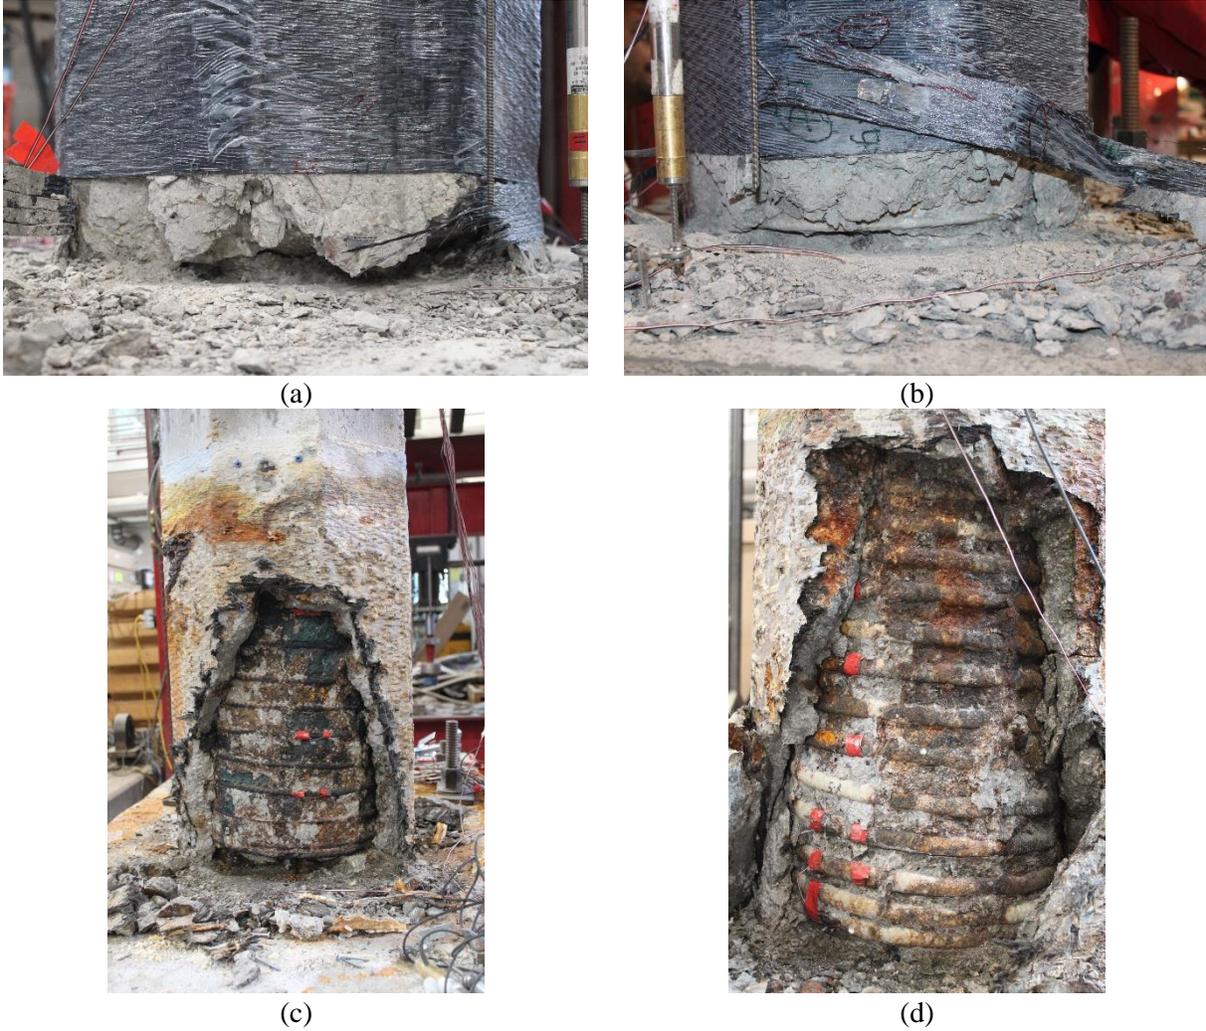
Figure 8. End of test state of specimens: (a) AS control; (b) HYB control; (c) AS corroded; and (d) HYB corroded.

reached a peak value of 401 kN (90.2 kip) at a drift ratio of 10.0%. The experiment was terminated at the 10% drift ratio cycle during which the lateral force had dropped 20% from the peak value. The condition of the specimen at the end of the test is shown in **Fig. 8(b)**.

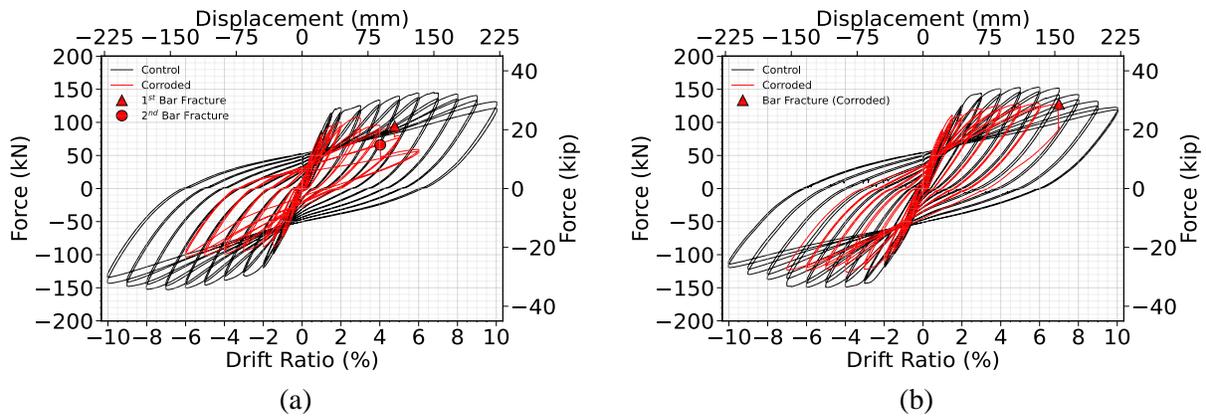
Figure 9. Comparison of hysteretic performance of control and corroded specimen for: (a) AS specimen; and (b) HYB specimen.

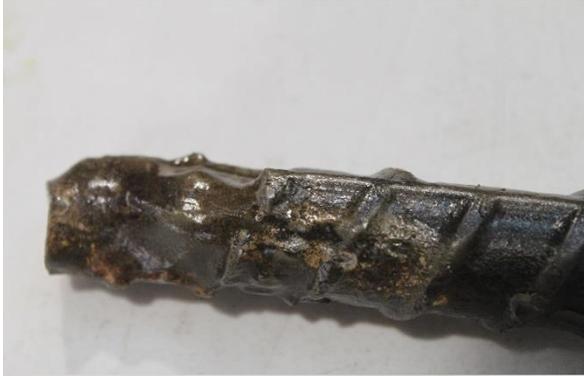
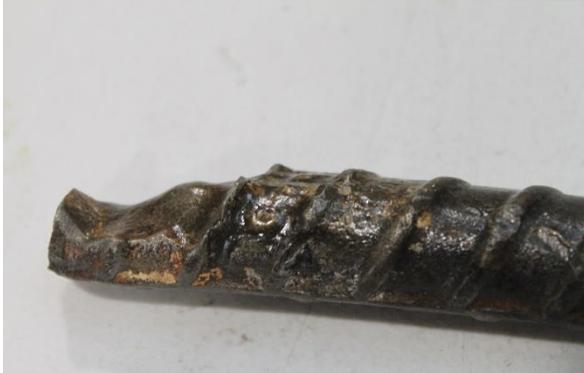
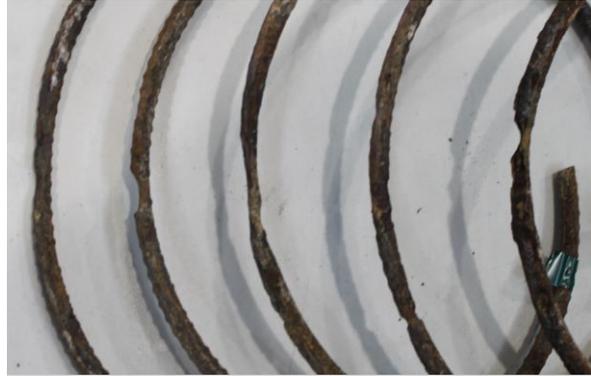
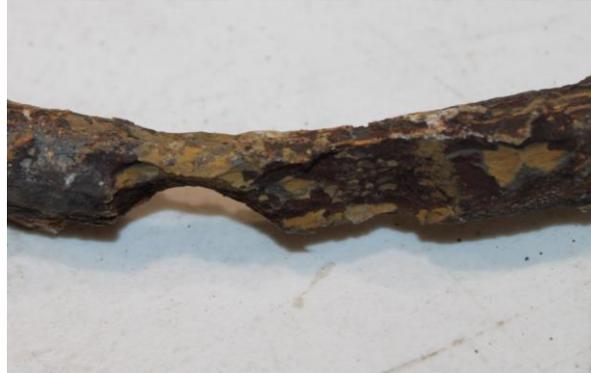
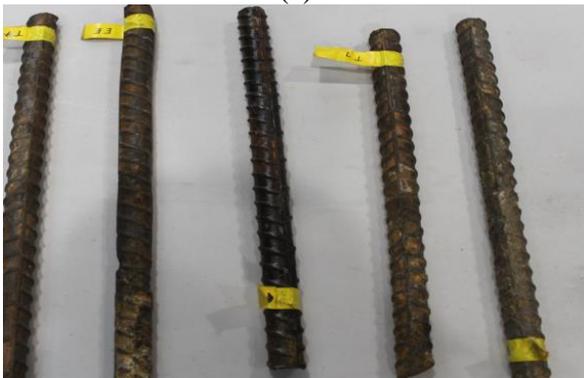
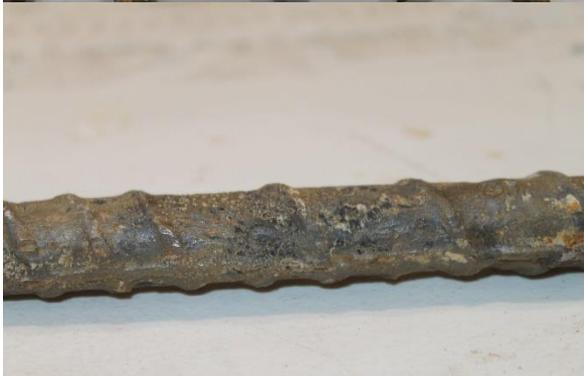
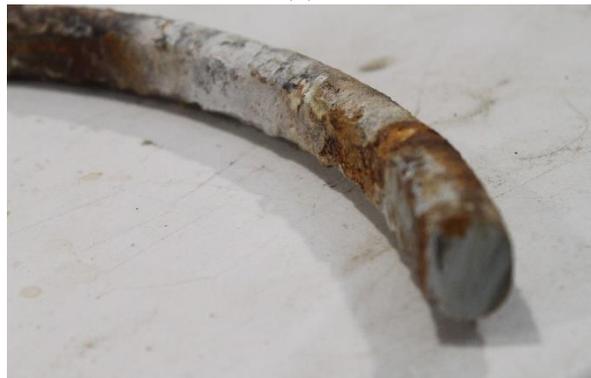
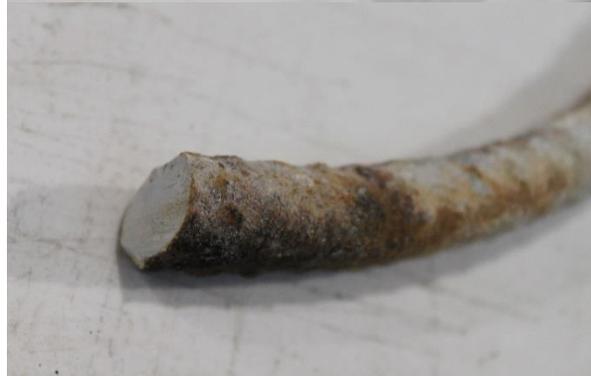
Figure 10. Rebar removed from corroded specimens: (a) longitudinal AS ; (b) steel spirals AS; (c) longitudinal HYB; and (d) GFRP spirals HYB.

After conducting the experiments, the corroded longitudinal steel reinforcing bars were removed and weighed to determine the mass loss caused by accelerated corrosion. The rebars after being removed from the columns are shown in **Fig. 10**. The average mass loss of the longitudinal steel bars is presented as a percentage in **Table 4**. The AS corroded specimen had an average mass loss of 21.1% in the longitudinal reinforcing bars and 20.3% in the spiral reinforcement. The HYB corroded specimen had an average mass loss of 16.6% in the longitudinal reinforcing bars and the GFRP spirals were not affected by the corrosion process. The specimens were put through the accelerated corrosion process to achieve a target mass loss of 25.0% in the longitudinal reinforcement. Notably, the single layer of CFRP jacket was able to reduce the corrosion of the steel reinforcement in the AS and HYB corroded specimens. Moreover, the use of a GFRP spiral instead of a steel spiral reduced the corrosion in the longitudinal steel reinforcement of the HYB specimen to an even greater extent.

The steel spiral in the AS corroded specimen was removed and weighed after the experiments. Pitting corrosion areas were observed where the spiral and longitudinal steel reinforcement came into contact. The AS corroded specimen had localized area loss of 90% to 100% or complete area loss of the spiral steel reinforcement in certain locations.

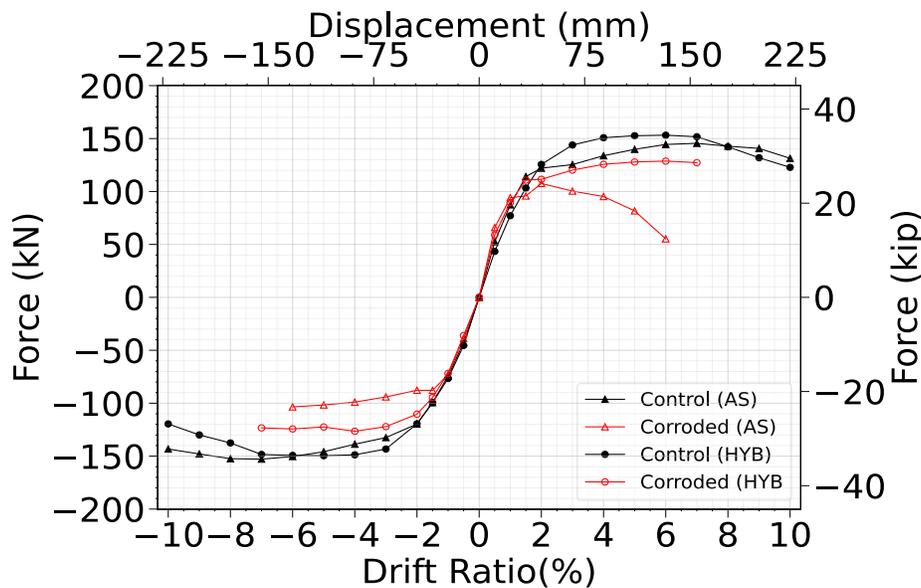
Figure 11. Force displacement response backbone for the four post-tensioned specimens.

The displacement ductility capacity was determined by constructing backbone curves using peak force values at each drift ratio, as shown in **Fig. 11**. The effective yield and ultimate displacement were calculated based on an equal energy of the idealized elastoplastic system. The ultimate displacement was determined at a drift ratio where either bar fracture or a 20% drop in lateral force capacity occurred, whichever came first. The displacement ductility, defined as the ratio of ultimate to yield displacement, decreased with corrosion. The AS specimen had a displacement ductility of 5.1 and 4.7 for the control and corroded specimens, respectively. The HYB specimen had a displacement ductility of 4.7 and 4.4 for the control and corroded specimens, respectively.

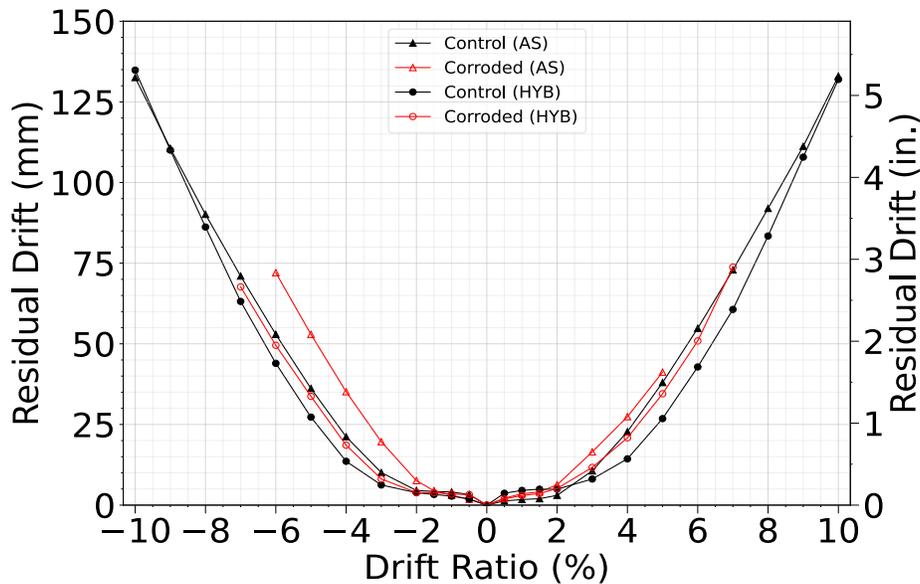
Figure 12. Residual drift.

The four post-tensioned specimens in this study were constructed with PT bars to increase the self-centering capacity of the columns. **Figure 12** shows the residual drift of the four columns. The residual drift of the corroded columns is compared to the control columns in the case of both the AS and HYB specimens. The HYB specimen at a certain drift ratio has a better self-centering behavior than the AS specimen. Even the corroded HYB specimen had better self-centering than the control AS column. This is due to the GFRP spirals not deteriorating during the accelerated corrosion of the specimens. The corroded HYB specimen still had similar core concrete confinement to the control HYB specimen. However, the AS specimen lost concrete core confinement due to corrosion of the steel spiral which caused further decrease in self-centering of the column.

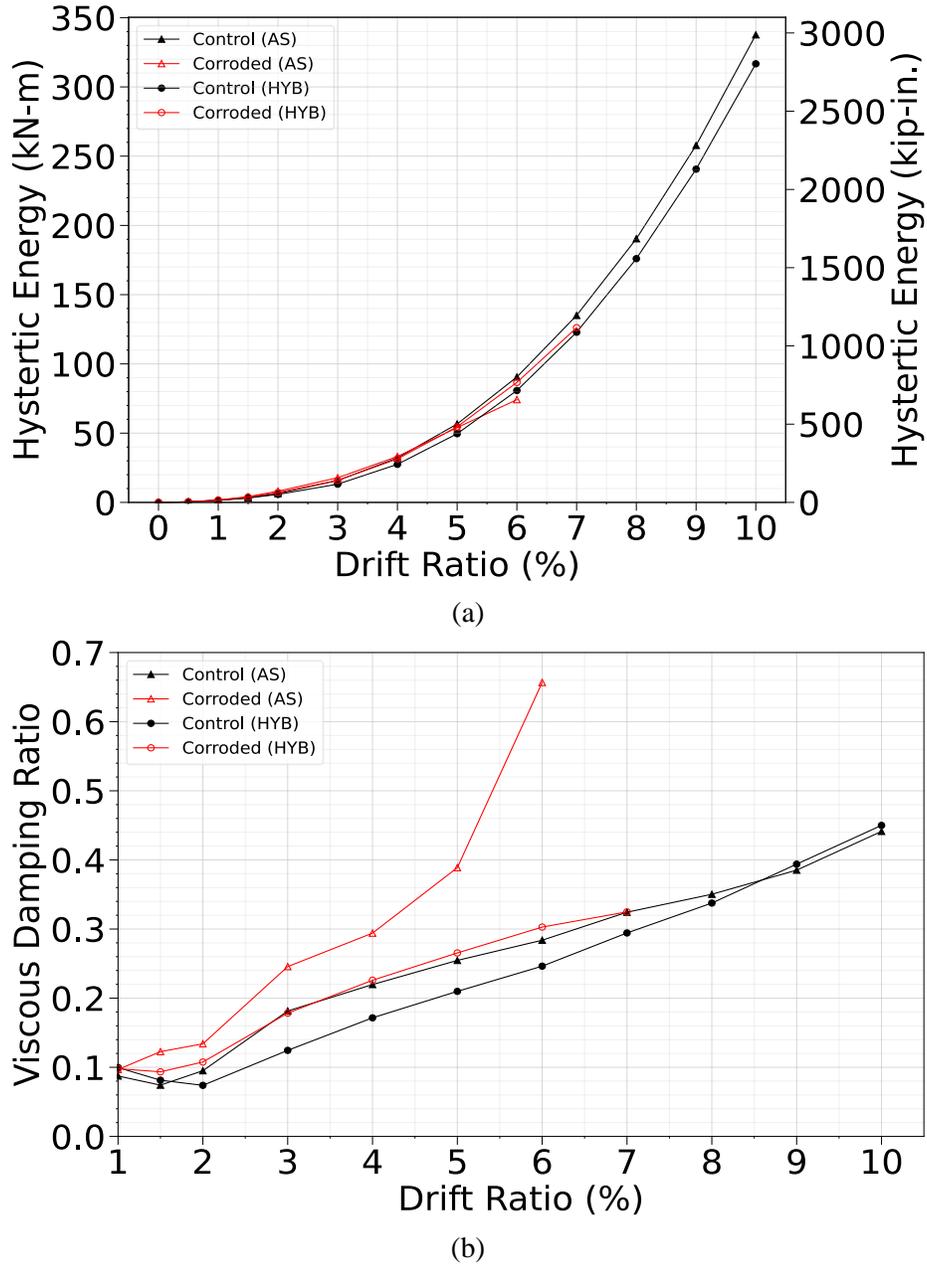
Figure 13. Energy dissipation capacity: (a) cumulative hysteretic energy; and (b) equivalent viscous damping ratio.

Figure 13(a) shows the cumulative hysteretic energy capacity. Up to a 5.0% drift ratio, the four post-tensioned specimens exhibit similar energy dissipation; however, the two corroded specimens show reduced hysteretic energy dissipation beyond that point. The cumulative hysteretic energy dissipated by the corroded specimens is 78.0% and 60.0% less than the control specimen for the AS and HYB specimens,

Figure 13(b) displays values of equivalent viscous damping ratio. Corroded columns show increased hysteretic damping due to a sharp decrease in strain energy compared to the decrease in the hysteretic energy.

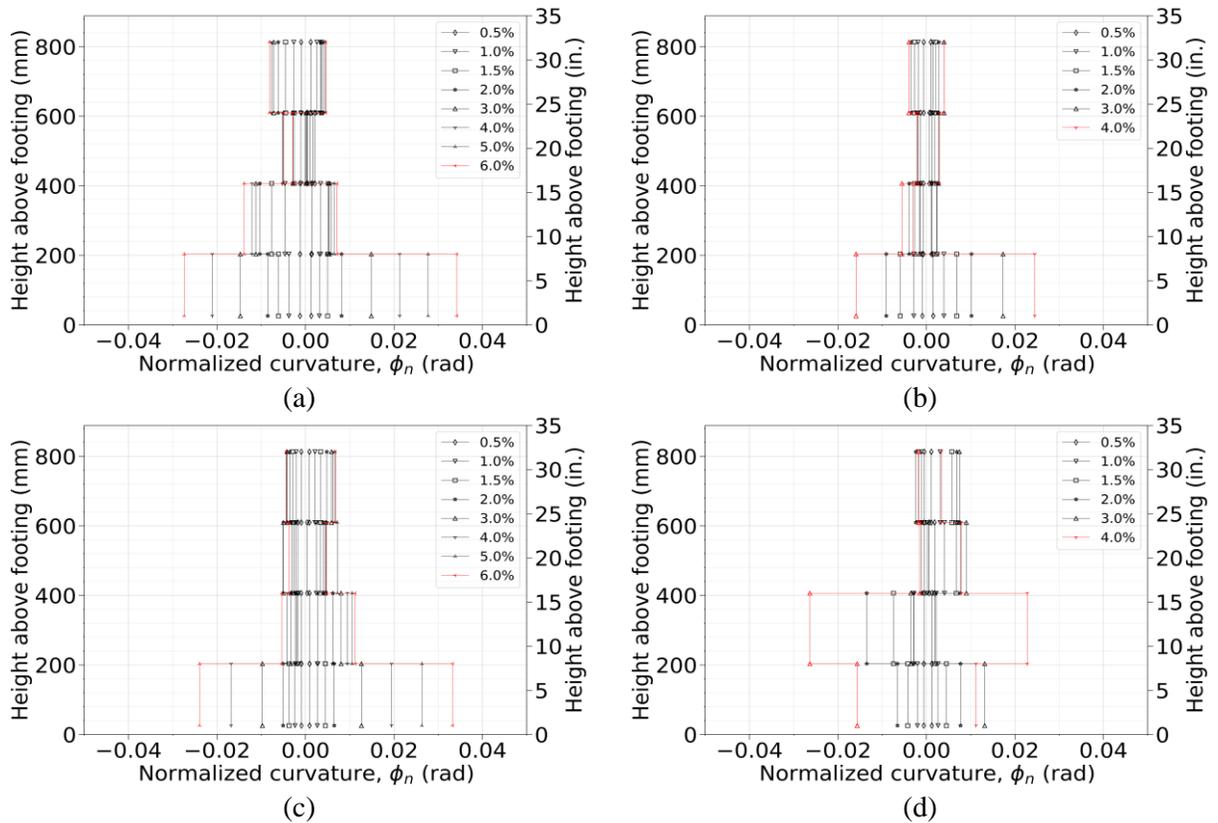
Figure 14. Normalized curvature of specimens: (a) AS control; (b) AS corroded; (c) HYB control; and (d) HYB corroded.

profiles are shown in **Fig. 14.** for the four post-tensioned columns. These profiles show increased curvature in the corroded region of the column, especially in the 203-406 mm (8-16 in.) range above the footing.

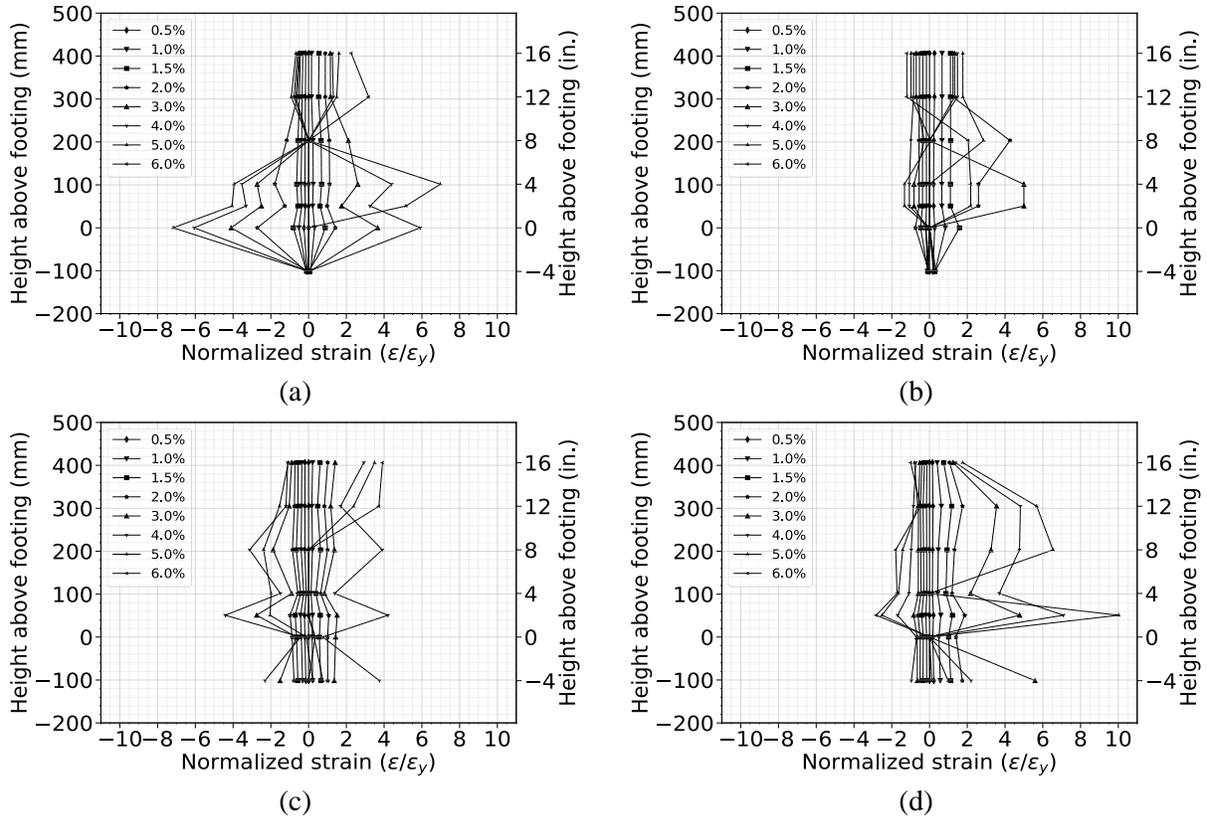
Figure 15. Strain in longitudinal bar for control specimen: (a) AS east; (b) AS west; (c) HYB east; and (d) HYB west.

The strain in the east and west longitudinal bar of the control specimen of the AS and HYB specimen is shown in **Fig. 15.** Strain gauges attached to the longitudinal steel bars show yielding along the instrumented height up to 406 mm (16 in.). Additionally, the strain in the steel spiral for the AS specimen and the GFRP spiral in the HYB specimen is shown in **Fig. 16.** Strain gauges in the corroded specimens were damaged during accelerated corrosion.

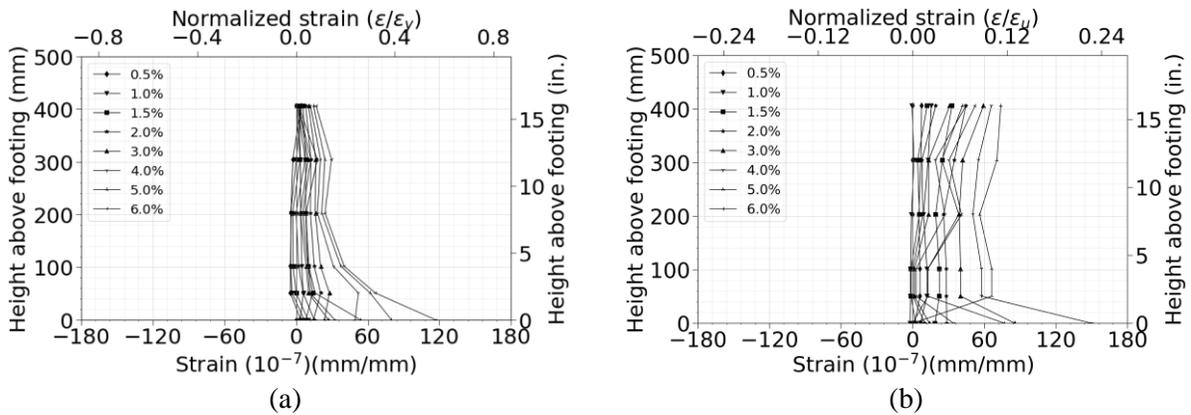
Figure 16. Strain in spiral reinforcement control specimen: (a) AS steel spiral; and (b) HYB GFRP spiral.

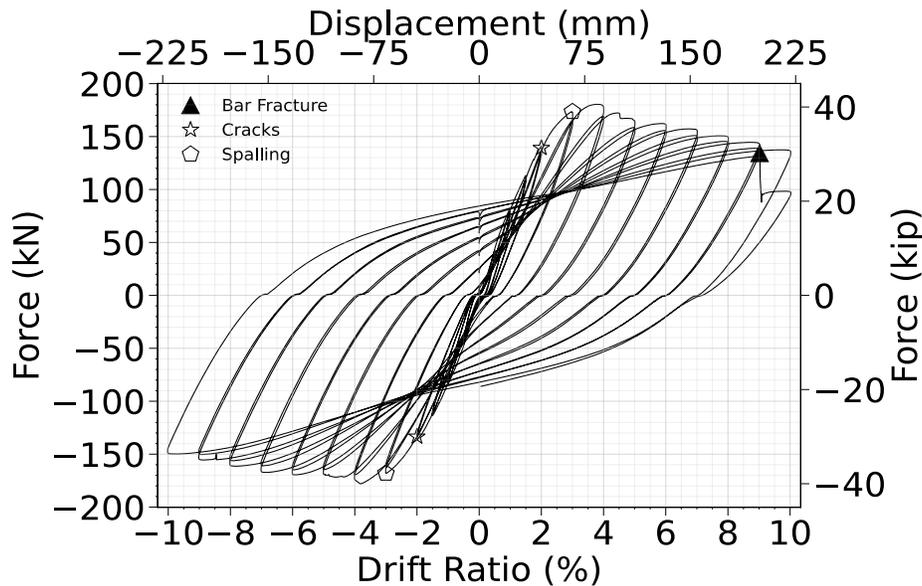
Figure 17. Hysteresis of repaired specimen.

The hysteresis response of the repaired specimen is shown in **Fig. 17**. A maximum lateral force of 180 kN (40.5 kip) was achieved at a drift ratio of 4.0%. After the peak value was reached, the lateral force dropped in subsequent cycles until bar fracture at 10.0% drift ratio. The repaired specimen developed hairline cracks above the CFRP shell during the 2.0% drift ratio cycle. At 3.0% drift ratio, spalling occurred with cracks extending from the CFRP shell up to a height of 813 mm (32 in.). At the 4.0% drift ratio, the cracks reached a width of 1 mm (0.04 in.) and concrete spalling was initiated. The steel spirals became visible once all cover concrete was lost due to spalling at the 6.0% drift ratio. A discernible decline in lateral force, amounting to 10% reduction of the maximum lateral force was observed at 7.0% drift ratio, which intensified during the 9.0% drift ratio. A longitudinal steel bar ruptured during the second cycle of the 10.0% drift ratio when the test was terminated. The cumulative hysteretic energy dissipation and equivalent viscous damping ratio for the control (Shrestha and Pantelides 2024) and repaired specimen after corrosion are shown in **Fig. 18(a)** and **Fig. 18(b)**, respectively. The repaired specimen dissipated a cumulative hysteretic energy of 491 kN-m (4344 kip-in.) before fracture of a longitudinal steel bar at 10.0% drift ratio.

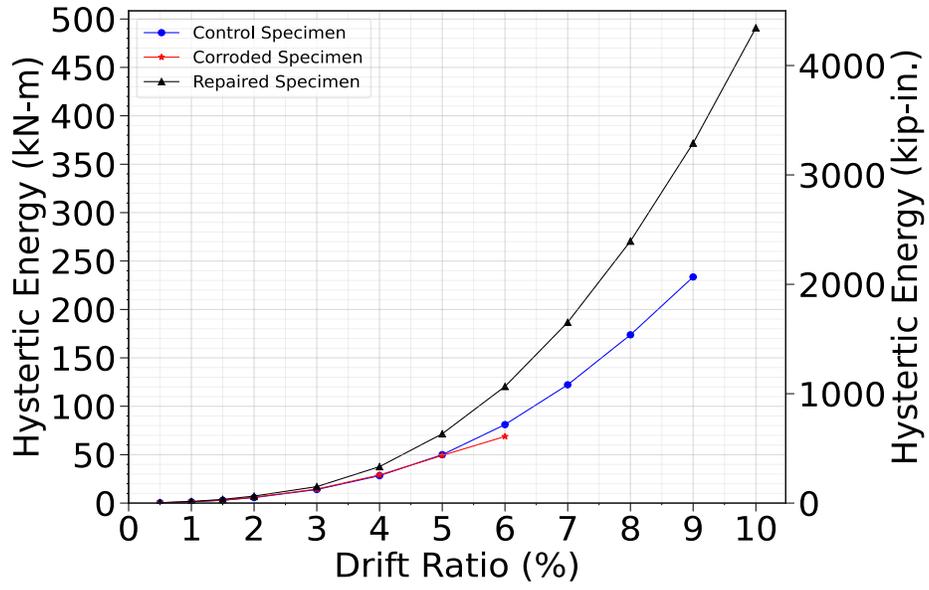
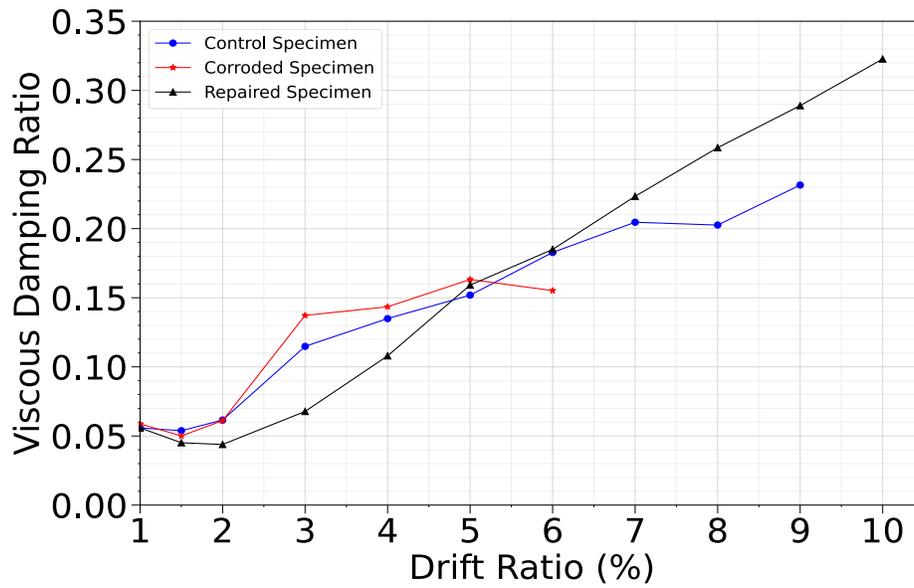
Figure 18. Comparison of repaired specimen with control and corroded specimens: (a) cumulative hysteretic energy; and (b) equivalent viscous damping ratio.
