**National Center for Transportation
Infrastructure Durability & Life-Extension**

Project ID: FAU2

**Corrosion propagation monitoring of legacy samples and forensic
analysis on selected samples**

Final Report

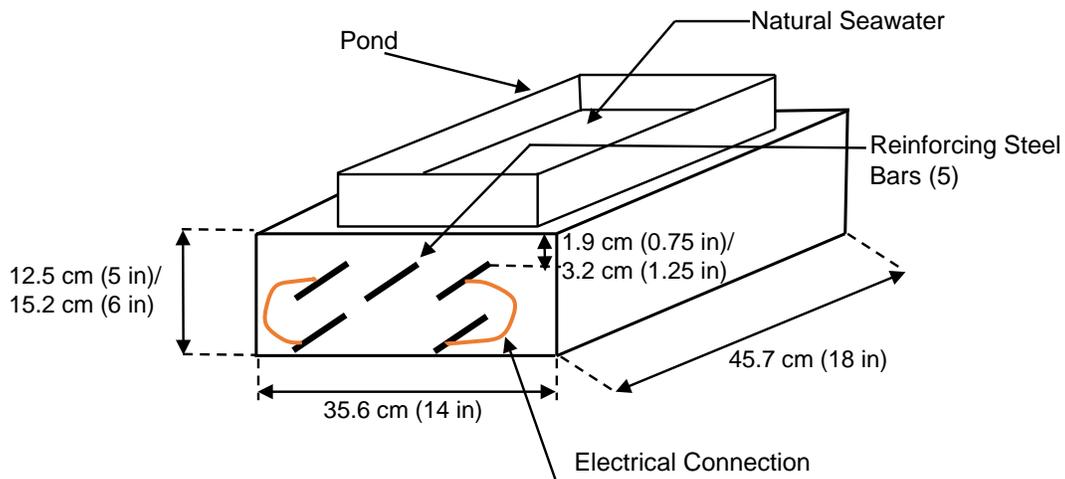
Figure 1. Five-rebar specimen diagram (outdoor specimens)

Figure 1 shows the dimensions of the 5 rebar specimens exposed outdoors at FAU-SeaTech in Dania Beach, FL. These samples were prepared in 1994, Appendix A contains tables describing the concrete mix compositions for the specimens. All samples were prepared with low w/cm, target w/cm of 0.37 was used. Prior to outdoor exposure testing (shortly after casting), the specimens were inverted (as-cast face down); and a plastic pond was mounted on what became the top surface (see Figure 1). The exposure took place outdoors most of the time, but early on the specimens were exposed indoors for a couple of years. A one week wet — one-week dry ponding cycle was instituted in January 1995 using fresh natural sea water. The typical conductivity of seawater measured at the FAU site is ~ 35 mS/cm. As shown in Figure 1, each of the bottom bars was electrically connected to one of the top bars so that a macrocell resulted between the two. These connections stop working around 2018 due to weathering and were not replaced. The wet and dry cycles were suspended from June 2018 to June 2020. Starting summer 2020, the samples were subjected to wet and dry cycles with seawater. Typically, the samples were with seawater for two weeks with and two weeks without. Rebar potential, corrosion rate measurements, solution resistance and resistivity were obtained using a Gecor 8 (NDT James Instruments Inc., US.). Probe B (submerged condition) was used as the measurements were carried out when the reservoir was filled with seawater. There were 30 outdoor samples remaining (summer 2020), with several samples having only two rebars left on the top row and one sample with only one. Out of the 30 samples, 25 are of known composition with the remaining five the composition is not known, other than the w/cm was still 0.37. 13 samples were selected for forensic analysis, and 24 rebars were removed. Table 1 lists the samples from which rebars were removed. Longitudinal cuts were done in between rebars, and transverse cuts were performed at the rebar depth, avoiding touching the rebar. A chisel was used to expose the rebars. Pictures were taken upon opening the specimens and the rebar condition after sandblasting with walnut sand was documented. The cross-section loss as a function of the rebar length was obtained using a conical calliper. The pitting factor was calculated using only the corroding sections of each rebar. Concrete cores were obtained samples, the core milled to obtain several layers of concrete powder. The chloride concentration of the concrete powders was determined using the Florida Department of Transportation (FDOT) titration method.

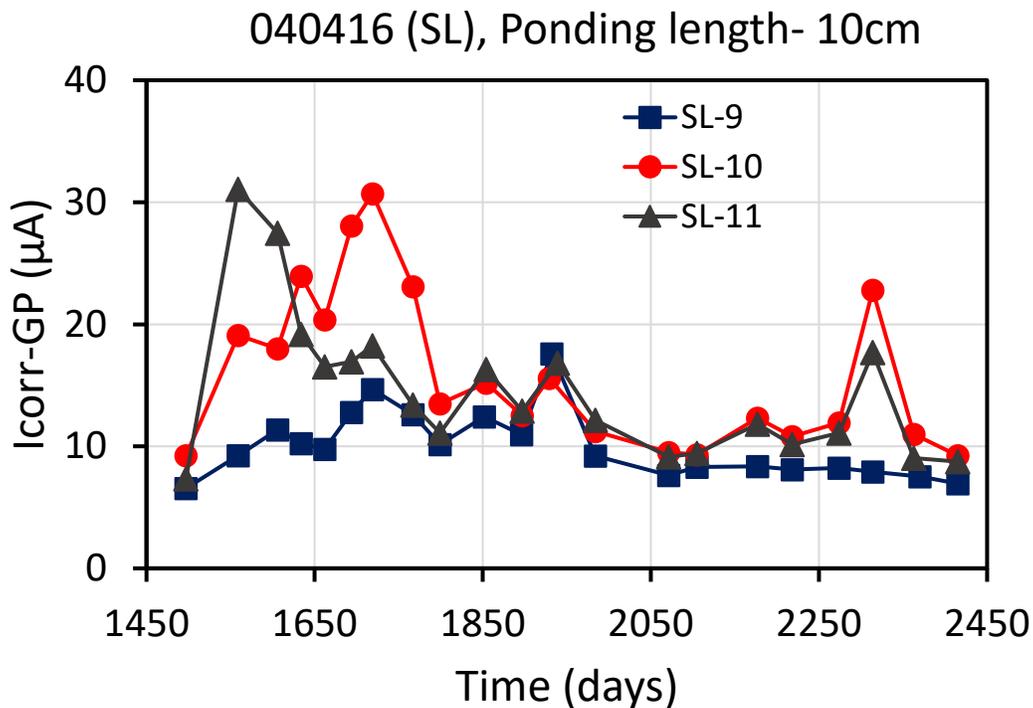
Figure 2. I_{corr} vs. time for SL single rebar with 10 cm long reservoir

The largest I_{corr} was observed on rebars embedded in samples with 10 cm solution reservoir and reached values as high as $30 \mu A$, the most recent I_{corr} ranges between 8 and $10 \mu A$. Figure 2 shows the I_{corr} values during the monitored period for the SL samples with 10 cm long reservoir. The remaining sample with a 17.5 solution reservoir, shows recent I_{corr} values close to $7 \mu A$. Samples with reservoirs of 2.5 to 5 cm long, had recent rebar I_{corr} values that ranged between 4 and $8 \mu A$. The observed values appear to have plateau. Figure 3 shows the I_{corr} vs. time for the rebars embedded in samples with 5 cm long reservoirs, note that SL-7 and SL-8 were placed in the environmental chamber and hence there are several measurements (shown on the left of the plot) that were performed as the sample regained moisture. The images for the other SL single rebar samples can be found in the appendix.

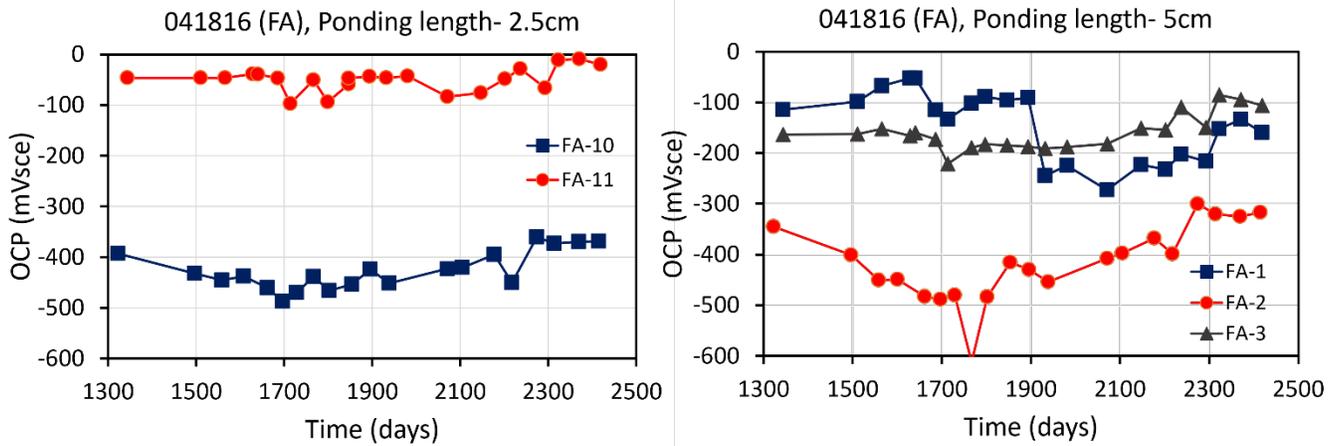
Figure 4. OCP vs. time for selected FA single rebar specimens

Two rebars consistently (FA-10 and FA-2, see Figure 4 below) had rebar potential values more negative than the rest of the rebars and were most of the time more negative than -0.4 Vsce. These two rebars also showed higher corrosion currents when compared to the other samples with the same solution reservoir length. The rebars in sample FA2 (5 cm reservoir) and FA5 (7.5 cm reservoir) showed Icorr values > 15 μ A several times, but also showed some oscillation (transients) in the measured corrosion current values. Figure 5 shows the Icorr values for the rebars embedded in FA samples with 5 cm solution reservoir, most recent Icorr values on FA2 rebar are close to 15 μ A. The other plots for FA single rebar samples can be found in Appendix B.

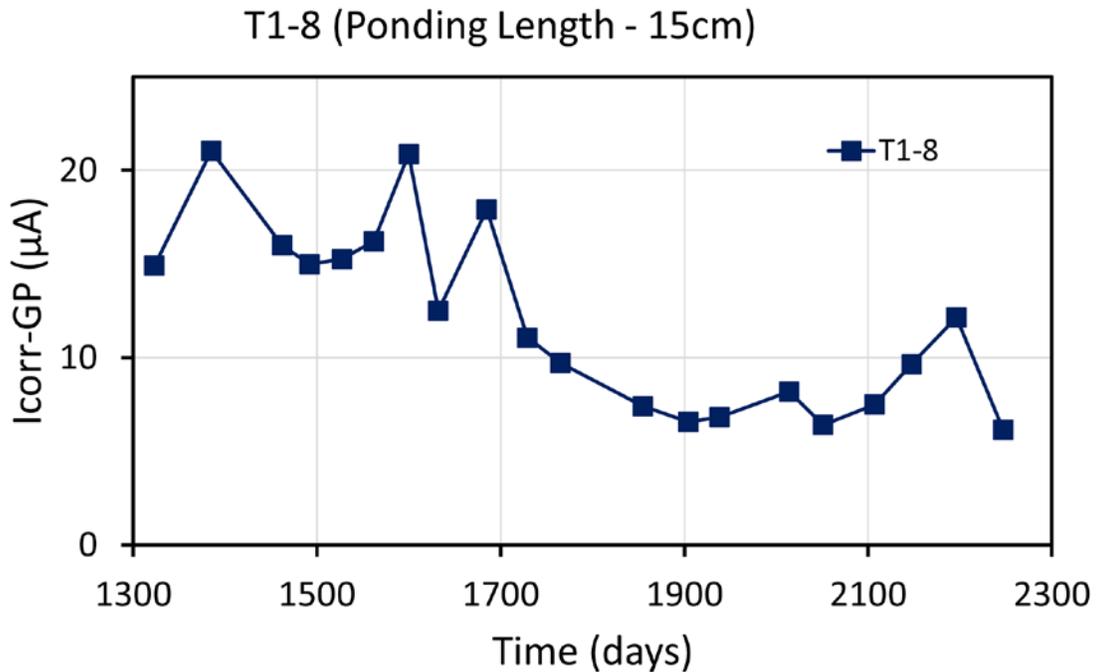
Figure 6. Icorr vs. time for T1-8 single rebar specimen (15 cm long reservoir)

Single Rebar T1 samples. The larger Icorr values were observed on T1-8 specimen which has a 15 cm long reservoir. During the monitored period reported in here, it started at values ranging between 15 and 20 μA , but the latest Icorr was close to 7 μA (See Figure 6). The other three T1 samples had smaller Icorr values (See appendix B). Samples with reservoir length of 5 cm had Icorr values that changed little over the reported period ($\sim 5 \mu\text{A}$), the Icorr values on the samples with a reservoir of 10 cm tended toward smaller values, and currently is also about 5 μA .

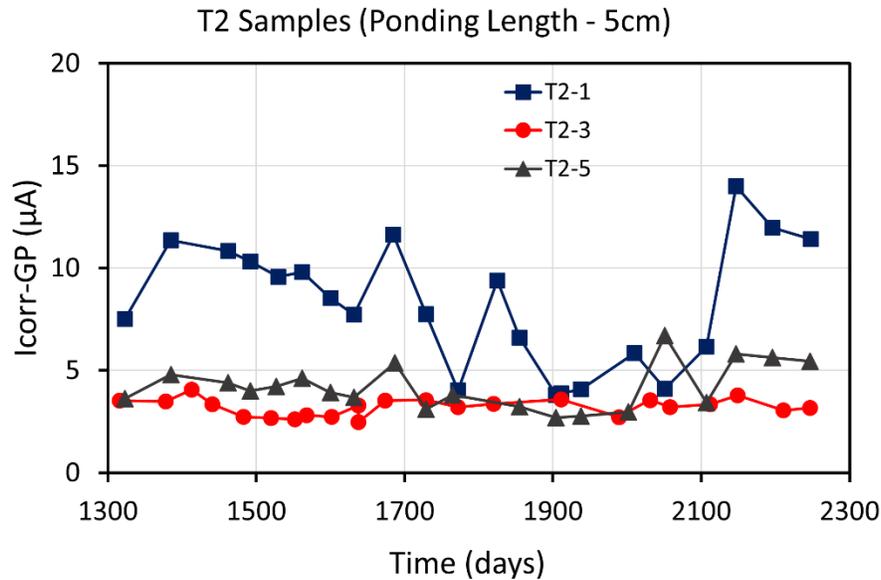
Figure 7. I_{corr} vs. time for T2 single rebar specimens (5 cm long reservoir)

Single Rebar T2 samples. Modest fluctuation in I_{corr} overtime were observed on the rebars embedded in single rebar T2 samples. The rebar with the most negative potential (T2-1, see appendix B) had the larger I_{corr} (T2-1, for samples with 5 cm solution reservoir), see Figure 7. Similar I_{corr} values (around $10 \mu A$) were observed on the rebar embedded in T2-11 specimen (in this case the reservoir is 15 cm long).

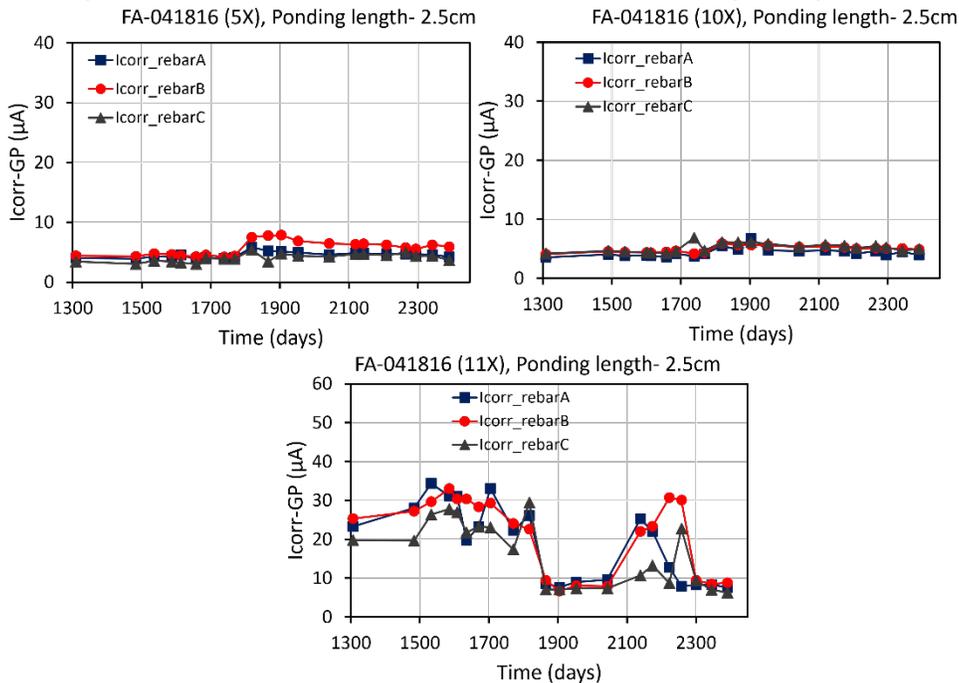
Figure 8. I_{corr} vs. time for rebars embedded in three rebar FA specimens with 2.5 cm reservoir

Three rebar specimens. This section describes how I_{corr} changed during the monitored period on FA three rebar specimens. Appendix C presents the I_{corr} observed values on SL, T1 and T2 three rebar specimens. Figure 8 shows how I_{corr} evolved on rebars of FA specimens with 2.5 cm long reservoir. Most I_{corr} values measured on three rebar FA specimens with reservoir of 2.5 cm, were less than $8 \mu A$, however sample 11X had rebars that showed values that ranged between 20 and $30 \mu A$, with the most recent readings being less than $10 \mu A$.

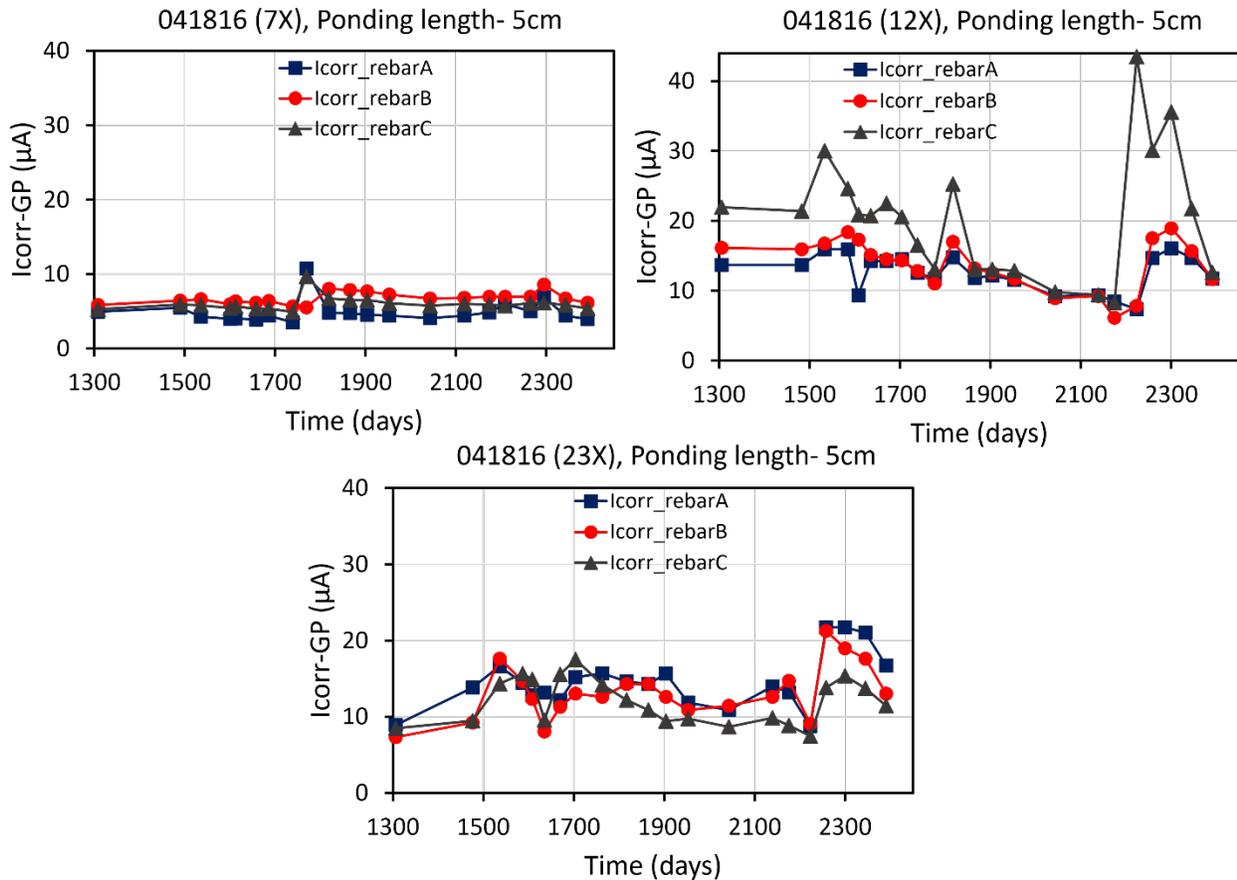
Figure 9. I_{corr} vs. time for rebars embedded in three rebar FA specimens with 5 cm reservoir

Figure 9 shows how I_{corr} evolved on rebars of FA specimens with 5 cm long reservoir. Over the monitored period reported in here, the I_{corr} of all three rebars remained at almost constant values on the specimen with lower I_{corr} values (i.e., sample 7X). I_{corr} ranged between 10 and 22 μA (with a couple of transients) on the rebars of sample 23X. Finally, the I_{corr} values were initially constant on the rebars of samples 12X, Rebar C had several instances in which I_{corr} values were greater than 20 μA and once it exceeded 40 μA , more recently the I_{corr} of this rebar transitioned downwards, reaching values of around 12 μA . The trend towards lower I_{corr} values was also observed on rebars A and B in specimen 12X. The three rebars in sample 12X showed momentary increase in the observed corrosion current between day 2150 and 2300 followed by a decrease.

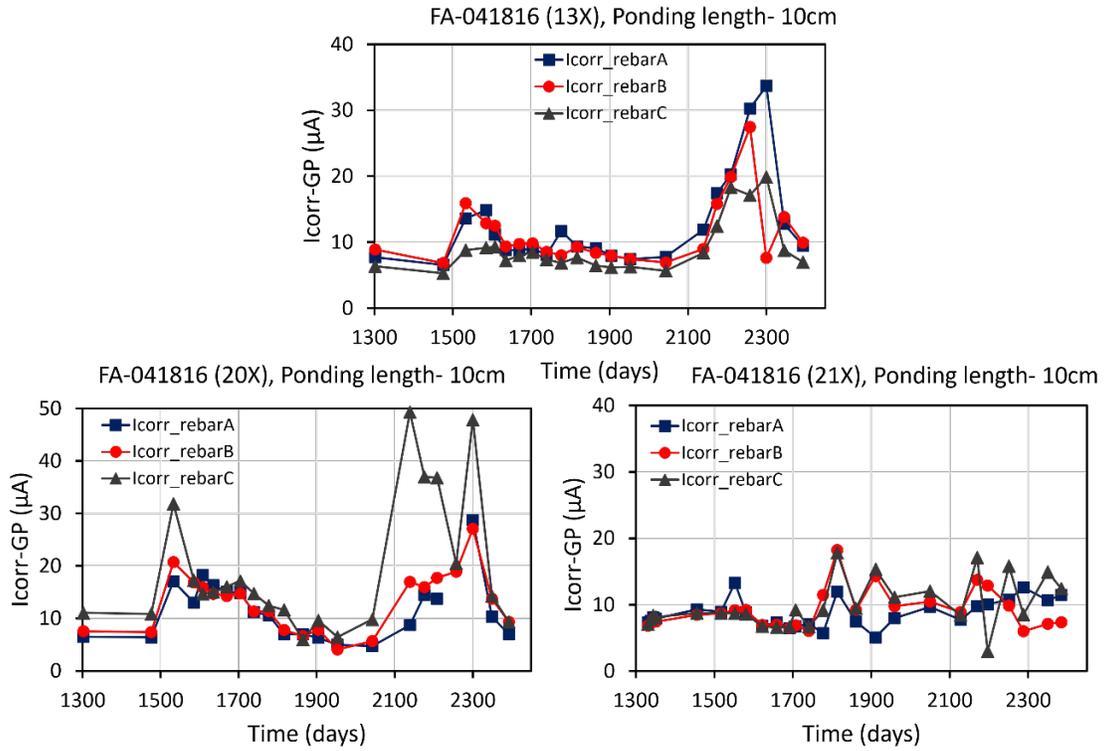
Figure 10. Icorr vs. time for rebars embedded in three rebar FA specimens with 10 cm reservoir

Figure 10 shows the I_{corr} vs. time for rebars embedded in FA specimens with 10 cm long reservoir. A downward trend in I_{corr} was observed on the three specimens between day 1500 and day 1800. Most rebars experienced an increase in corrosion current, reaching values as high as 50 μA , but later transition to smaller values. The most recent I_{corr} values ranged between seven and 12 μA . Figure 11 shows the I_{corr} vs. time for rebars embedded in FA specimens with 15 cm long reservoir. On these samples, there was an initial downward trend on the I_{corr} observed followed by an upward trend, during this latter transition a couple of rebars in sample 18X show I_{corr} values as high as 50 μA . The I_{corr} oscillated in some rebars, and transition to lower values on rebars of samples 14X and 18X. The most recent I_{corr} values ranged between 10 and 25 μA .

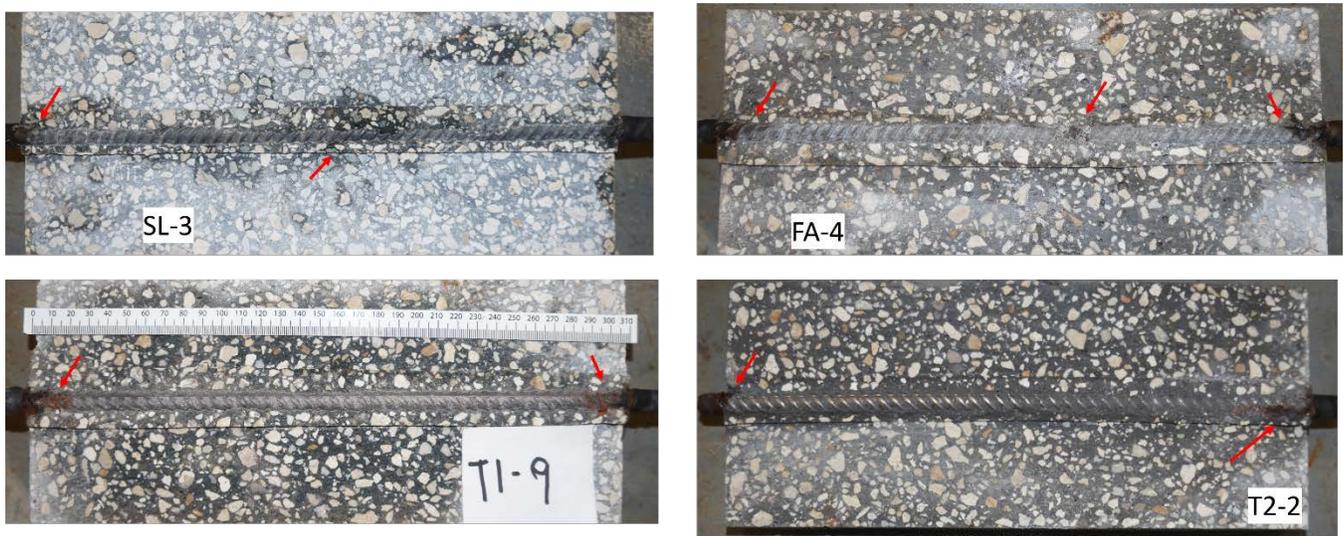
Figure 12. Photographs upon exposing rebars for single rebars specimens

Four single rebar samples were selected for forensic analysis: SL-3, FA-4, T1-9 and T2-2. One sample per concrete composition. Figure 12 shows the location of the corrosion sites observed upon opening exposing the rebar. Most corrosion spots were small. In addition to the corrosion spots within the embedded rebar, corrosion was found under the shrinkage wrap on the rebar section not embedded. The rebar in SL-3 sample had a very small spot under the reservoir and on the left side there was another visible corrosion site. The rebar embedded in FA-4 showed three distinctive corrosion spots: one under the reservoir section and two other sites close to each embedded end. The corrosion site on the right was dark green with wetness on it. Rebars embedded in T1 and T2 did not show corrosion spots under the solution reservoir. However, rebars embedded in T1 and T2 samples did showcase corrosion spots in the embedded region close to the concrete ends. No significant cross section loss was observed in any rebar after cleaning the rebars within the embedded rebar surface.

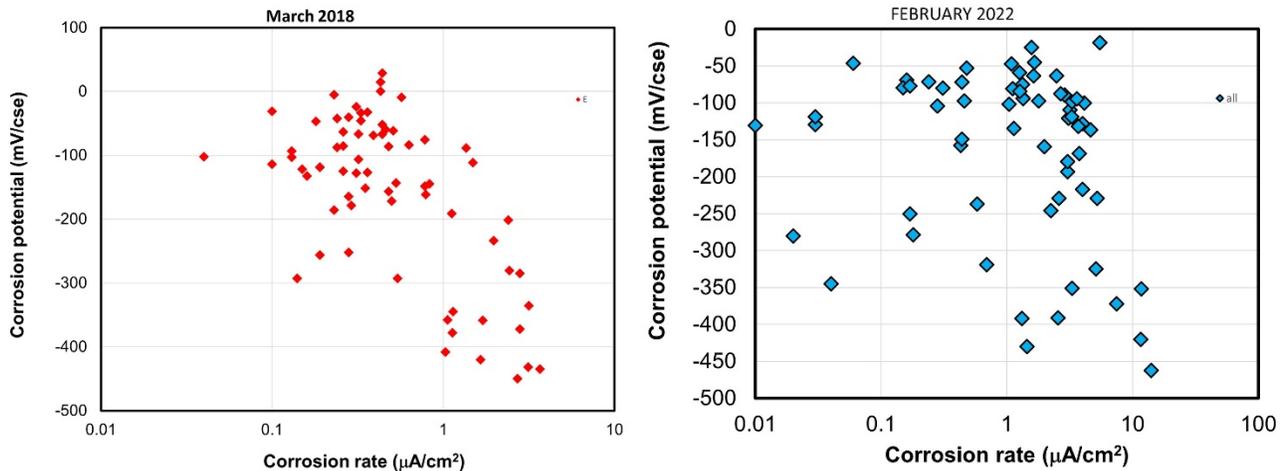
Figure 13. Rebar potential and icorr values measured in 2018 and 2022.

As indicated in the experimental section, a Gecor 8 was used to monitor the outdoor samples. Figure 13 shows the correlation between corrosion rate vs. corrosion potential for all rebars without grouping for composition. Figure 13 shows on the left a chart with a set of measurements made in March 2018 and on the right a chart with a set of measurements performed in February 2022 is shown. There is quite a bit of scatter on both plots. However, there is more scatter for the set of values taken in 2022, with icorr values being a little larger and potentials somewhat more negative.

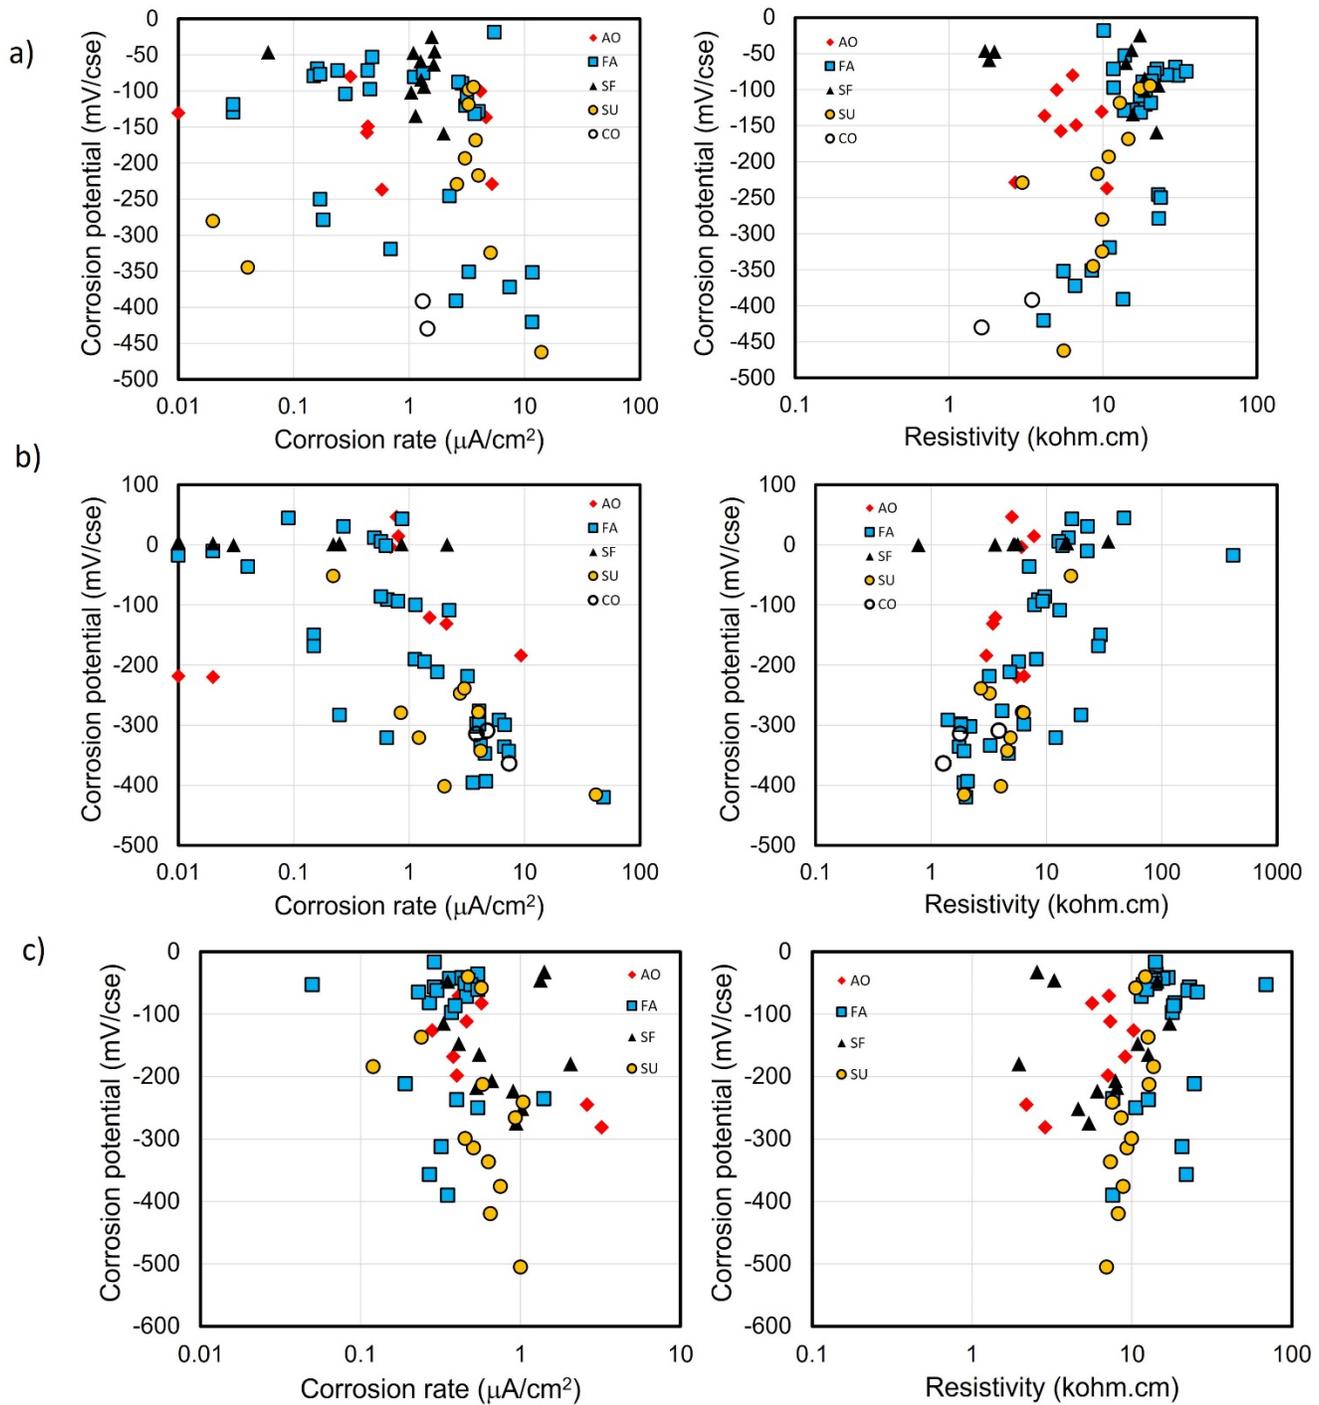
Figure 14. Corrosion rate vs. rebar potential and resistivity vs. rebar potential over time.

Figure 14 shows corrosion rate vs. corrosion potential and concrete resistivity vs. corrosion potential, for measurements taken between February 2022 (a), July 2022 (b) and May 2023 (c) for steel bars embedded in concrete after 27 years' exposure to a marine environment. It is noted that all the corrosion-related parameters are initially from a total of 83 rebars (14 rebars from SF samples, 39 rebars from FA samples, 9 rebars from AO samples, 3 rebars from CO samples, 18 rebars from unknown concrete composition samples). The rebar specimens were grouped into five categories according to different concrete compositions, the fifth group corresponds to rebars from samples with unknown concrete composition but with same low w/cm ratio of 0.37 than the other samples. For concrete specimens with additions of fly ash and silica fume, all four mix series with different percentages of additions were grouped into one category (FA or SF). Note that a number of samples were terminated as part of previous research campaigns. For the period reported here, 24 rebars were removed for forensic analysis, and hence the number of data points decreased as time progressed. There are a few observations that can be made. Depending on when the measurements were made (season) and the condition of the reservoir the values measured sometimes changed. The presence of cracks affected the resistivity (no longer sound concrete) values measured and icorr values, particularly if the concrete was quite moist. The corrosion current density values spread three orders of magnitude. The most recent set of measurements suggest that most rebars are corroding at a rate greater than $0.1 \mu\text{A}/\text{cm}^2$.

Moisture state appears to influence significantly the R_s , ρ and hence the i_{corr} and E_{corr} measured with the commercial device. Even for samples with cracks. It is possible that moisture content was not high enough on some occasions (either due to leaks or short time with seawater). A rebar surrounded with lower moisture showed significantly larger concrete resistivity values and typically lower i_{corr} (Figure 14), when comparing measurements performed over the monitored periods.

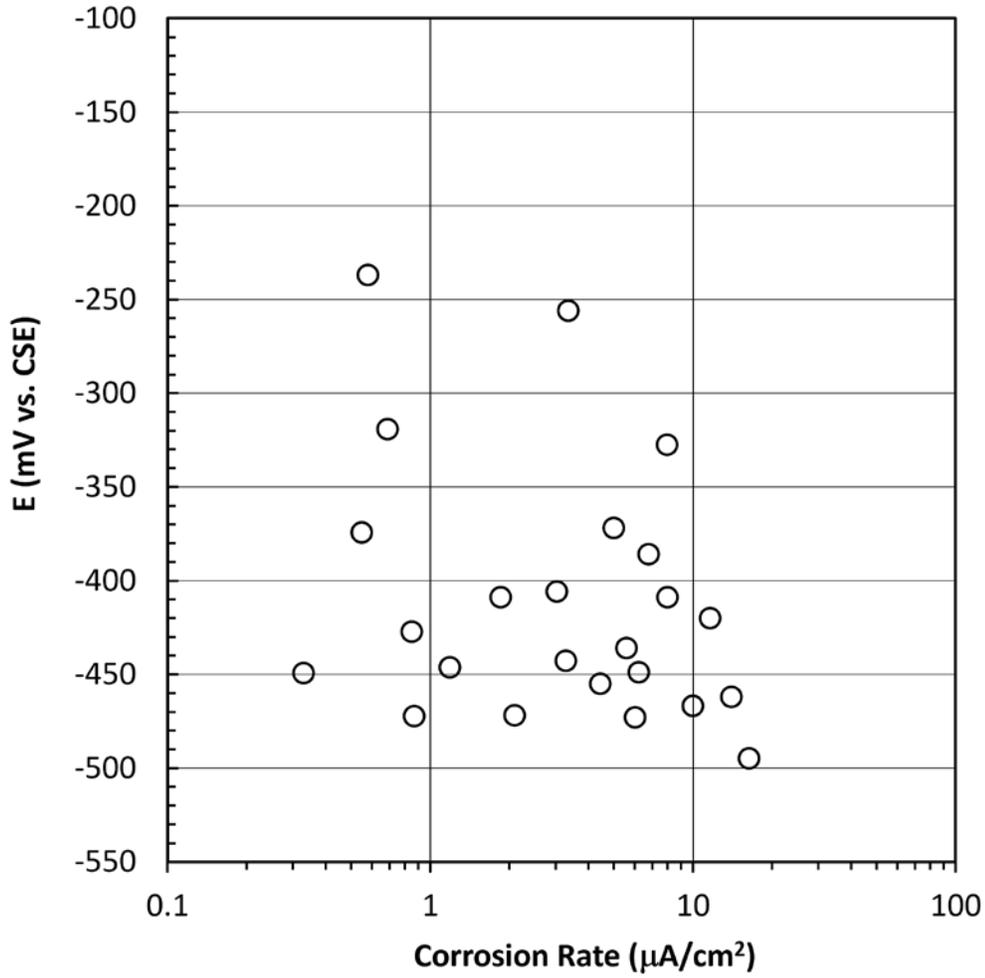
Figure 15. Rebar potential and i_{corr} measured before termination (removing each rebar).

Figure 15 shows the corrosion rate vs. corrosion potential measured shortly before the rebars were removed (note that the values are not grouped by composition). The rebar potential values ranged between $-250 \text{ mV}/\text{cse}$ and $-500 \text{ mV}/\text{cse}$, whereas the icorr ranged between $0.3 \mu\text{A}/\text{cm}^2$ and $18 \mu\text{A}/\text{cm}^2$. There is quite a bit of scatter observed in the chart. For example, rebars that had rebar potential approximately $-450 \text{ mV}/\text{cse}$ had icorr values that ranged between 0.3 and $6 \mu\text{A}/\text{cm}^2$.

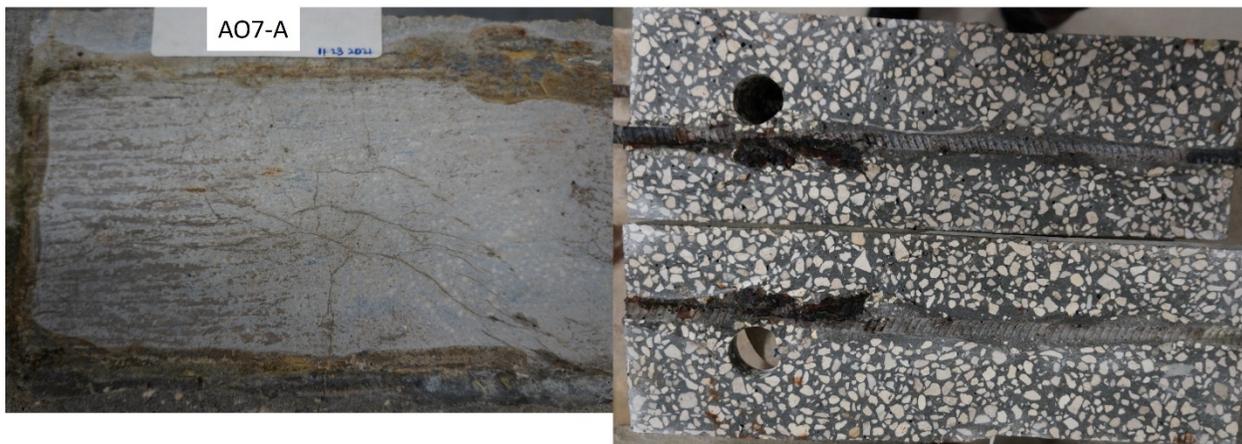
Figure 16. Concrete pattern and rebar condition upon opening and exposing rebar AO7-A.

Figure 16 has two images, on the left the concrete surface showing the crack pattern corresponding to sample AO7, the cracks shown were above rebar A. On the right, the image shows the exposed rebar (top right block) and that the corrosion products are on the left. The corrosion products are visible on concrete pieces. Figure 17 shows the crack pattern above rebar FA1-2-A and Figure 18 shows the rebar surface condition upon exposing rebar FA1-2-A. Corrosion spots are visible, with a larger one observed on the left side and a smaller one on the right side, with several smaller spots along the rebar length. The larger corrosion spot observed in FA1-2-A rebar is significantly smaller than that observed on AO7-A rebar, but it was large enough to cause the observed crack.

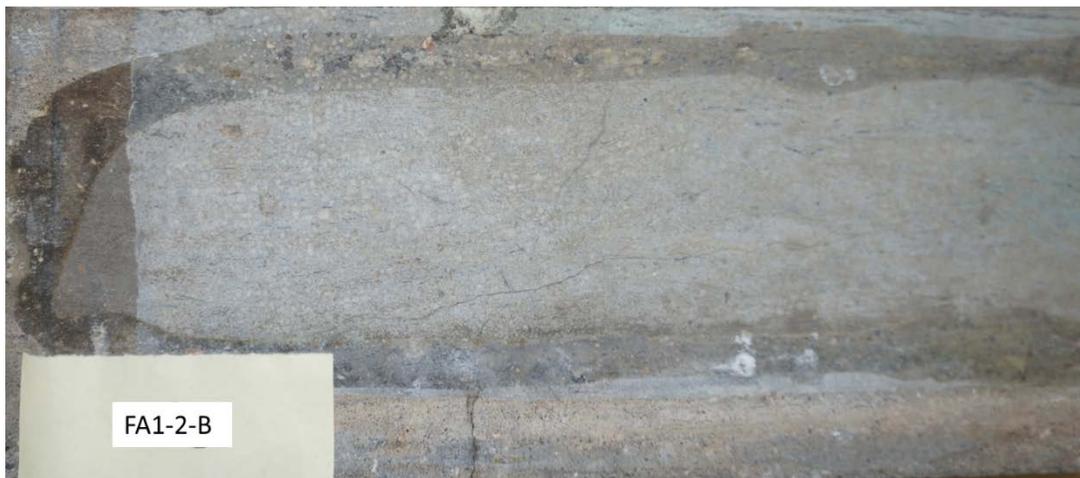
Figure 17. Crack pattern observed on FA1-2, shortly before terminating rebar FA1-2-B

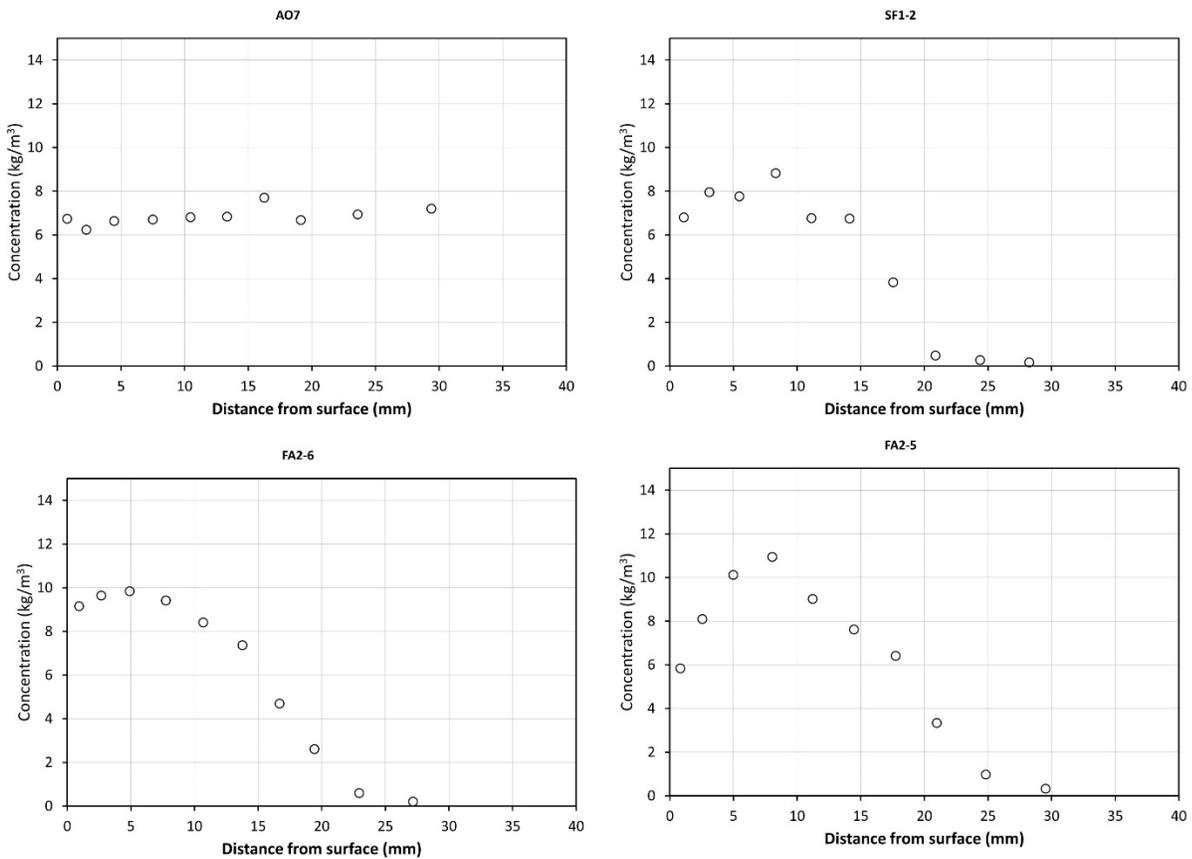
Figure 19. Chloride profiles obtained on selected samples.

Chloride Profile. This section shows the chloride profiles for the samples that were cored, milled and the concrete powder titrated. Figure 19 shows four chloride profiles, in all cases the chloride at the rebar depth was greater than 6 kg/m^3 . The method used obtains the total chloride per each layer analyzed.

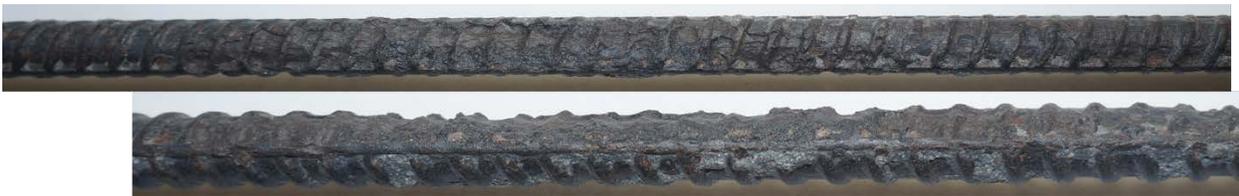
Figure 21. Two views of Rebar CO4-C

Figure 20 shows rebar AO7-A, it shows two views of the rebar, and it presents a long corrosion spot with regions with it that suffer significant cross section loss. Figure 21 shows two images taken after cleaning rebar CO4-C, the corrosion site is also long and some areas show significant cross section, mostly on the side directly below the solution reservoir, i.e., corrosion did not spread around the whole rebar on the corroding site. Rebar C is the rebar that showed the most cross section loss from the three rebars removed from CO4 sample (appendix X includes images of the other two terminated rebars).

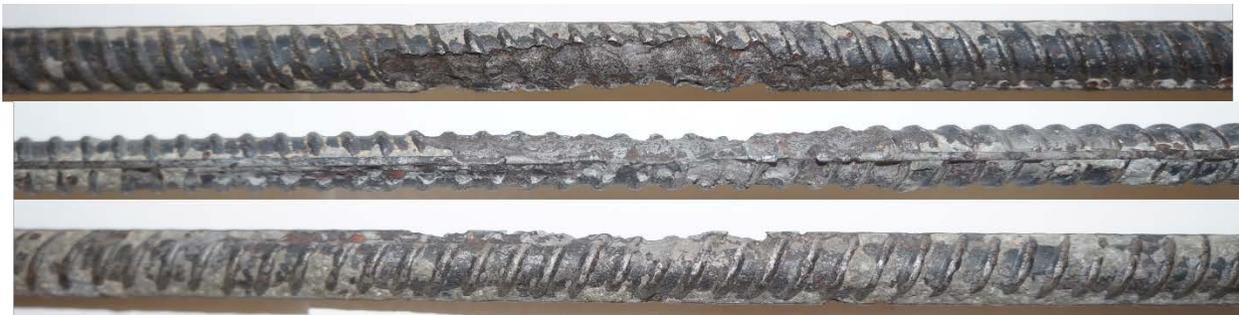
Figure 22. Three views of rebar FA2-5-B after cleaning.

FA1-2-C is the rebar from those removed from FA1 samples that showed the greatest cross section loss. Figure 22 presents three views of this rebar that corresponds to the same rebar section. In this case, the corrosion site extended to parts of the bottom rebar half (close to center). Figure 23 shows rebar FA2-5-B, which showed less cross section loss when compared to rebar FA1-2-C. The morphology of the corrosion site is less pronounced for rebar FA2-5-B.

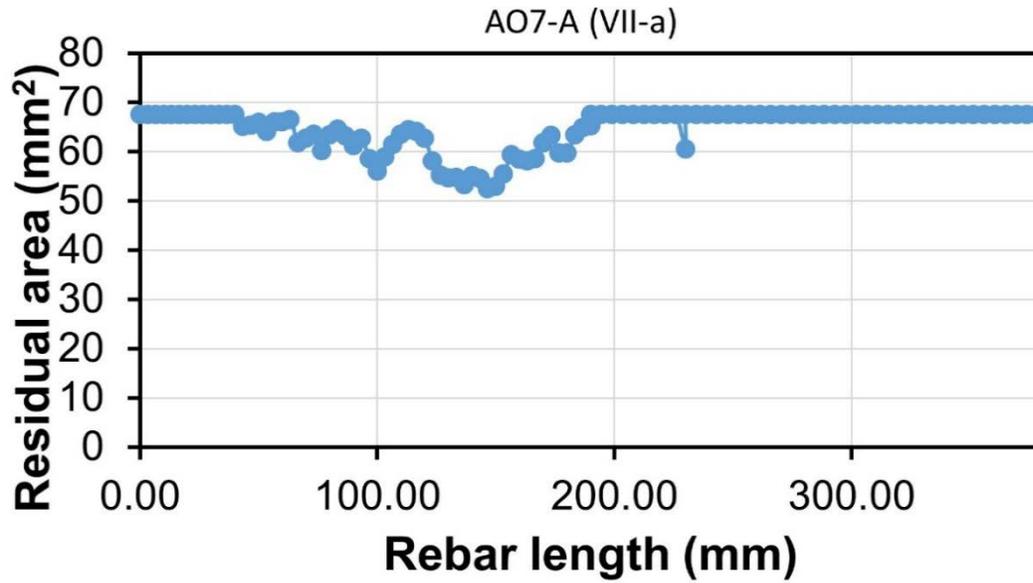
Figure 24. Cross section loss vs. rebar length for the embedded section in AO7-A.

Figure 24 to Figure 27 show the distribution of the residual cross-sectional area of several selected steel bars embedded in concrete specimens with different admixtures. Obvious localized corrosion is present on all the surface areas of these steel bars. The corrosion on most of the steel bars is located at one site with a length varying from 3.0 cm to 15.0 cm, with a few cases in which the length was shorter. In a few cases more than one corroding section was observed. Rebar AO7-A (Figure 24) displays one long corrosion site (15 cm) and one short site (~0.4 cm). Figure 25 and Figure 26 show two rebars removed from sample FA1-2, a larger cross section loss is observed on rebar FA1-2-C (Figure 26) than on rebar FA1-2-B (Figure 25). Figure 27 shows rebar FA2-5-B, in this case the site was 15.4 cm long and several regions within that site show significant cross section loss.

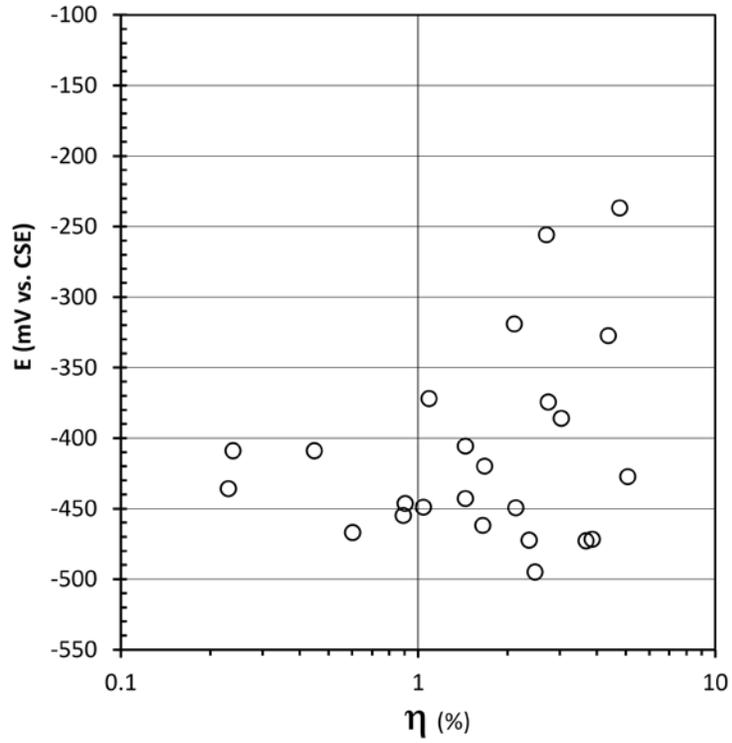
Figure 28. η vs. rebar potential.

Figure 28 shows a plot of percent averaged corrosion mass loss (η) vs. rebar potential (vs. CSE). The rebars with potential more negative than -400 mVcse had corresponding η values that ranged between 0.2% and 6. Note that samples with the more positive rebar potential showed η values ~ 6%. Figure 29 shows a plot of percent averaged corrosion mass loss (η) vs. the corrosion rate. Note that at the time the rebars were removed, all experienced corrosion rates greater than $0.3 \mu\text{A}/\text{cm}^2$, with three rebars having i_{corr} greater than $10 \mu\text{A}/\text{cm}^2$. The smaller η values were around 0.3% with corresponding i_{corr} values between 2 and $5 \mu\text{A}/\text{cm}^2$. Several rebars with the larger η values had corrosion rates smaller than $1 \mu\text{A}/\text{cm}^2$, which suggest that these rebars had moved to a less active state (compared to the rebars with rates greater than $1 \mu\text{A}/\text{cm}^2$ and similar η value). Figure 30 shows a plot of η vs. the concrete resistivity. The plot shows quite a bit of scatter. The scatter might be due to the measurements performed at different stages in the corrosion propagation, even if cracks had appeared at the concrete surface in all cases. The samples with lower resistivity value could be due to a combination of cracks present and a high moisture state, and no longer representing the concrete bulk resistivity.

Significant scatter was observed on the plots correlating η to rebar potential, η to rebar corrosion rate, and η to concrete resistivity. It appears that when corrosion has propagated for an extended period of time (actually different periods of time), some rebars show modest η values with high current density.

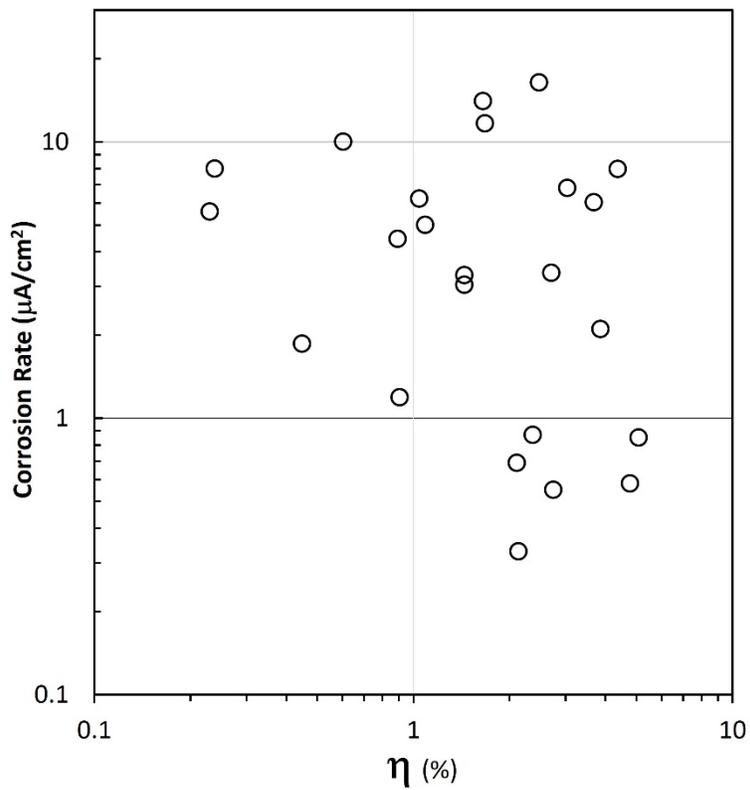
Figure 29. η vs. rebar corrosion rate.

The scatter observed can in part be explained by the following paragraph. In some samples corrosion took place for longer periods (i.e., crack was observed and was present for several months to years, plus corrosion that took place before the crack was visible on the concrete surface) of time before removing a selected rebar. Still the corrosion extent varied. In other cases, the rebar was removed shortly after the crack was observed. The rebars removed spring 2023, started showing cracks on the concrete surface after last summer. For the latter rebars, the η (average mass loss) value tended to be smaller than for cases in which the rebar corroded for a longer period of time with a visible crack. The corrosion rate (via the portable device) of the rebars removed spring 2023 was larger than $4 \mu\text{A}/\text{cm}^2$. The presence of the crack, concrete composition and size of the corroding site could result in low resistivity (within the evaluated area) and high corrosion rates. In other cases, the resistivity was larger (again within the area measured), but comparable corrosion rates were observed.
