**Final Report for
BMPs for Cranberry Farms Grant No. G0200278**

April 14, 2005

**Kim Patten
Washington State University Long Beach Research and Extension Unit**

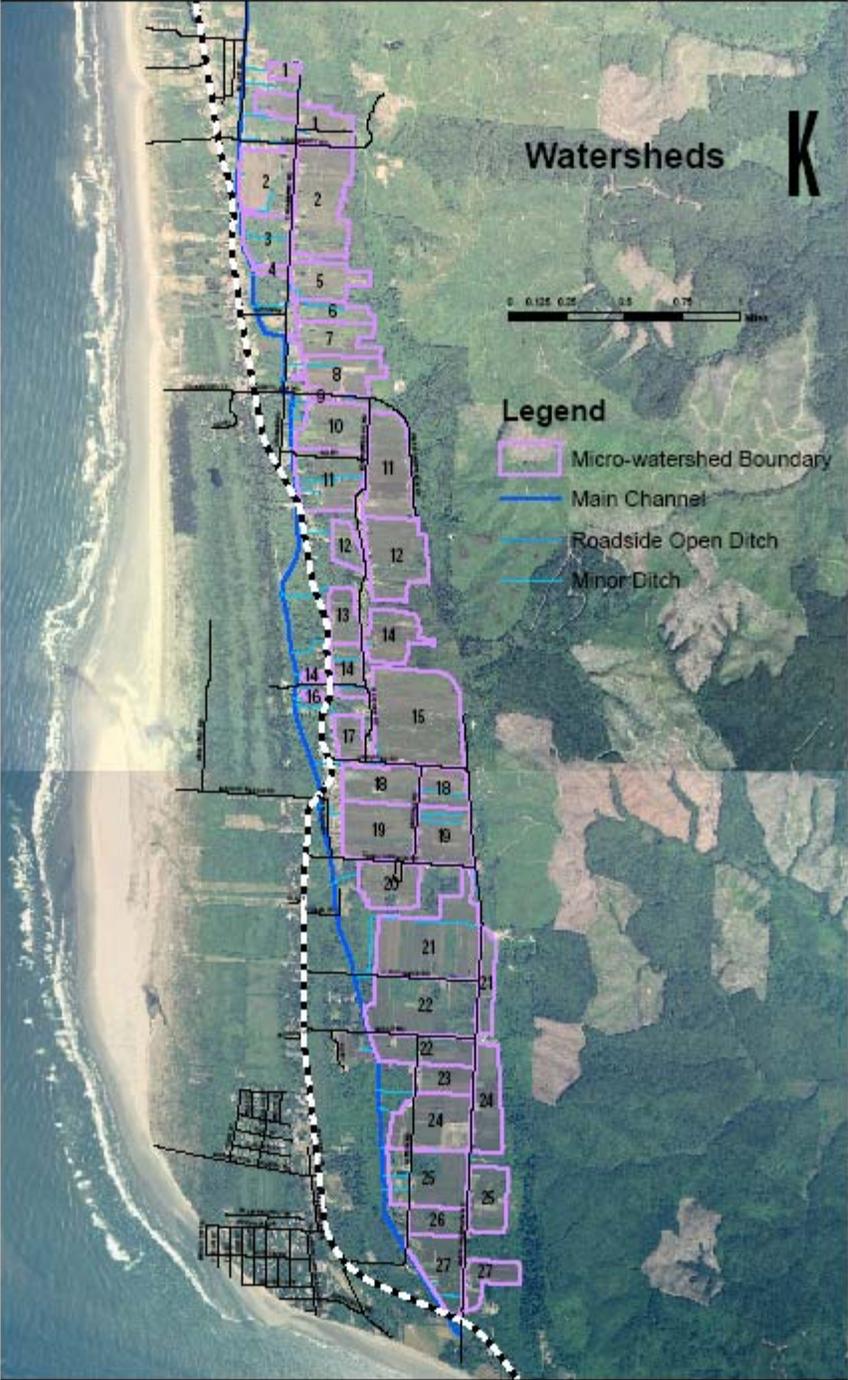
Figure 1. Locations of micro-watersheds within the Grayland cranberry growing area

An aerial overview of the study site and the 27 micro-watersheds evaluated in this study are shown in Figure 1. A graphic overview by watershed showing the BMP status and type of BMPs implemented are indicated in Figures 2 and 3. The specific details of these maps are broken down across 40 discrete sites in Grayland and presented in the Appendix. A numerical summary of BMP mapping results by watershed are provided in Table 2. Based on a linear foot of ditch analysis, several watersheds (4, 6, 16, 17, 23, 26) have been 100% covered by BMPs, and several were >90% treated (8, 11, 12, 13, 14, 15, 20, 27). Watersheds 2, 5, 18, 19, 21, 22, 24 and 25 were between 55% and 89% treated. Only watersheds 8, 18 and 19 were less than 50% treated. Many of the improvements in these watershed BMPs came after 2002. Covered ditches were the preferred method of treatment. Of the projects completed to date, 57%, 3%, and 11% are covered ditches, buried pipe and diked beds, respectively. These data are particularly important in indicating how many ditches still need to be treated with BMPs, where they are and how much EQIP monies will be needed to finish all the ditches in Grayland.

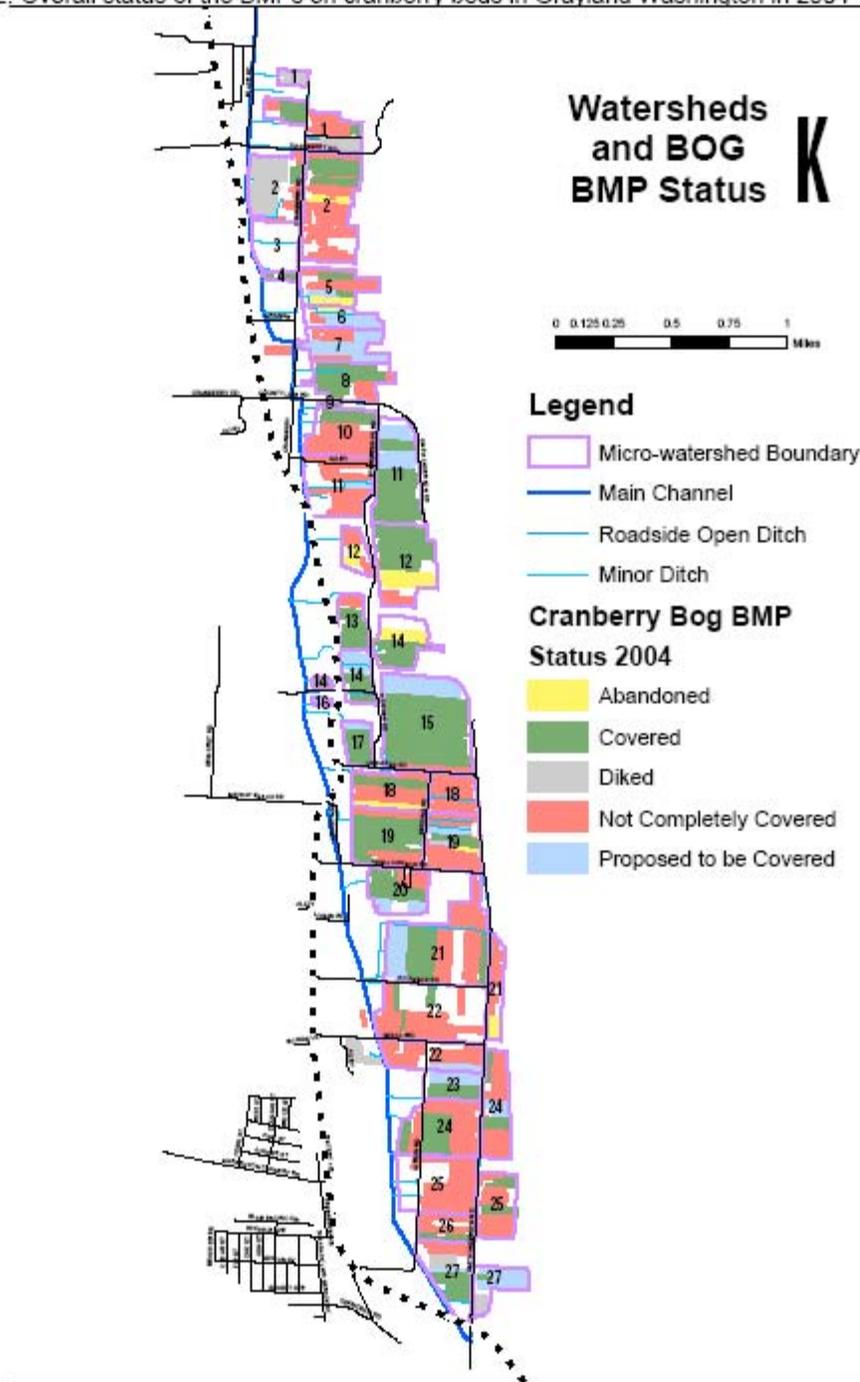
Figure 2. Overall status of the BMPs on cranberry beds in Grayland Washington in 2004

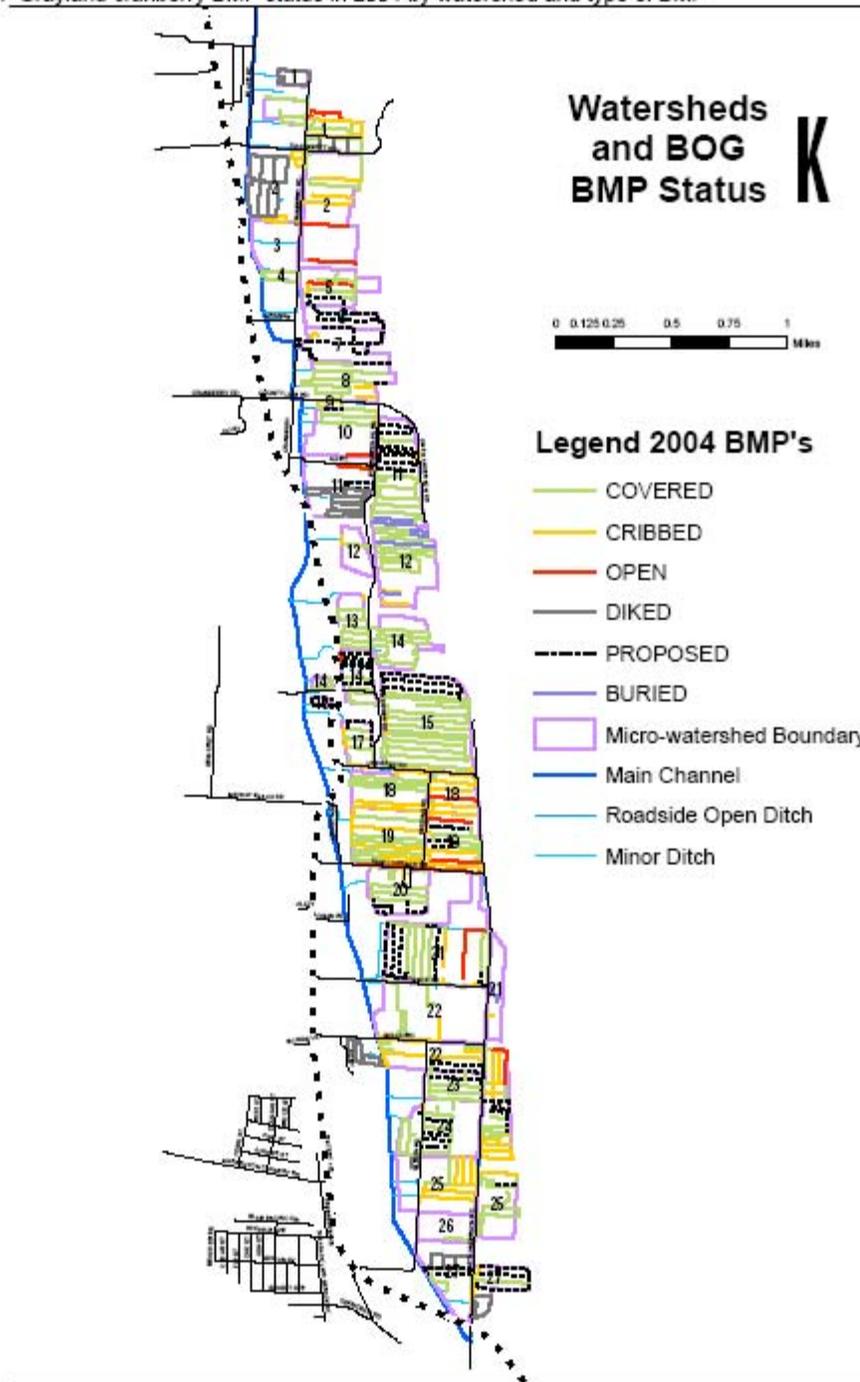
Figure 3. Grayland cranberry BMP status in 2004 by watershed and type of BMP

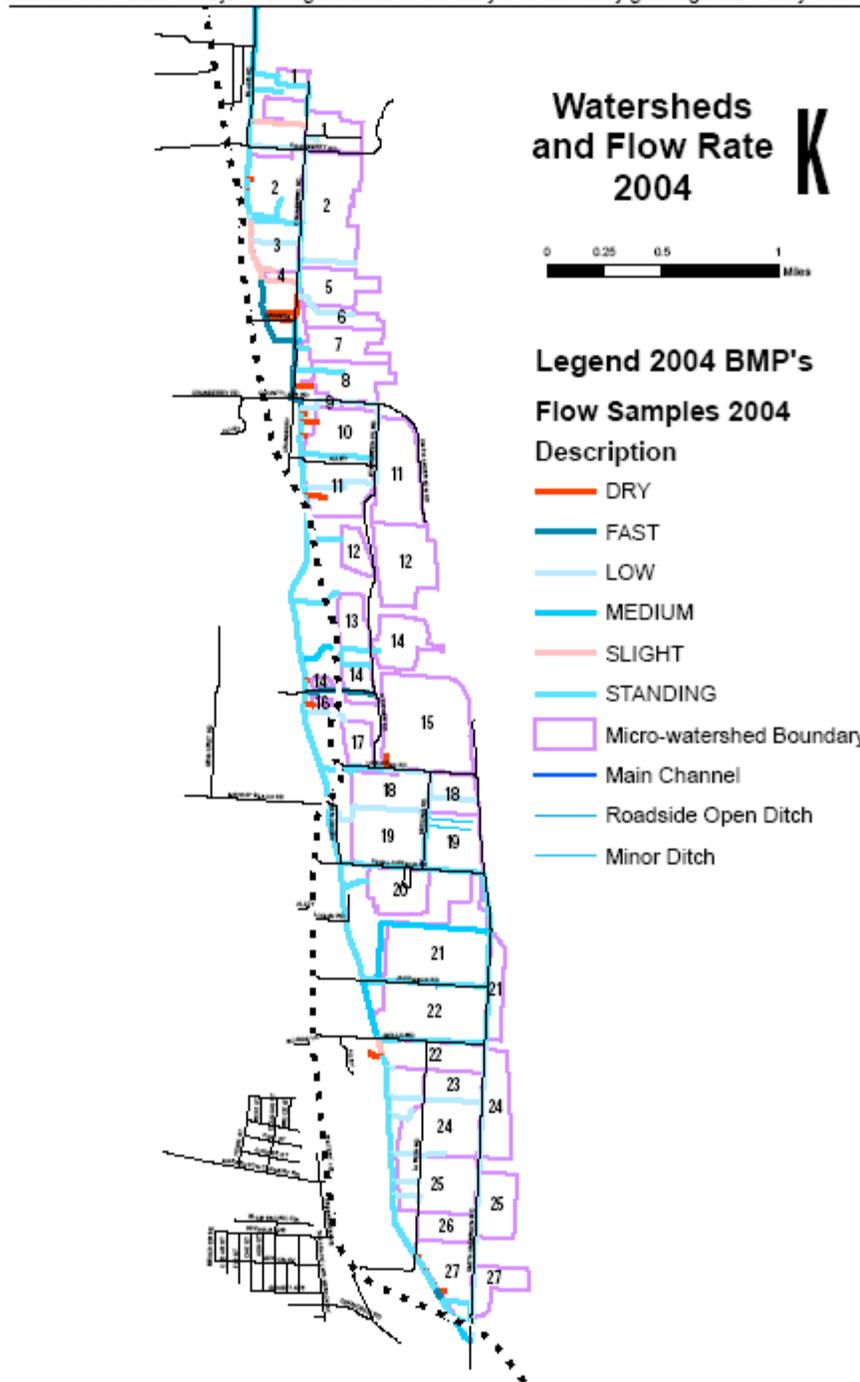
Figure 4. Relative flow rates in major drainage ditches in the Grayland cranberry growing area in July and August 2004

Additional information is provided across the watershed by locations for relative summer water flow in 2004, flow direction, contours, water quality sampling, ditch discharge flow, sampling sites and ownership (tax lots) (Table 5, Figures 4, 5, 6, 7 and 8). More detailed information on this data can be found by individual beds in the appendix.

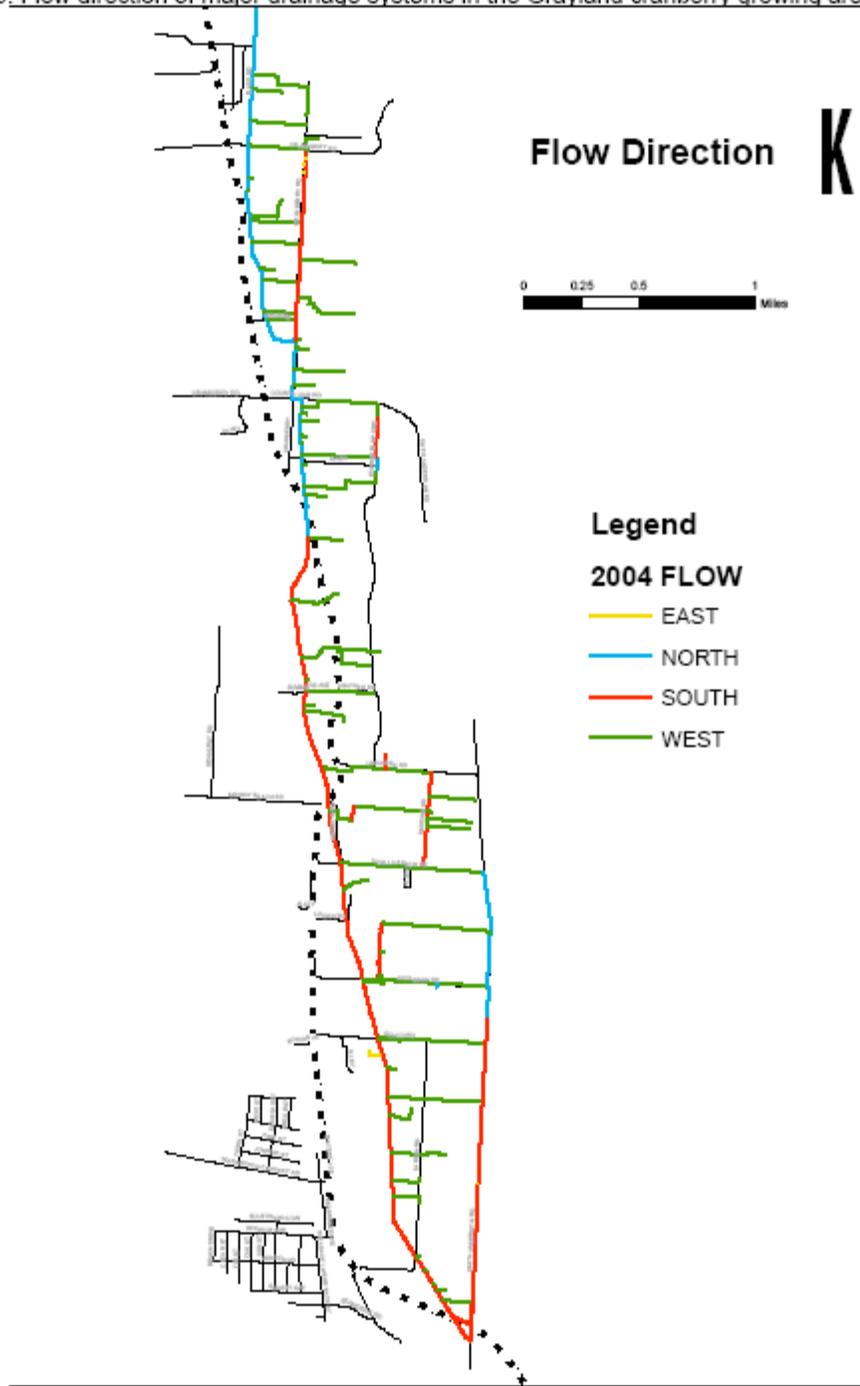
Figure 5. Flow direction of major drainage systems in the Grayland cranberry growing area.

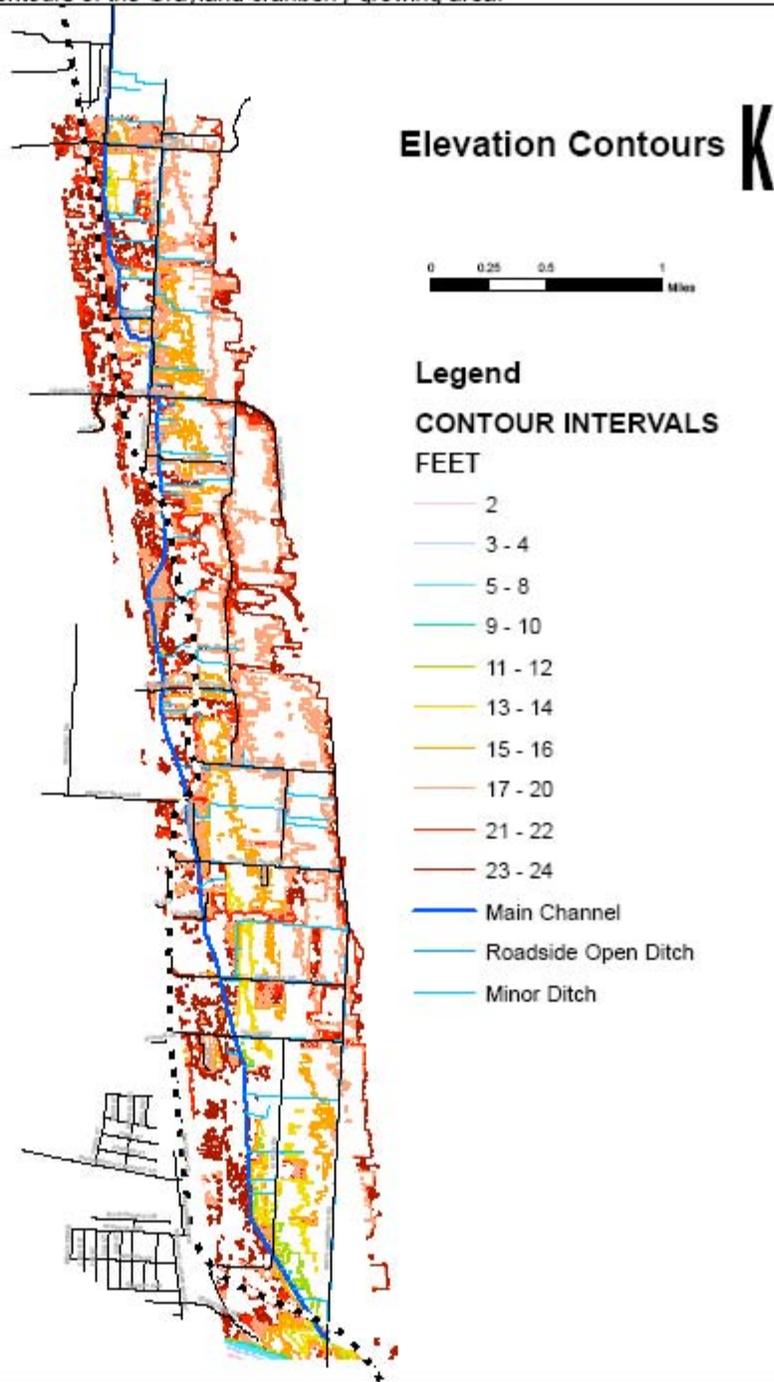
Figure 6. Elevation contours of the Grayland cranberry growing area.

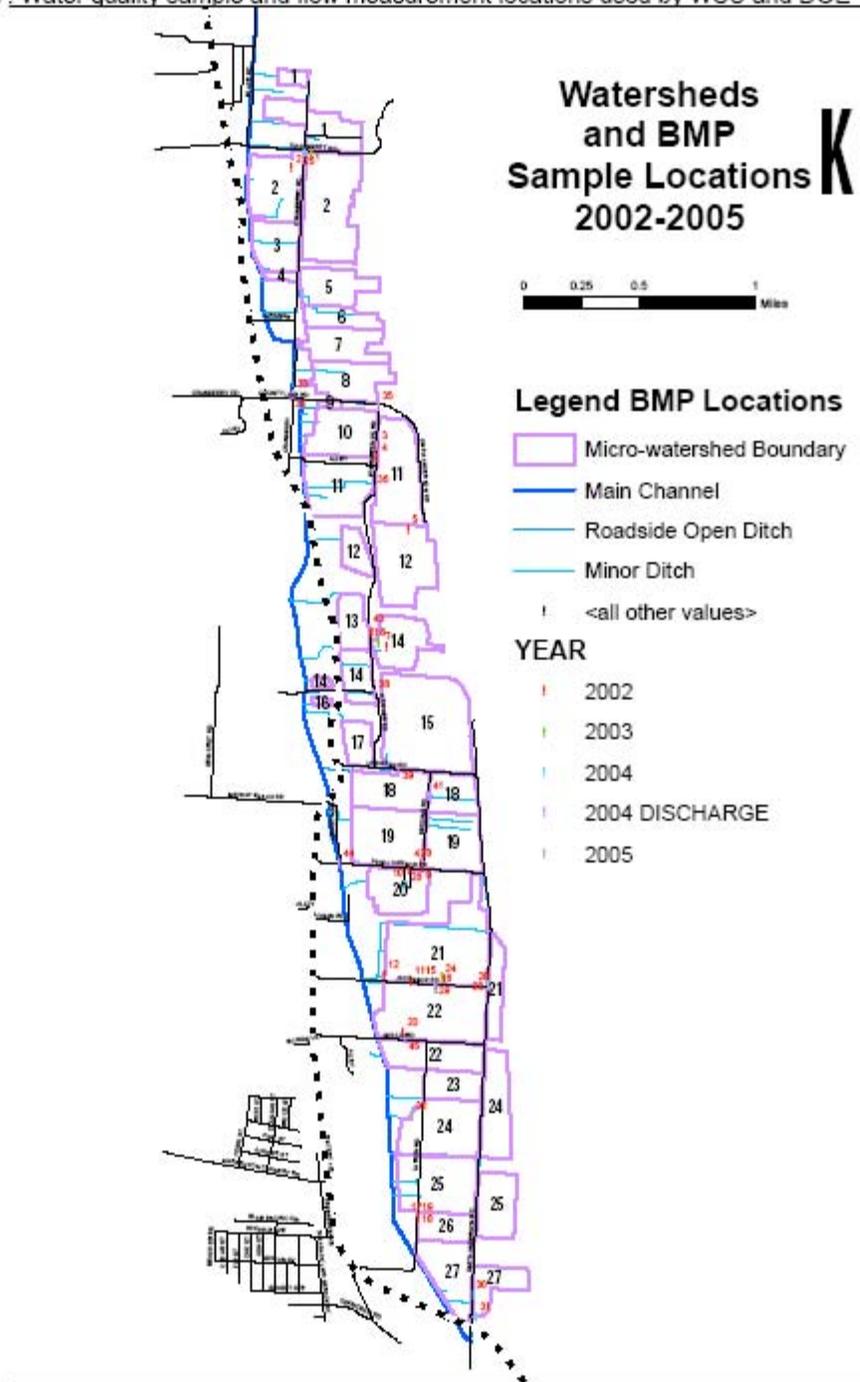
Figure 7. Water quality sample and flow measurement locations used by WSU and DOE

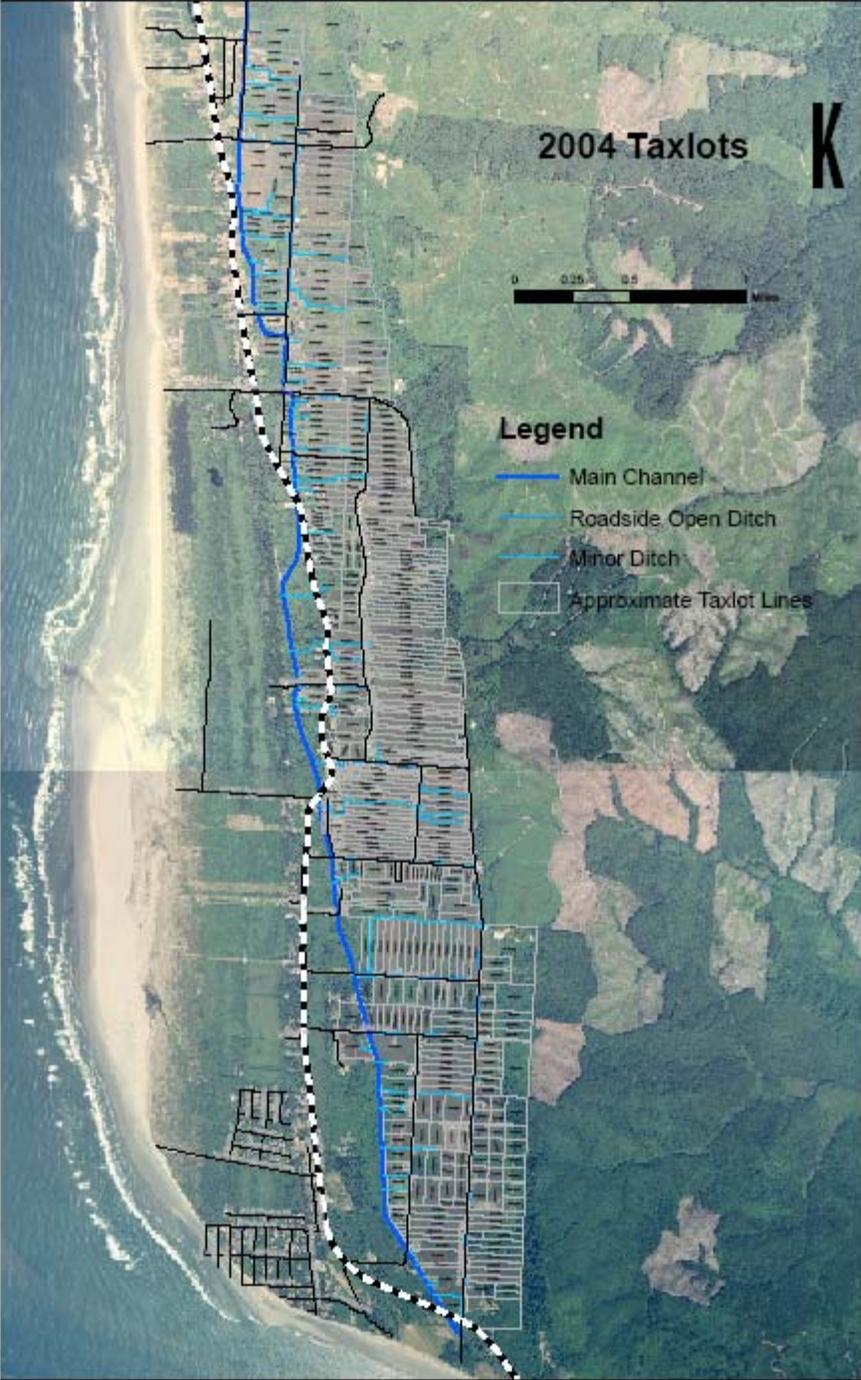
Figure 8. Taxlot information on cranberry beds in Grayland Washington.

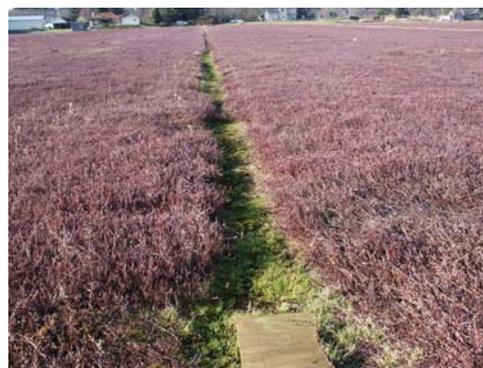
Buried drain line: Monitoring was done at a site that was installed by the grower in 2002 (see adjacent photo). Based on the results shown in Table 5, this type of system was fairly effective. There was a single hit of Guthion shortly after application indicating that the system was not entirely sealed from surface water. Although we did not sample enough farm systems with buried drain line to be completely confident in the results, it is likely that this system is overall fairly effective for keeping insecticide from surface water.

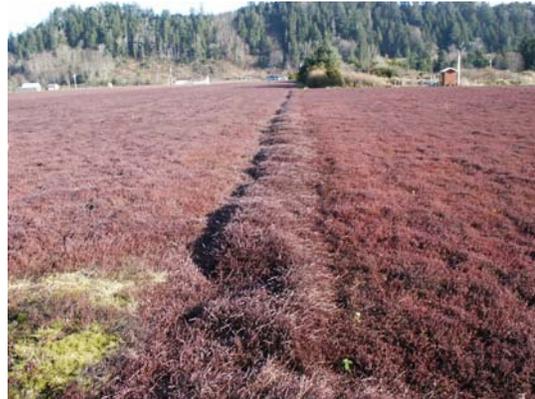
Vine overgrowth: Numerous farms have let the cranberry vines grow thick over small drainage ditches under the assumption that this thick cover would allow drainage, but prevent pesticides from entering the surface water system (see adjacent photo of site used in Tables 7 and 8). Since this system didn't have any summer flow, monitoring for efficacy in the surface water itself was not feasible. Instead we placed wide-mouth glass canning jars above and below the canopy during several pesticide application events. Any pesticides passing through the canopy would be caught in the jars. Jars were then diluted to 1 quart of water and the sample analyzed. Based on the data in tables 6 and 7, vine overgrowth does not eliminate pesticide getting into surface water and should not be practiced as a BMP.

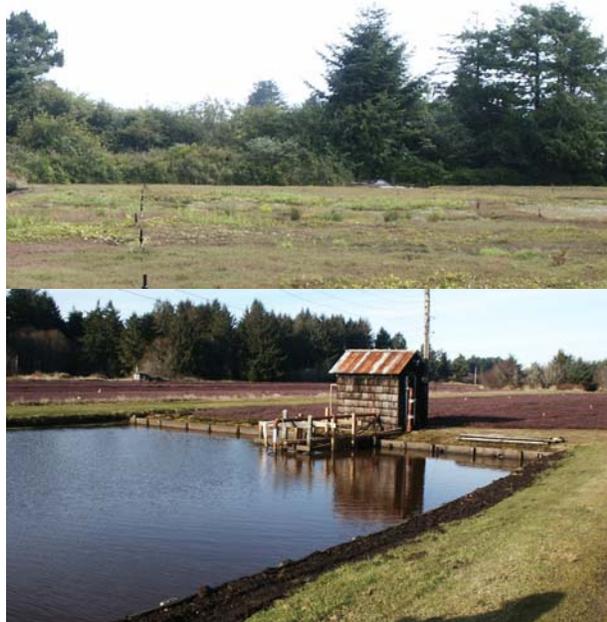
Offsite mitigation: Only one site was available for monitoring the efficacy of pumping water from a contaminated sump to a field to allow for off-site mitigation (see adjacent photo of sump where water was pumped from and the site to which water was pumped). It was assumed that water flowing from this mitigation field would be free of any pesticides, since it was vegetative shrub land on peat soil. Unfortunately, Guthion was detected in all the samples including the before treatment sample. It was therefore highly likely that the location selected for monitoring was contaminated from an adjacent cranberry bed. Therefore the results are inconclusive. Unfortunately, obtaining additional monitoring samples was not feasible as this practice was only used by one grower. Despite the lack of positive results, we nevertheless would suspect that the system would be effective. However there are very few sites in Grayland available where this could be maintained as a BMP.

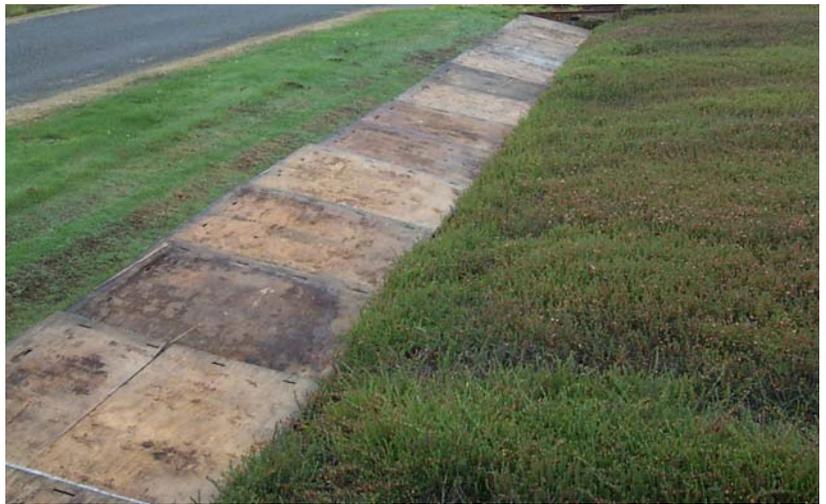
Temporary Ditch Covering: A site was selected where a grower placed used plywood over the ditch during pesticide applications. This temporary cover (see adjacent photo of site) was supposed to prevent any entry of pesticide during a chemigation event from entering the stream under the plywood. Based on the data found from one monitoring event, this system appeared to be very effective in preventing surface water contamination. Since Orthene was used as the insecticide by the grower, it is uncertain how reliable the monitoring data are. Orthene is notoriously difficult to analyze for, and rapidly degrades. The results, however, are only as reliable as the covering system. The on-off removal of this temporary covering system did not have much long-term functionality to the grower.

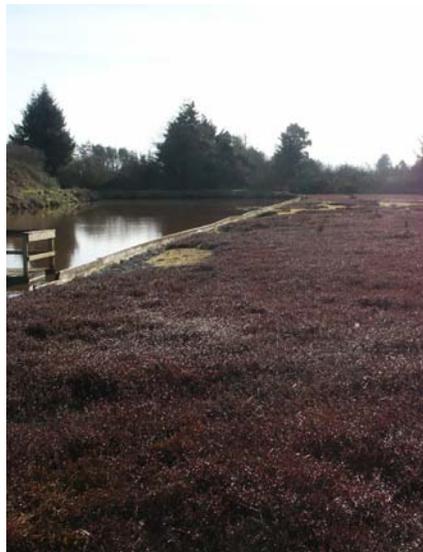
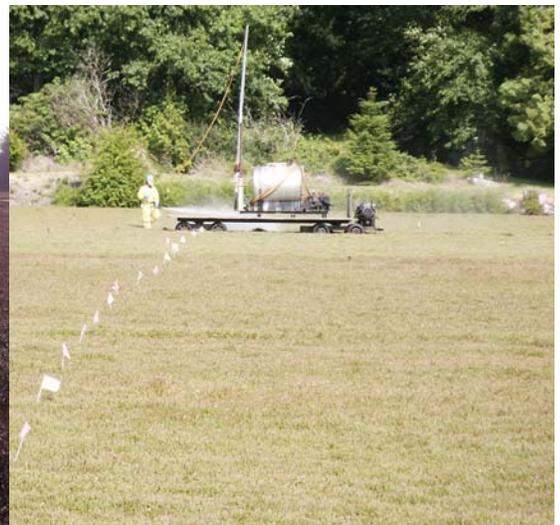
One method used to avoid ditch contamination via the chemigation process is targeting the insecticide application more precisely using a hand sprayer and applying out from the ditch or sump (see adjacent photo of sprayer and sump) to carefully avoid any off-site application to water. We evaluated this at one grower site. There was no

evidence of ditch contamination using this method. However, since the grower used Orthene, the favorable results must be viewed with caution. From a practical point of view, most growers are not willing to spray by hand along their thousands of feet of ditch two to four times during the season.

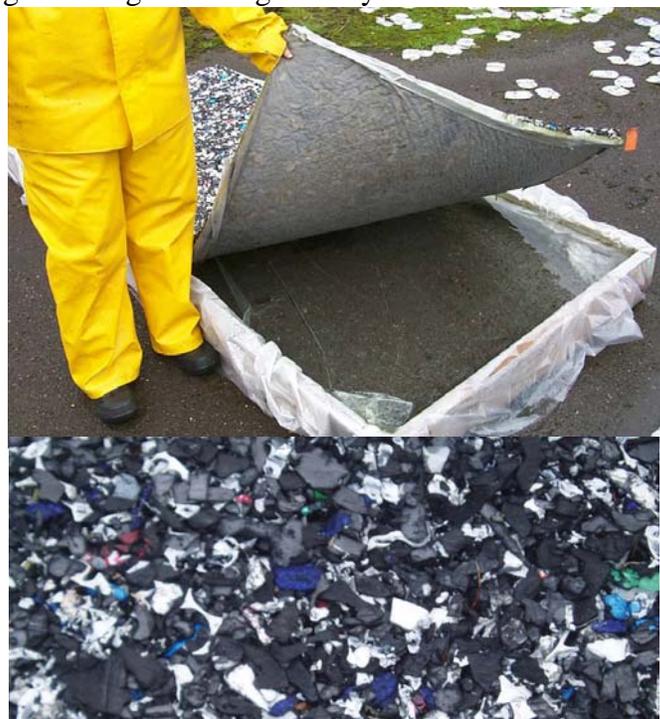
Floating filtration beds: A floating system was designed using a floating filter system from Environmental Fabrics, Inc. These 4' x 8' pads were filled with 1" recycled foam padding glued over a geotextile fabric cloth (see adjacent photo of floating pad). Different amounts (56 and 113 g/m²) of powdered activated charcoal were filled into the loose cell of each pad. Since not enough pads were available to cover an entire sump, a simulated container monitoring plan was conducted. Containers holding the pad were made and filled with water. Diazinon was sprayed over the tops of several types of charcoal-loaded pads. Water quality underneath the pads was monitored over time. Results from this monitoring study were inconclusive. Over time, insecticides were detected under all the floating filters. Apparently with rain and wind and other activity there is a loss of insecticides off the filters into the water. The site also picked up some off-site contamination from a nearby pesticide application event. It can be concluded that these floating covers are not reliable enough to work for growers.

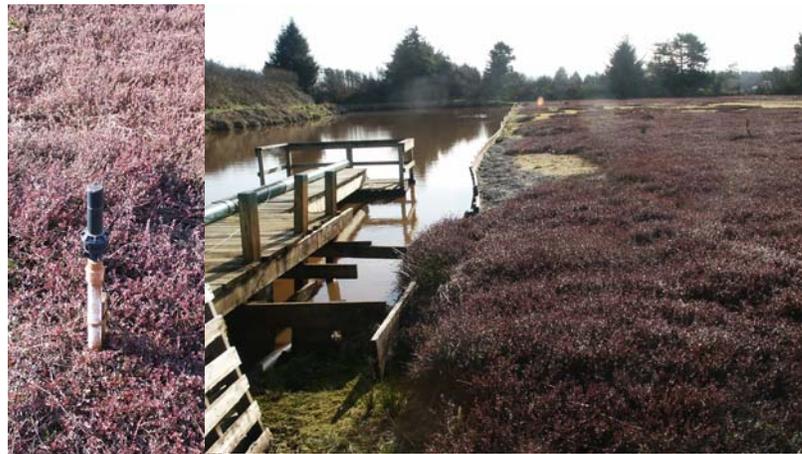
Traditional cranberry sprinkler systems have very little flexibility for adjusting throw, backwash, and pattern. Therefore during a chemigation event it is hard to avoid contaminating surface water. Adjustable gear-driven irrigation sprinkler heads however, can be adjusted for flow, throw, backwash, and pattern. Thus, by switching over selected sprinklers in a bed that hit surface water, it

may be feasible to reduce offsite contamination. Such a system was installed at a grower site in 2004 to evaluate the adaptation to an existing cranberry production system (see above photo of

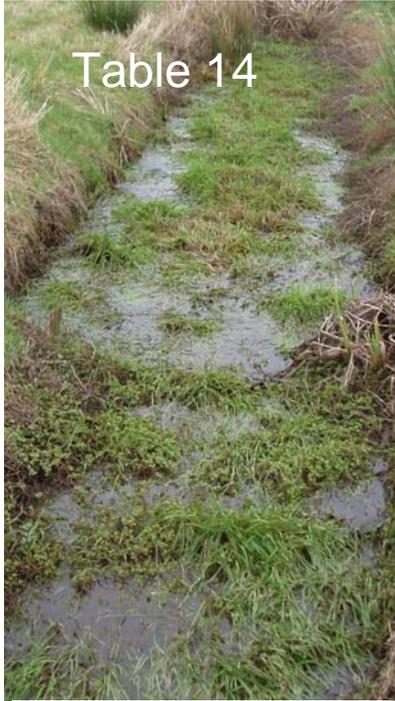
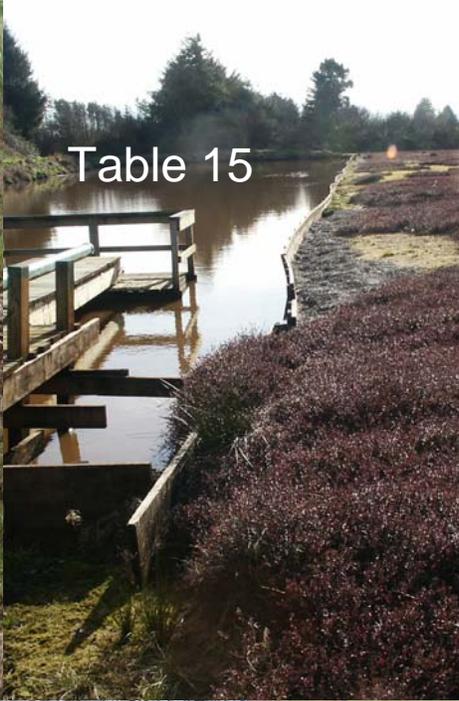
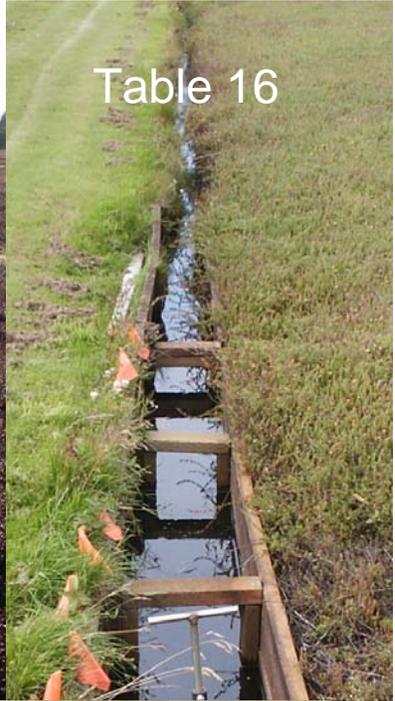
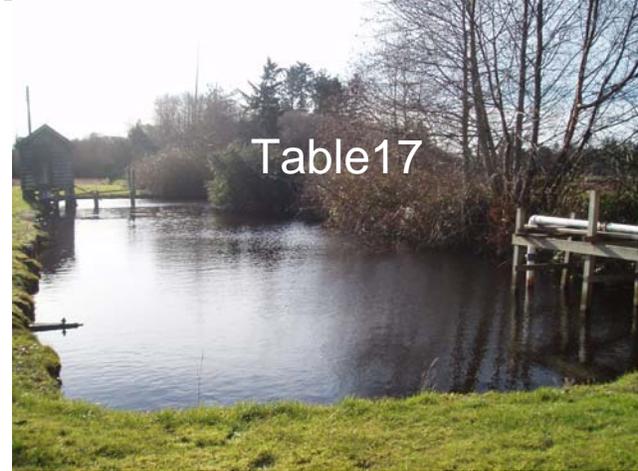
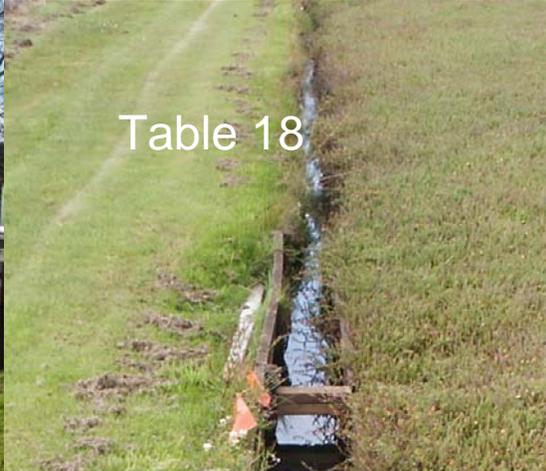
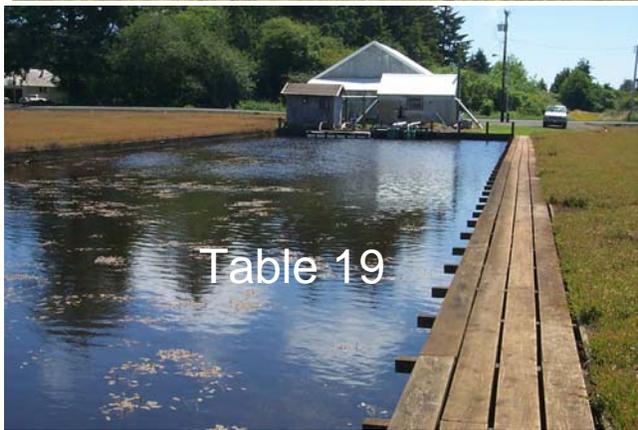
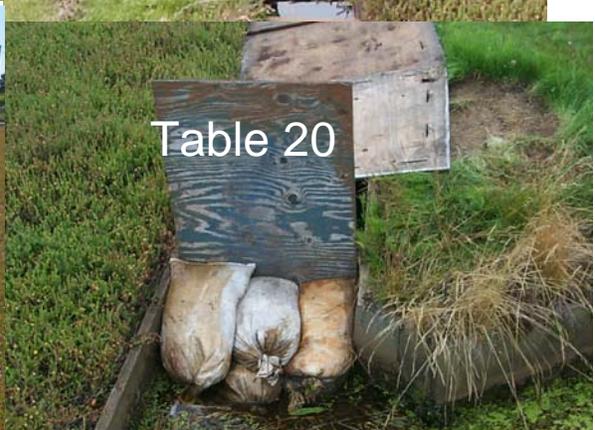
In 2002, three sites were monitored (see attached photos of all water holding sites). In the first site (Table 14), the dammed ditch contained significant weedy vegetation. Guthion went from 8 ppb to 2 ppm in ~ 2-3 weeks, and it took 2 months to get to the non-detectable level. In the second site (Table 15), a closed sump, no Orthene was detected at any of the samples. This most likely reflects the problems with Orthene detection rather than BMP efficacy. In the third site in 2002 (Table 16), a combination sump and ditch system was evaluated. Due to a leaky dam on the ditch end, samples were not collected on the ditch part of the system long enough to make an inference. In the pond part of the system, Guthion was not immediately detected as it was in the ditch. It took one month before it went below the non-detection level.

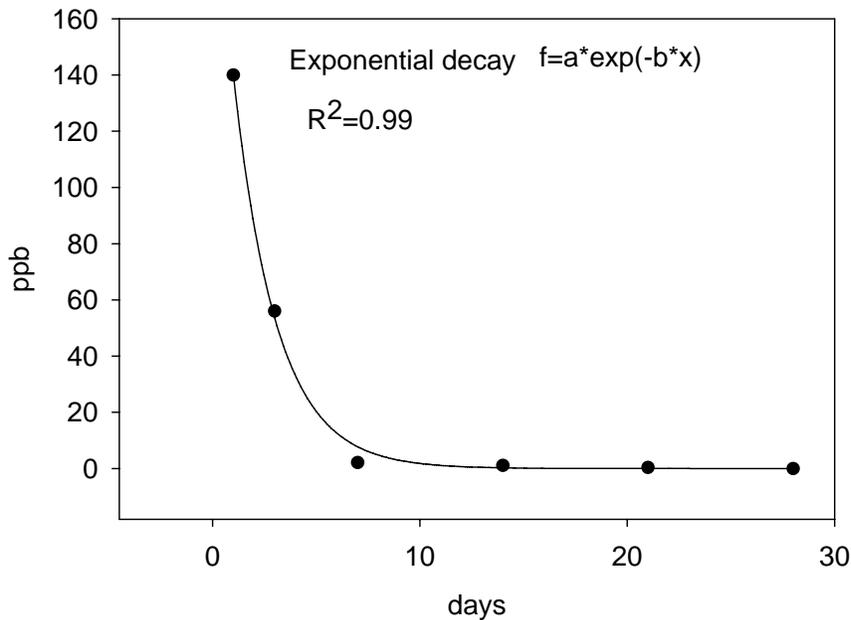
Figure 9. Guthion decay in a cranberry drainage ditch in 2003

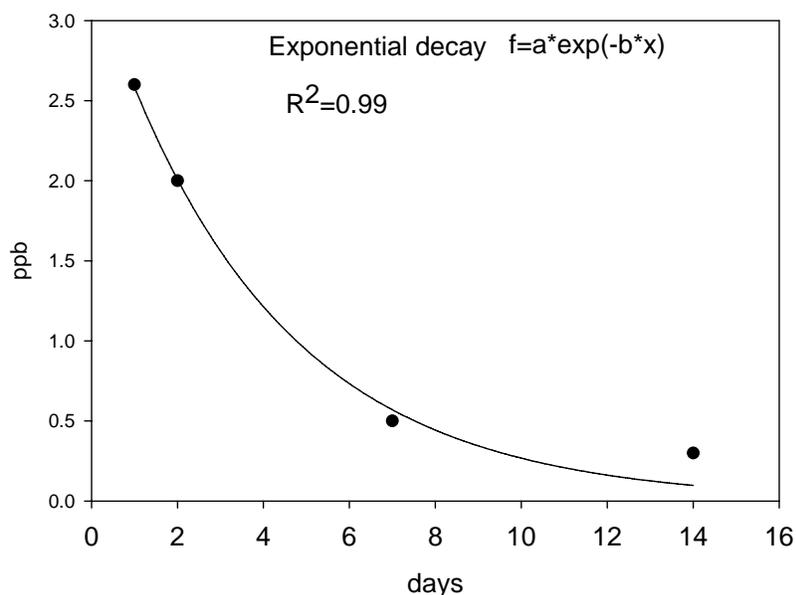
Figure 10. Lorsban decay in a cranberry pond in 2004

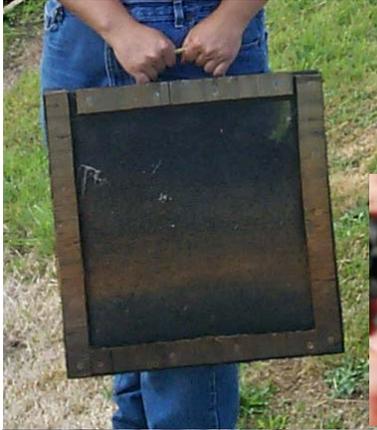
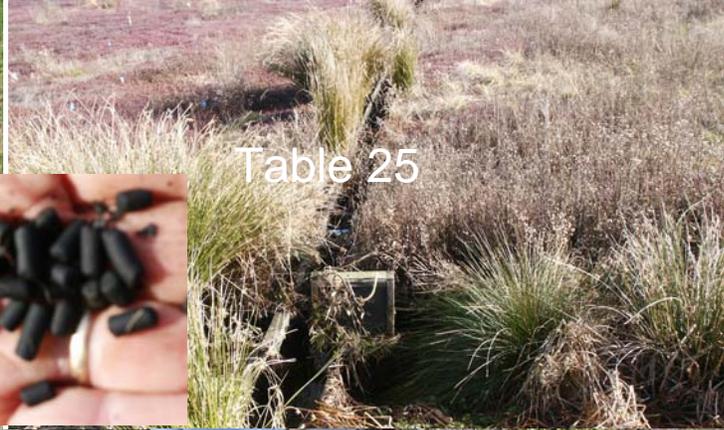
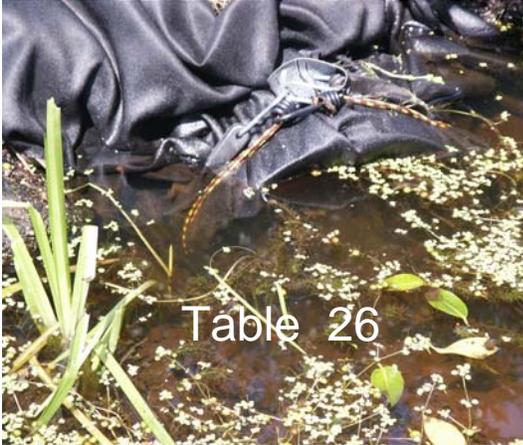
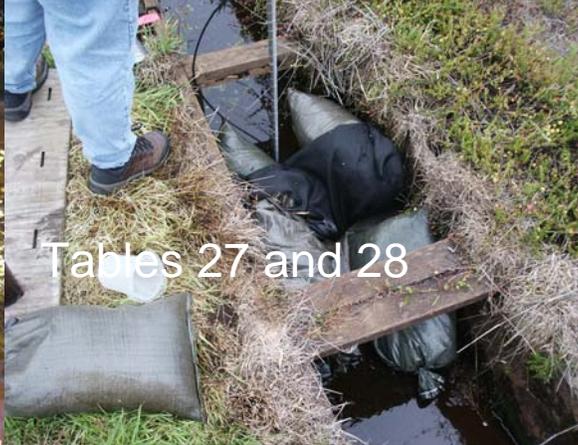
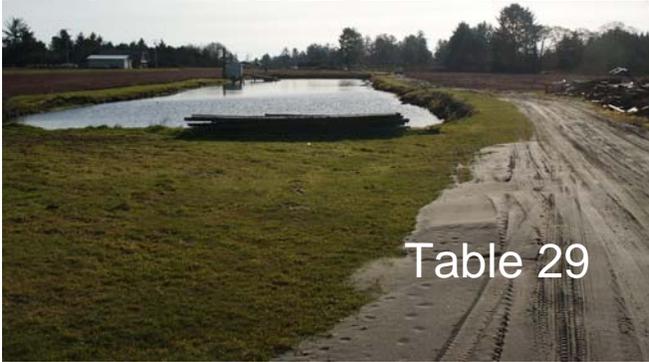
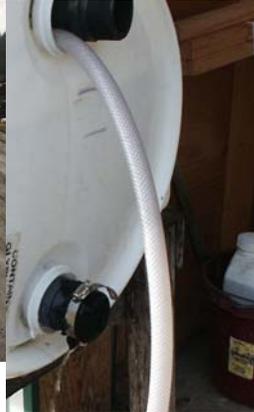
Activated Carbon filters: Two different sets of monitoring studies were done using activated carbon. In 2002, we utilized a system installed by a grower which contained charcoal pellets in a small ditch with a good water flow (Table 25) (see photo of filter and site). Before and after samples indicated that the filter reduced the amount of Guthion in the water by about half. The amount of Guthion in the water after the filter, however, was still many orders of magnitude about the critical level. In 2004, a series of monitoring studies was done using carbon filter cloth (Calgon Zorflex Activated Carbon Cloth - FM1/250) (see photos).

These were installed over small drainage culverts or across small impoundments and water was allowed to slowly move through them. In the first study, two layers of cloth reduced Guthion from 18 to 11 ppb (Table 26). In the second study, 3 and 6 layers of cloth reduced Guthion from 2 to 1 and 0.5 ppb, respectively, but it didn't have much effect on Diazinon (Table 27). In the third study Guthion was reduced from 1.7 to 1.28 to 0.78 to 0 with 0, 3, 6 and 10 layers of cloth, respectively (Table 28).
