Irrigation Uniformity

Teryl R. Roper
Dept. of Horticulture
University of Wisconsin-Madison

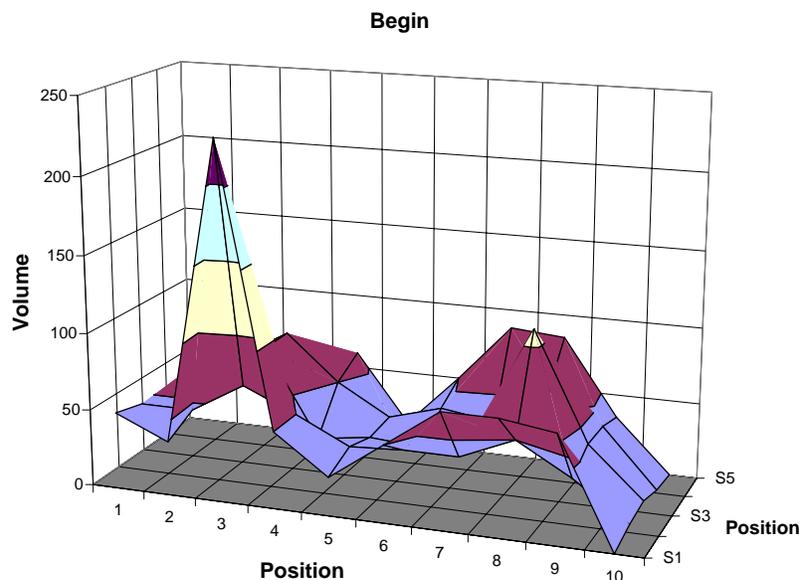
Without making any changes to the system we ran the pump for 30 minutes then measured the amount of water in each bucket. The results of this test are shown in Figure 1. The location of the sprinklers is clearly evident in the figure. We had a slight breeze blowing across the beds and that shows in the lack of water in the buckets at position 10. The uniformity coefficient for system was 51%.

Figure 1.   Volume of water per bucket in a 15 x 15 foot grid pattern before any changes were made to the system.

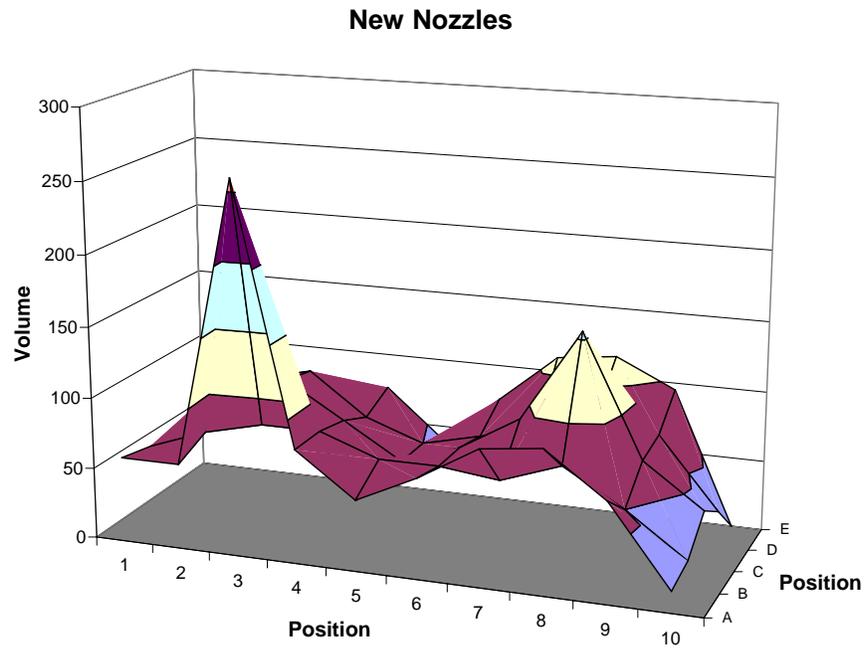
New Nozzles

Nozzle replacement. Our first upgrade to the system was to replace the worn nozzles with new ones of the same size. The old nozzles had worn a little bit and they had been cleaned of debris by inserting a wire through the nozzle and this had scratched the openings. We then ran the sprinkler system for 45 minutes and measured the amount of water in the buckets again. The results of this test are shown in Figure 2. We ran the system 15 minutes longer this time and that increased all values somewhat. However, notice that the surface is much flatter. The uniformity coefficient for the system with new nozzles was 66%; a substantial improvement.

Figure 2.   Volume of water per bucket in a 15 x 15 foot grid pattern after nozzles were replaced with new ones of the same size.

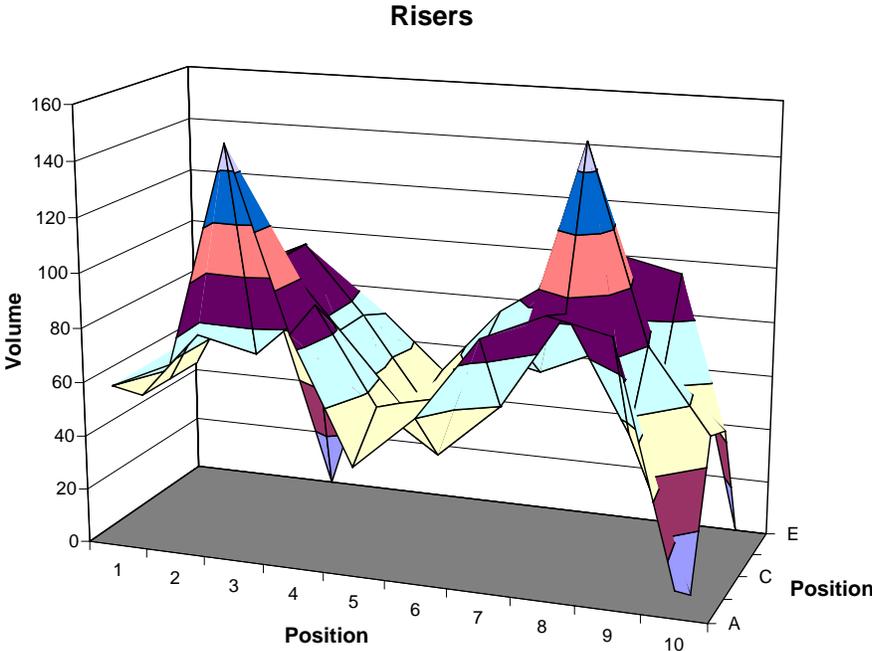
Risers

Riser Height. Our next upgrade was to increase riser height from 12 to 18 inches. We also staked the risers and made sure they were plumb using a spirit level. The existing risers were not completely plumb so water distribution was not completely even around their coverage area. We ran the sprinklers for another 45 minutes and measured the water caught again. The results are shown in Figure 3. Using taller risers evened out water distribution a little more, but the uniformity coefficient increased only a couple of points to 68%.

Figure 3. Volume of water per bucket in a 15 x 15 foot grid pattern after nozzles were replaced with new ones of the same size and rise height was increased from 12 to 18 inches.

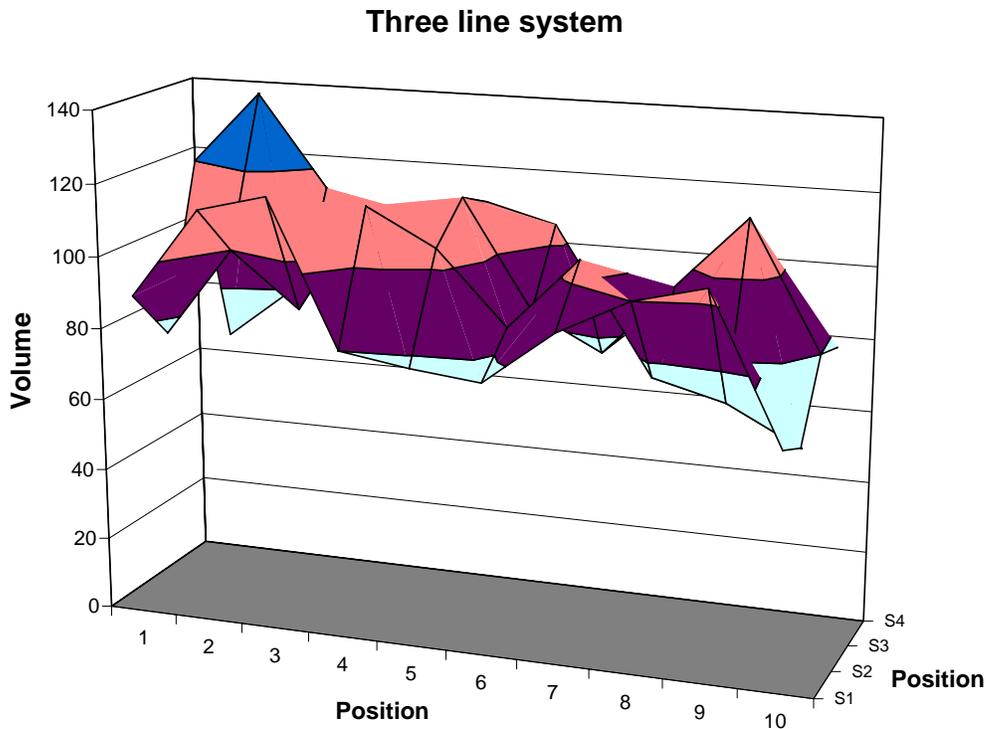
Three line system. We were then able to obtain funding to replace the irrigation system in this bed with a three-line system using high uniformity sprinklers. We ran our test again with the buckets in the same positions as before. The uniformity coefficient for this configuration was exactly 80%. The results are shown in Figure 4. Clearly the uniformity is higher. The uniformity would have been higher had we run the system longer. Further, some of the buckets were tipped and if they had been perfectly upright our results would have been more accurate.

Figure 4. Volume of water per bucket in a 15 x 15 foot grid pattern after the system was upgraded to a 3 line system with high uniformity nozzles.
