DENGERINK TILE COLUMN REPAIR

WASHINGTON STATE UNIVERSITY - VANCOUVER
C/O FACILITIES SERVICES, CAPITAL
P.O. BOX 641150
PULLMAN, WA 99164-1150

CONDITION ASSESSMENT
APRIL 2025

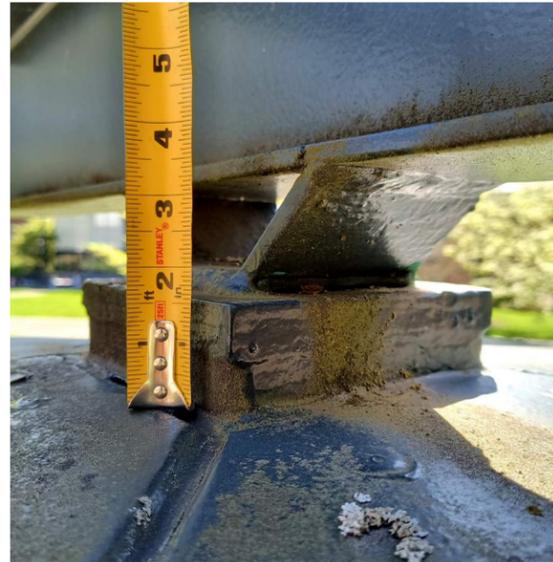
◀ Figure 1: (L) Central steel tube protrusion above column cap.

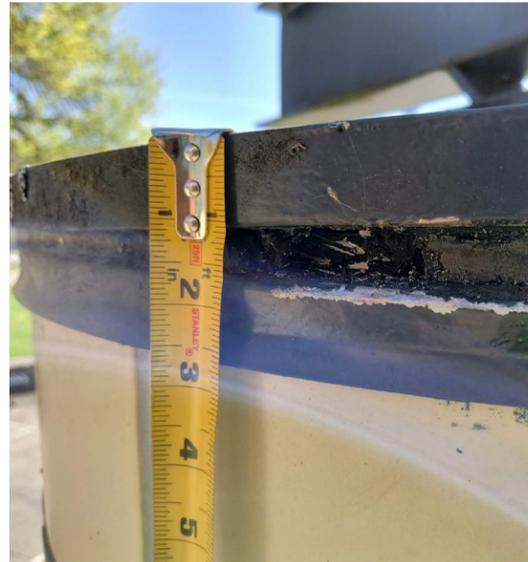
◀ Figure 2: (R) Column cap edge, sealant joint, and drip flashing.

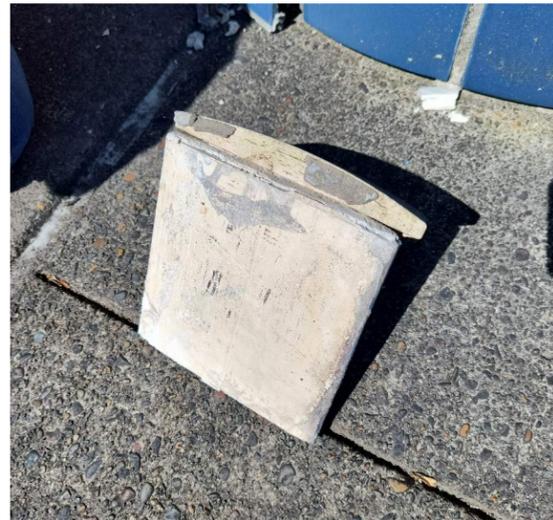
◀ Figure 3: (L) Column tile profile showing the tile is radiused.

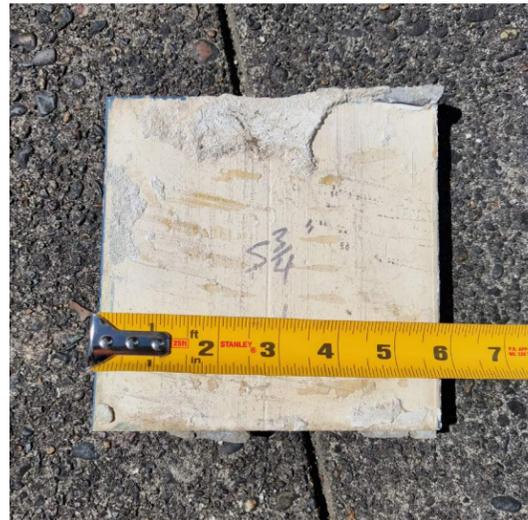
◀ Figure 4: (R) Square column tile measurement.

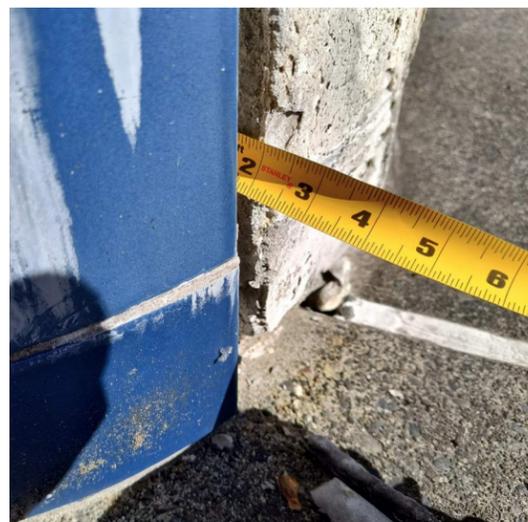
◀ Figure 6: (R) Tile substrate thickness.

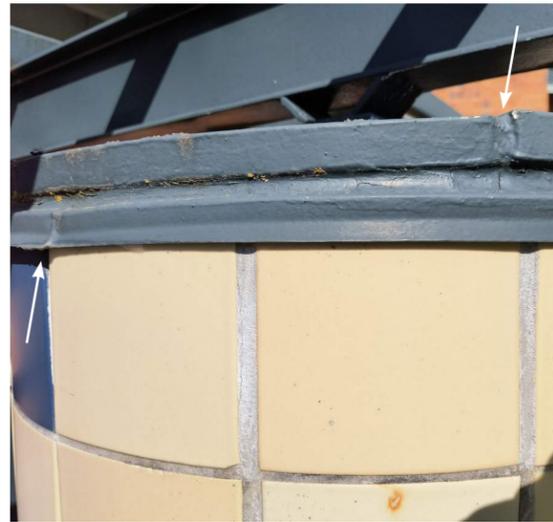
◀ Figure 15: (L) Staggered joints of column cap and drip edge flashing.
◀ Figure 16: (R) Sealant at welded joint; dirt build-up from water running over cap.

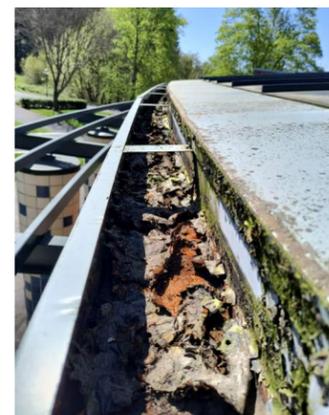
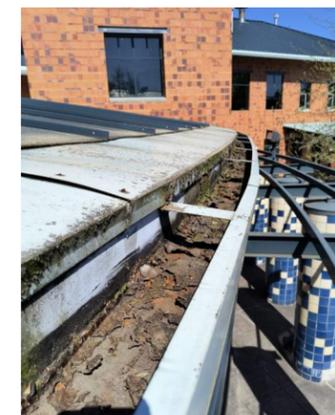
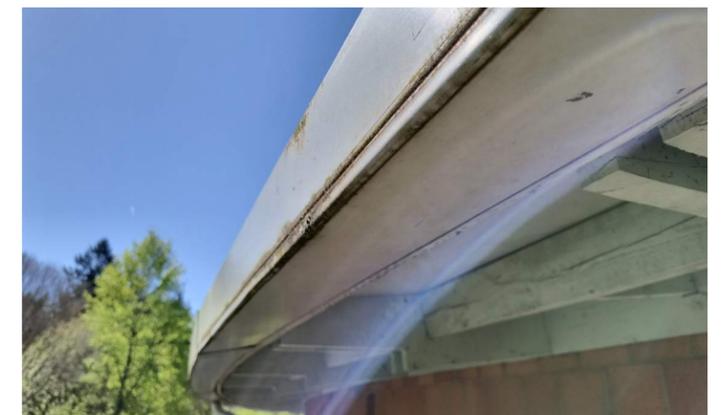
Unrelated to the "Dengerink" columns, PMA noticed the adjacent gutter system of the auditorium roof appears to be leaking as evidenced by a semi-continuous drip-line on the concrete directly below the gutter (see Figure 23). PMA visually assessed the gutter and confirmed it is not filled with debris (see Figures 30-32), but was unable to confirm where the gutter is leaking from given the dry conditions during both site visits.

▶ Figure 30: (L) Roof gutter, looking south.

▶ Figure 31: (C) Roof gutter, looking north.

▶ Figure 32: (R) Side and bottom of gutter.

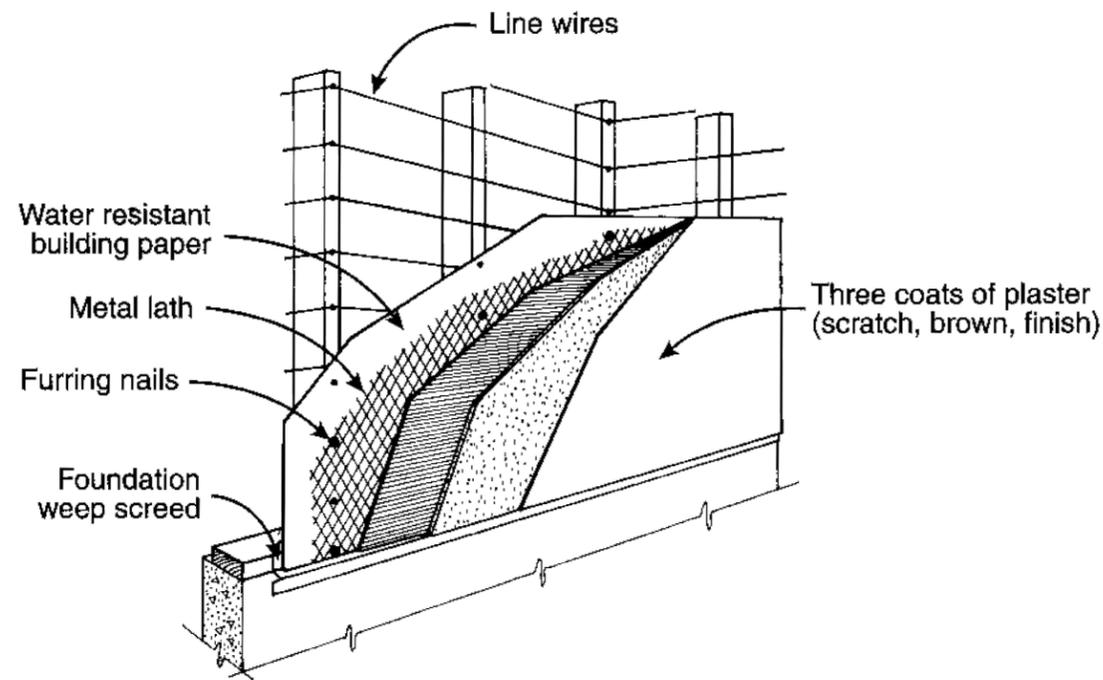
◀ Figure 33: Example of a stucco assembly over studs. (Portland Cement Plaster / Stucco Manual, 5th Ed., 2007)

- **Stucco:** Rebuild a new steel stud substrate sub-structure, with base tracks raised off of ground level to protect from moisture, and install a new stucco assembly. The stucco will provide an appropriate substrate for new paint or tile art. This option is most similar to the existing construction and the least expensive. (See Figure 33)

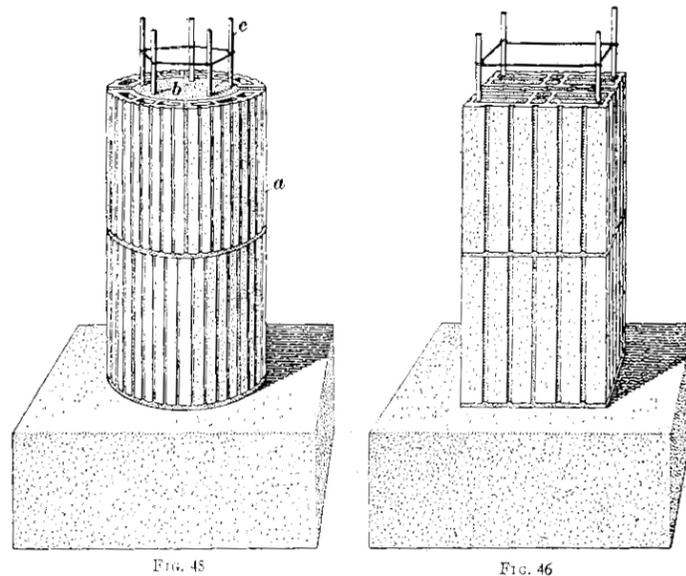
◀ Figure 34: Example of hollow clay tile columns. (Hollow Tile Construction and Stucco Finish, 1924)

- **Pre-cast or Hollow-Tile Blocks:** Rebuild each column out of pre-cast or hollow-tile blocks which will provide a durable, smooth substrate for art. This option is simple to install and has a high degree of longevity. (See Figure 34)
