# SAFETY, HEALTH, AND SECURITY COMMITTEE MEETING AGENDA AND MINUTES

| 1. MEETING DATE<br>July 23, 2026 | 2. CAMPUS, COLLEGE, AREA, DEPARTMENT, PROGRAM, BUILDING, OR WORK UNIT COMMITTEE OR MEETING NAME<br>Nuclear Science Center | | |

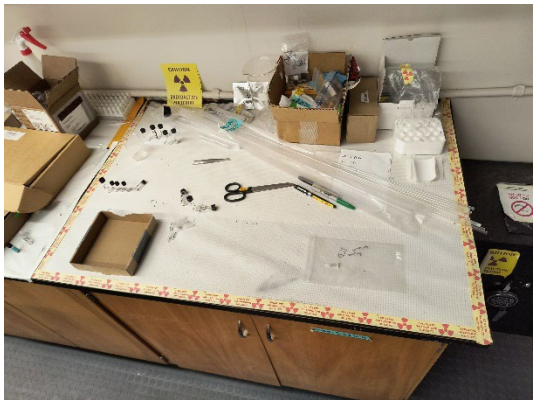
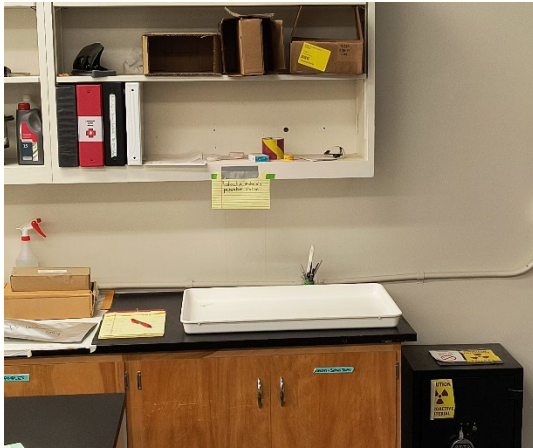
| ID INFO | SAFETY CONCERN | STATUS / RESOLUTION |
|---|---|---|
| | | <p>Picture of Rad area on 10/3/25</p> |
| <p>8/4/25<br/>Dodgen<br/>121<br/>#9076</p> | <p>There is an open (uncapped) bottle of nitric acid with something hanging out of it (not clamped) with no labels (see picture).</p> | <p>The Guo Group has been notified of the safety concern at 3:30 pm on 8/4/25. The Guo group removed the items in the nitric acid, but the nitric acid bottle remained on the counter and did not address any of the items of concern listed in the message to the Guo group.</p> <p>Picture of area on 8/26/25:</p> <p>No change as of 10/3/25.<br/>An email was sent to Dr. Guo and Eric Roalson.</p> |

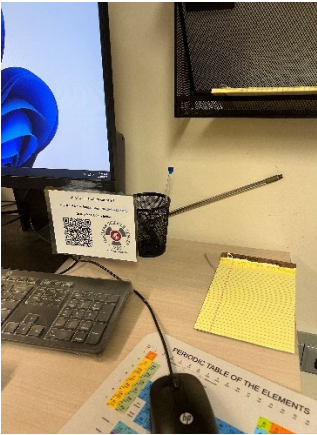
| ID INFO | SAFETY CONCERN | STATUS / RESOLUTION |
|---|---|---|
| | <p>I removed the sample and pen cup for now</p> | |
| <p>2/24/26<br/># 13076<br/>Fulmer<br/>B3</p> | <p>I turned around from the workstation and looked at the sample prep bench and saw another sample in the pen cup for the radioactive NMR sample prep pens and sharpie</p> <p>It was checked with the GM to at least verify the outside wasn't contaminated or radioactive.</p> | <p>Samples were discarded. User contacted.</p> |

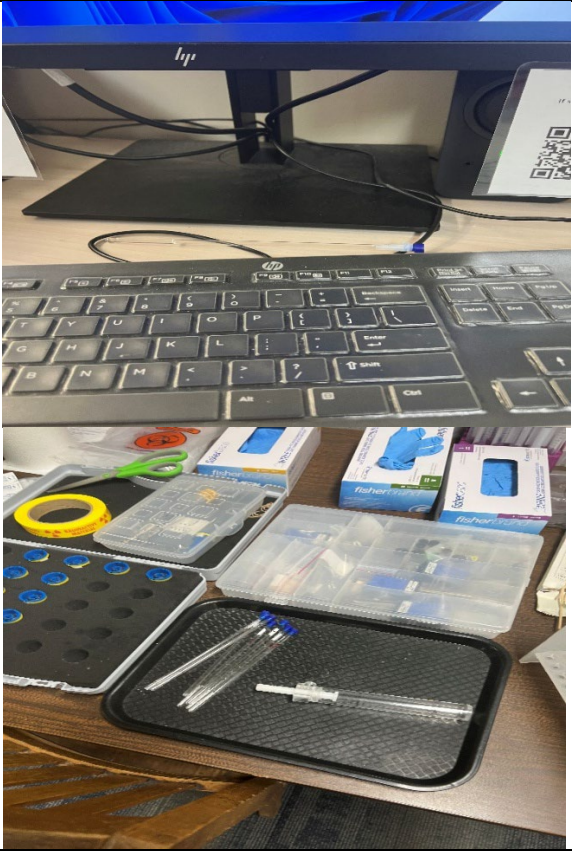
| ID INFO | SAFETY CONCERN | STATUS / RESOLUTION |
|---|---|---|
| <p>4/6/26<br/>#13429<br/>Fulmer<br/>B3</p> | <p>Plastic spinner for radioactive samples is missing. Looked in the case with all of the non-rad spinners, but it is not there. Radioactive depth gauge has not been moved. No other safety concerns at this time.</p> | <p>The spinner was found among the other spinners. The labeling on the spinner was faded (see below picture), making it not clear that it was the spinner designated for radioactive samples. The spinner was relabeled and placed with the radioactive sample analysis materials.</p> |
