Pacific madrone provenance trial – fall 2013 assessment

Starker Forests site

Pacific madrone trial: Starker Forest site -
fall 2013 assessment

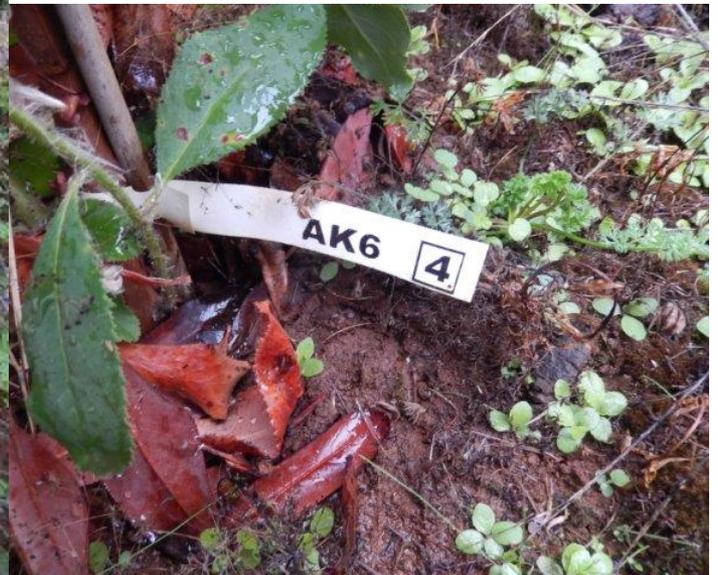
One of the variegation Pacific madrone at Starker Forests site – they occurred within ~3 rows of the road (DSCN606-607.jpg)

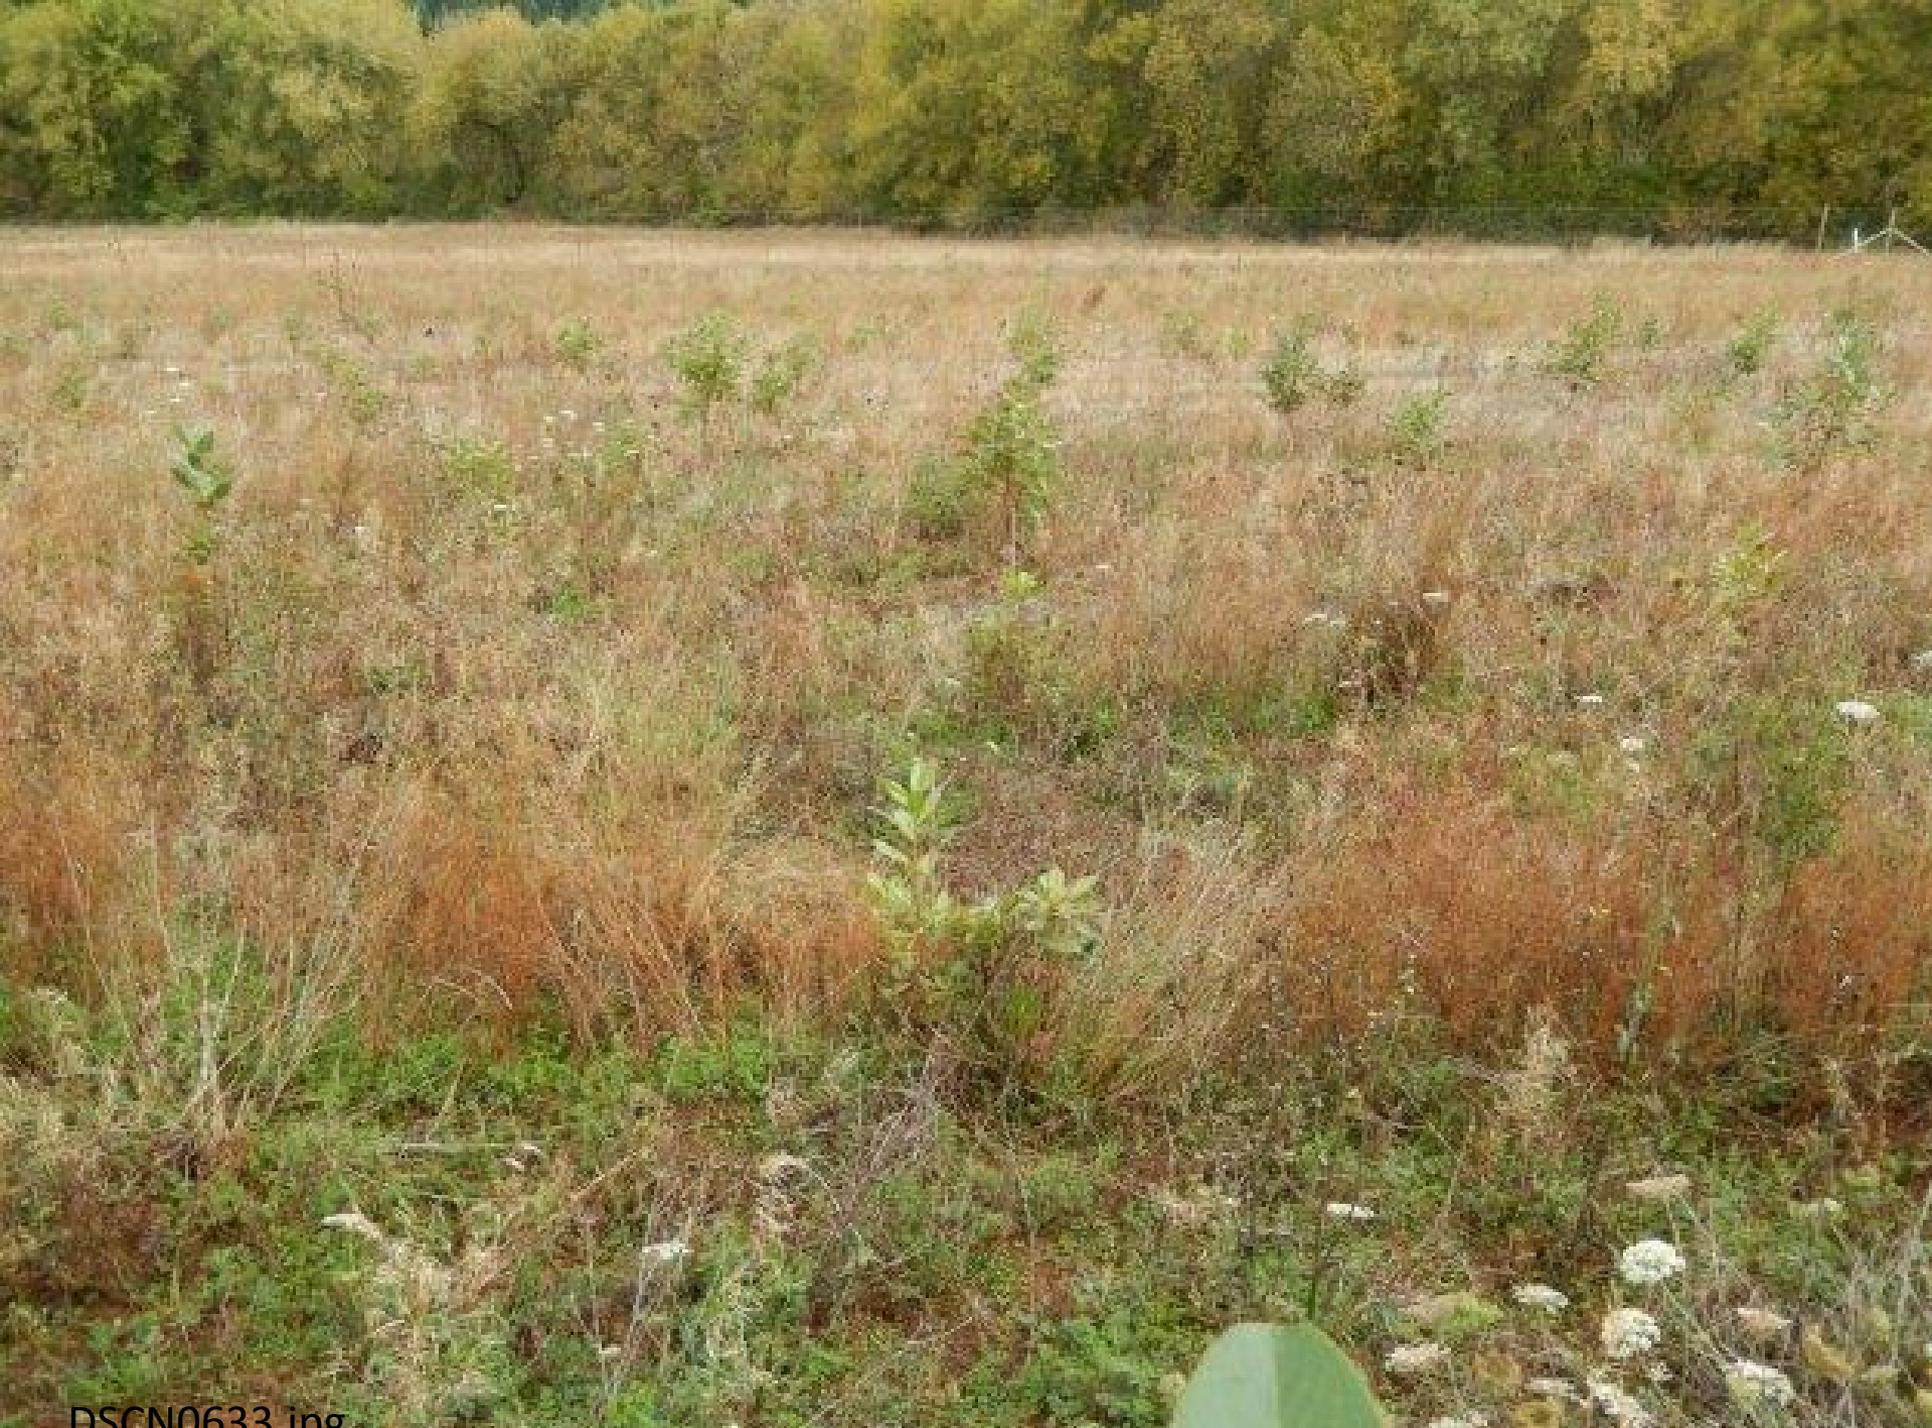
CP26 with leaf spots (DSCN0634.jpg)

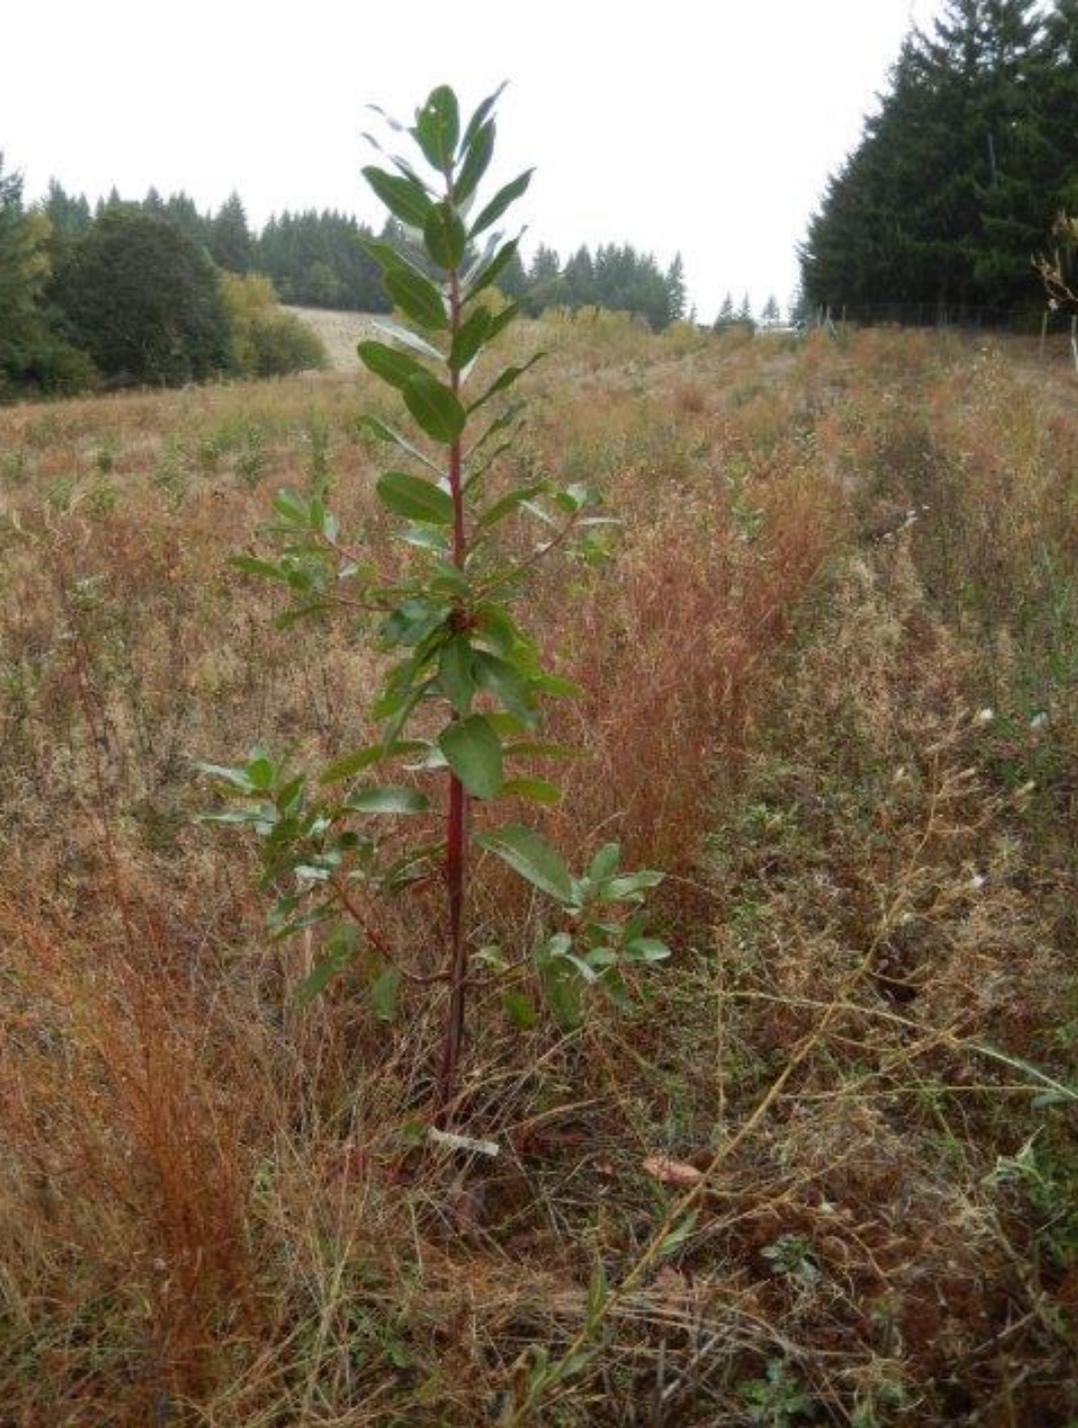
Tall, single stemmed madrone
(DSCN0639-0640.jpg)

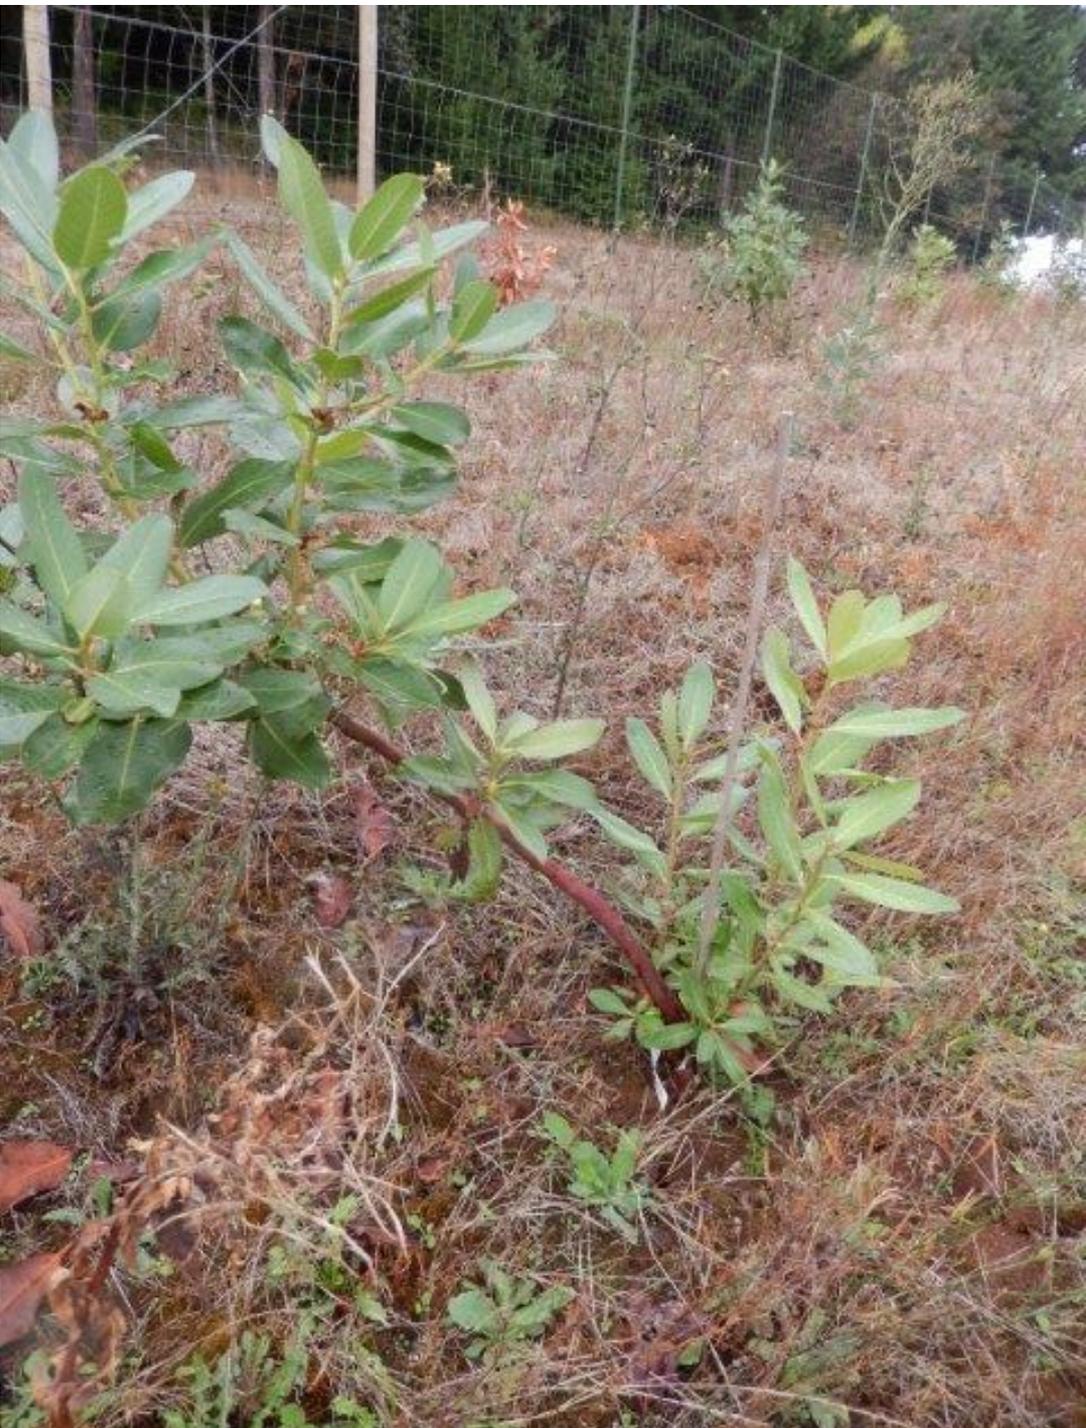
Leaning tree
(DSCN0641-0642.jpg)

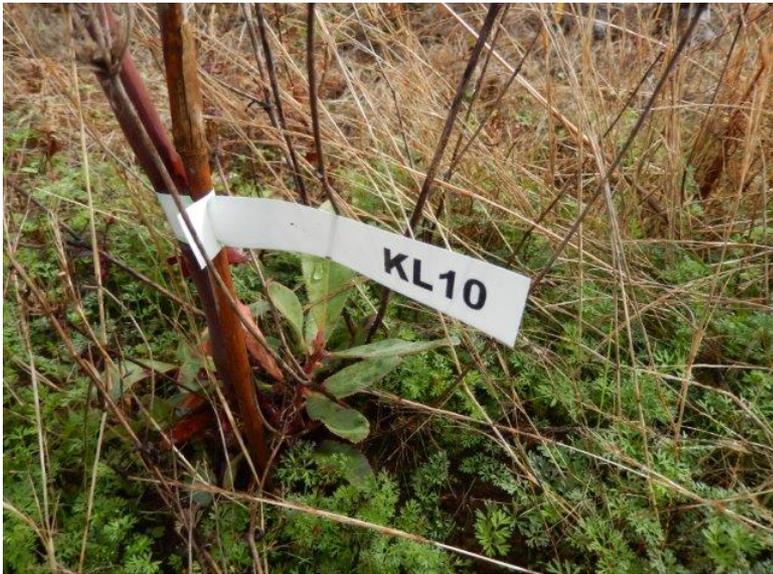
Leaf spotting on a KL10 tree (DSCN0643-0645.jpg)

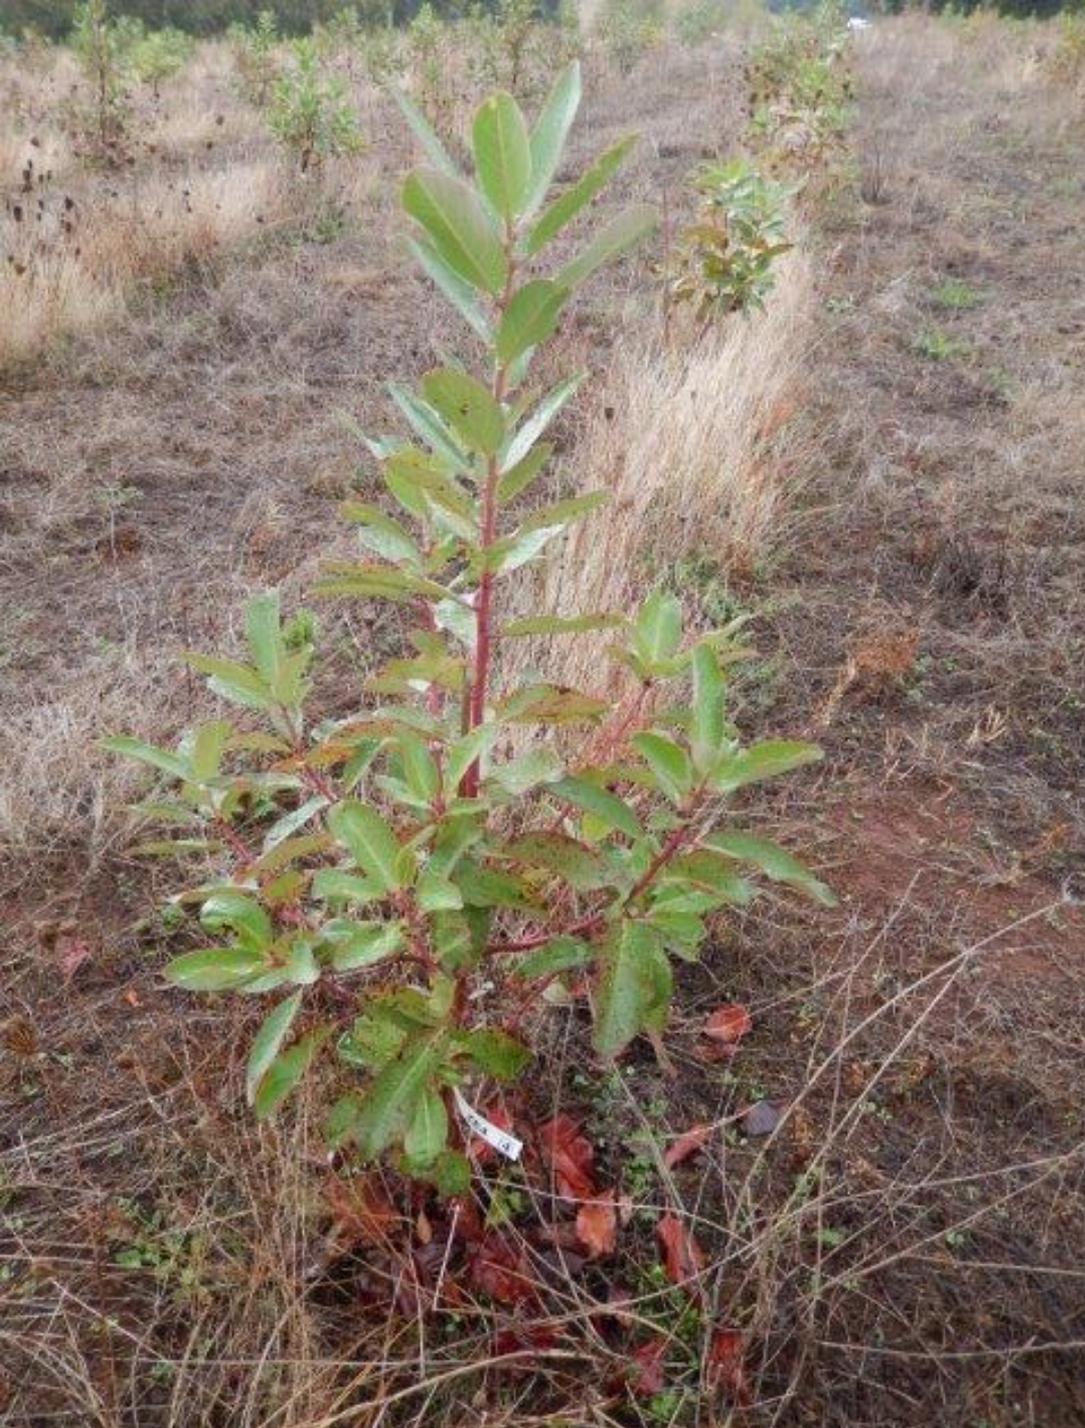
Leaf spot on old leaves
(DSCN0658-0659.jpg)

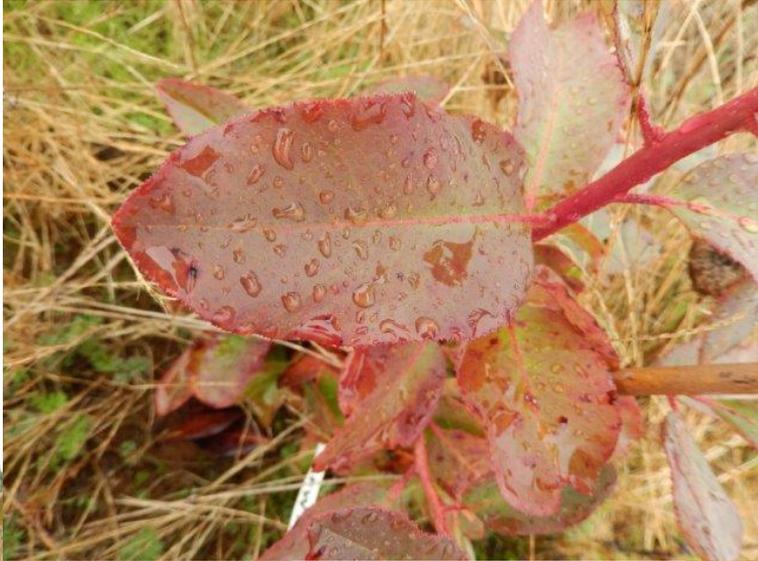
Red-green foliage on FW10 tree

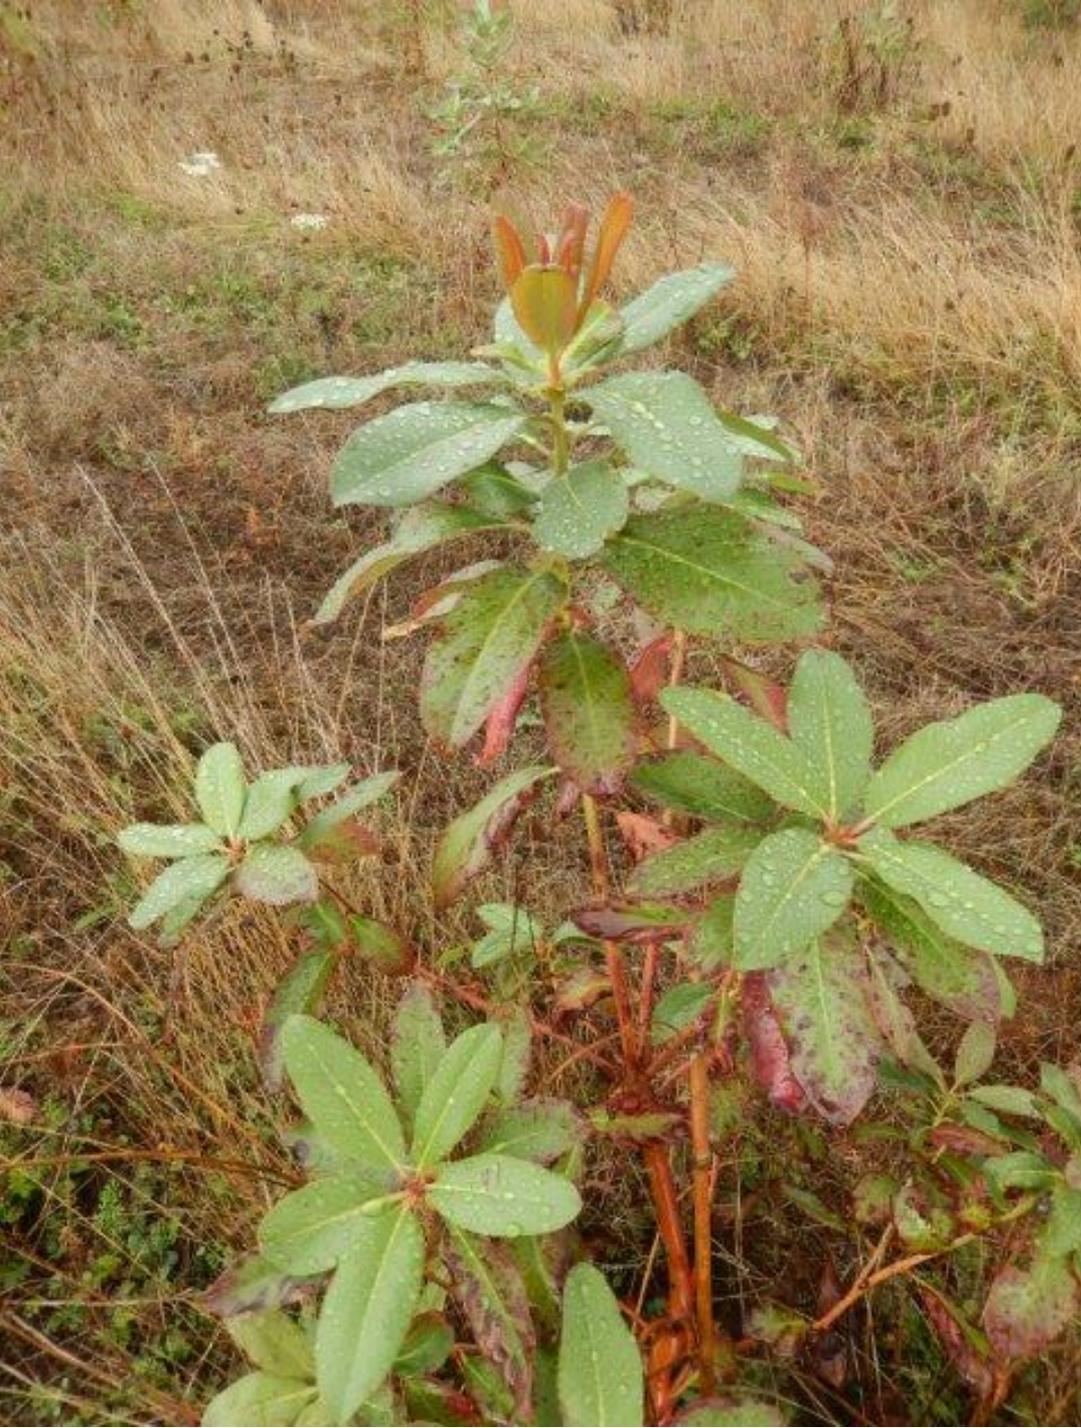
New growth at top of SA5(2)
